U.S. MAGNET
DEVELOPMENT
PROGRAM

15 T dipole coil potting issues: status report

January 24, 2018

US Magnet Development Program
Fermi National Accelerator Laboratory

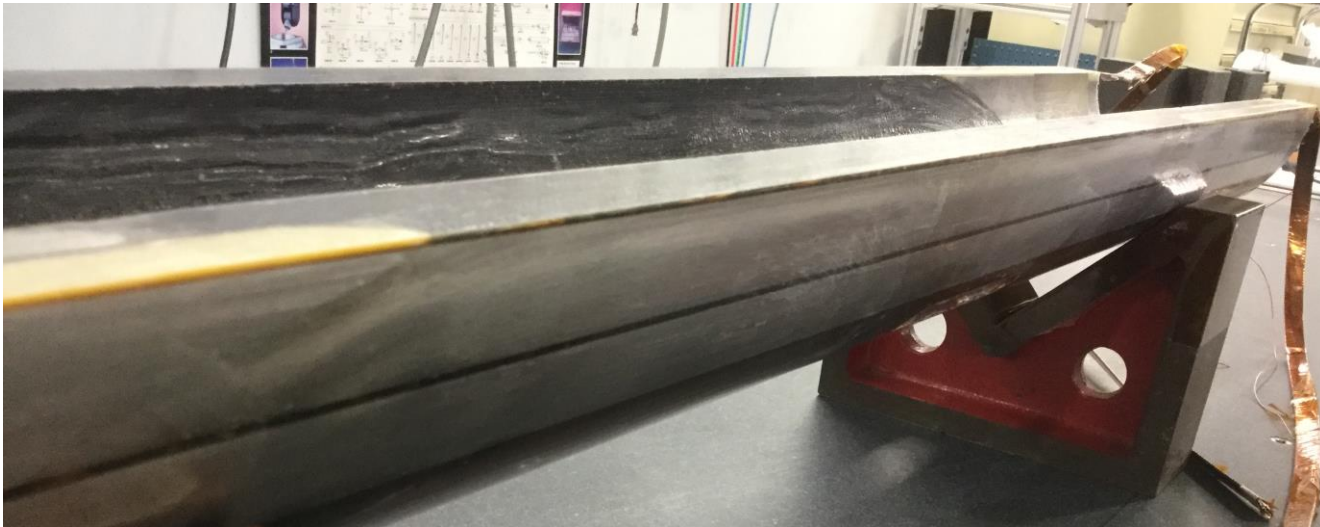
Introduction

- Visual inspection of the 1st impregnated L3-L4 coil HFD-CL2-002 has revealed large dents on both sides of the coil outer surface and wrinkles on the coil inner surface
 - substantial degradation of the magnet quench performance
- The purpose of the coil review
 - to identify and correct possible effects related to the coil impregnation procedure
 - develop a plan to replace the lost coil with minimal impact on the program.

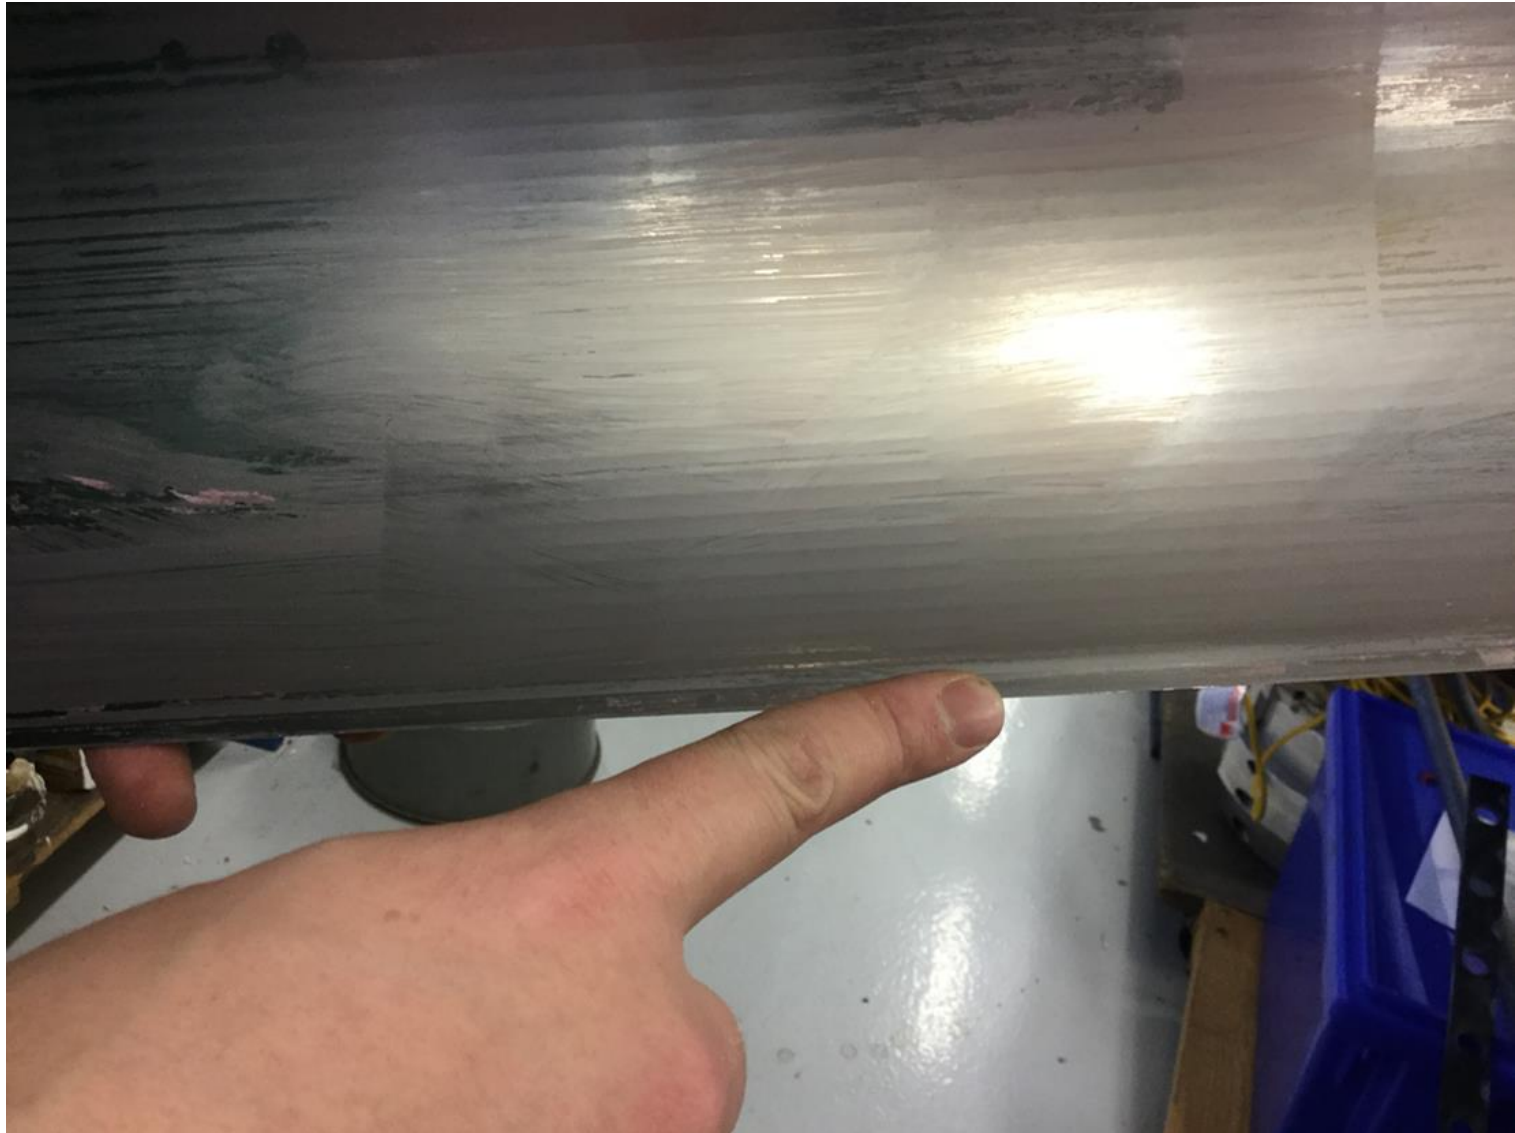
Shell buckling

Started from 35mil SS Shims

Buckling in shell

- **Outer surface dents**
 - Modify the impregnation base plate [186.3mm]
 - Trim the impregnation shell [2mm]
- **Inner surface pockets**
 - Increase mandrel OR by 0.127mm [sticky Kapton or Teflon tape]
 - Fill pockets with Stycast and re-cure

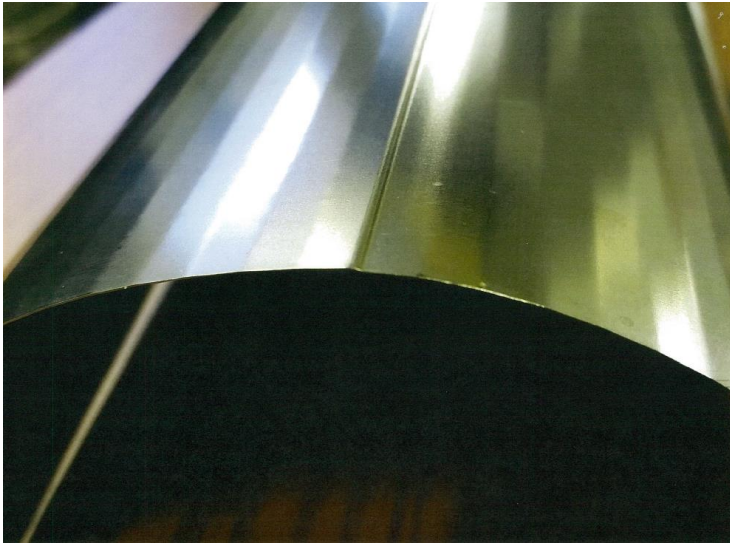
Causes of impregnation shell buckling

$$\rho_{\text{spec}} = 305.9 \text{ mm}$$

- Shell was initially rejected due to crease and it was slightly “short”
- Crease was rolled out by Igor and heavy duty rolling pin
- Undersize on arc length probably caused by crease

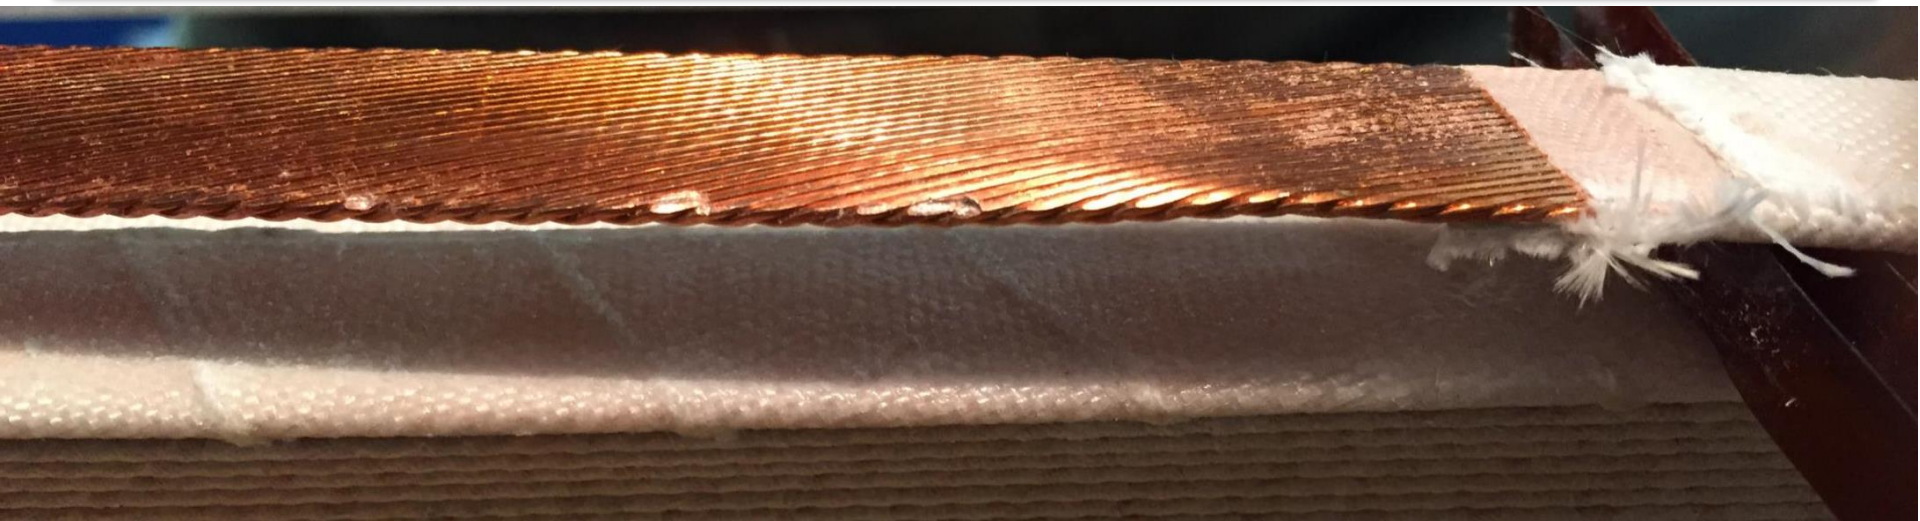
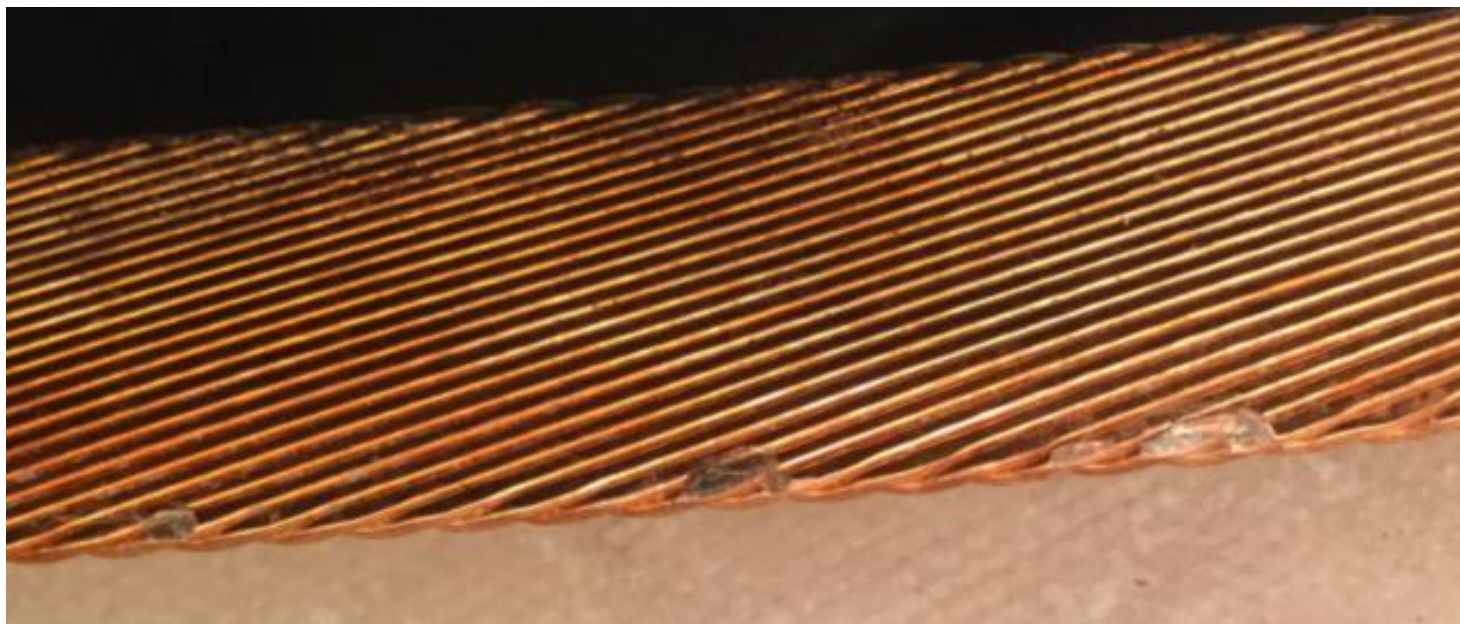
Transition cable damage
