Evidence of Excessive Ag-Mg Grain Growth Resulting in Sheath Rupture and Leakage of Bi-2212 Rutherford Cables During Overpressure Processing

Christopher Escobar¹, Jean-Francois Croteau¹, Jianyi Jiang², Mehul Nair¹,
Tengming Shen¹

1. Lawrence Berkeley National Lab
2. National High Magnetic Field Lab

Presented at the US Magnet Development Program Biweekly meeting.

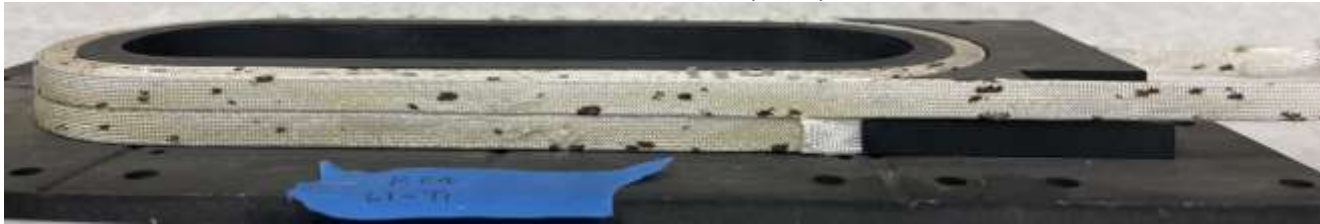
Racetrack Coil 4 (RC4)

- Leakage frequency is inconsistent. RC4, for example, leaked much more than RC5 despite having the same wire architecture, cable parameters, and heat treatment schedule.
- **Why such variation?**

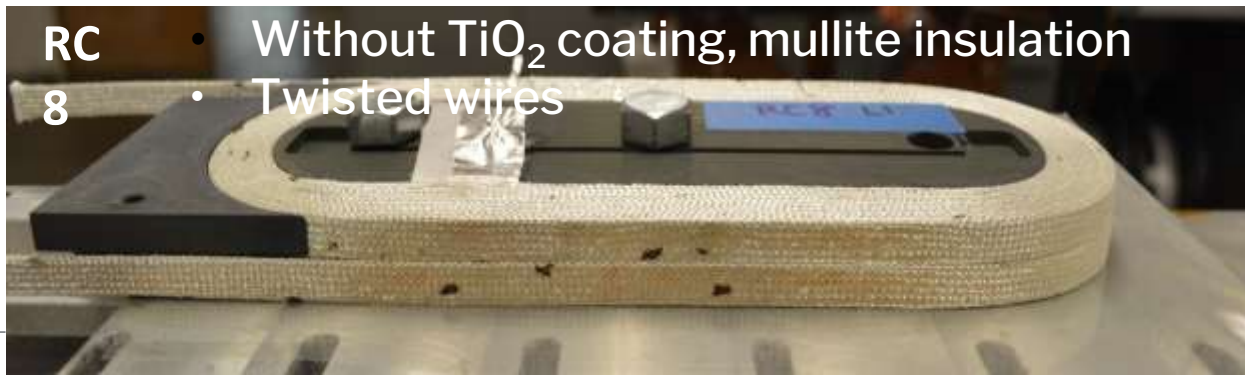
Mullite + TiO₂
Nearly no leakage

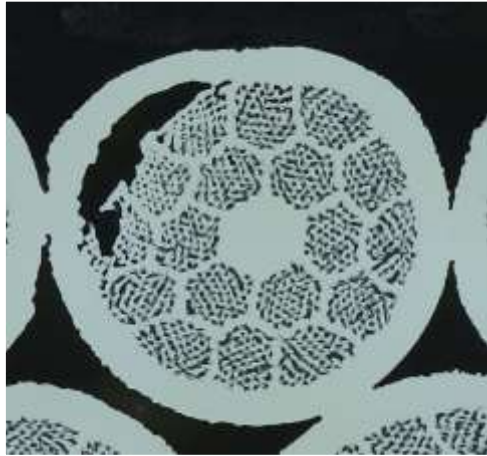
RC5: 3/18 Bundles affected

Sheath Debonding and
Internal Leakage

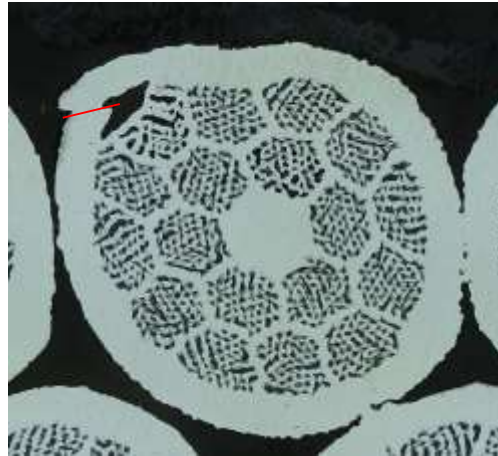
RC5: 1/18 bundles affected

Sheath Rupture resulting
in **external leakage**

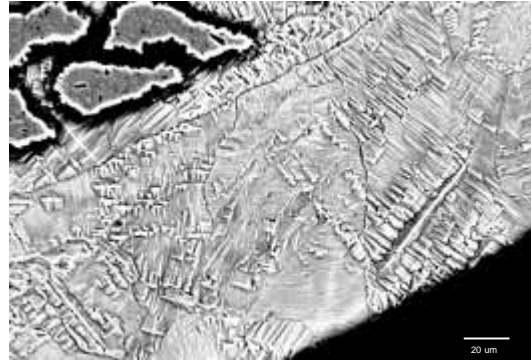
ARDAP #4: Very large grains, no intermediate annealing. Leakage in the OPHT round wires. (J. Jiang)

- Wire manufacturers: Understand how grain growths associated with their raw materials and thermomechanical processing.
- Cabling@LBNL: Can **intermediate annealing** (5% rolled, annealed, then 20% rolled; 10% rolled, annealed, and then 20% rolled.) help remove the strain energy and prevent excessive grain growths and leakage?

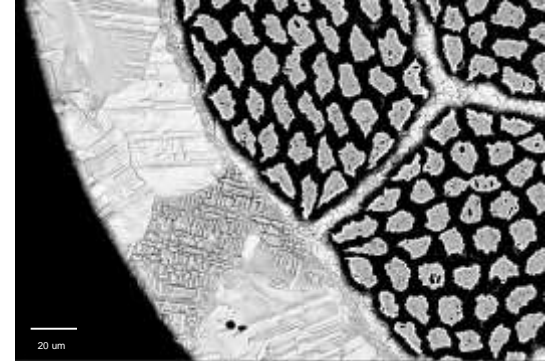
ARDAP #5: Large grains are present, some variance. Leakage in the rolled OPHT ARDAP #5 strands (S. Barua)

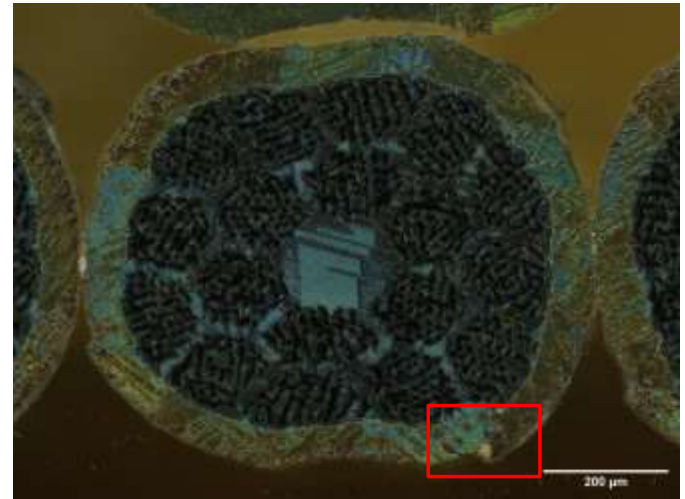
RC5 Strand in
Rutherford Cable
Coil: OPHT

- The deformation of the wire during the cabling process spurs grain growth at those boundaries.
 - We hypothesize that these grains are more ductile and densify at different rates, resulting in sheath rupture (indicated by red box).

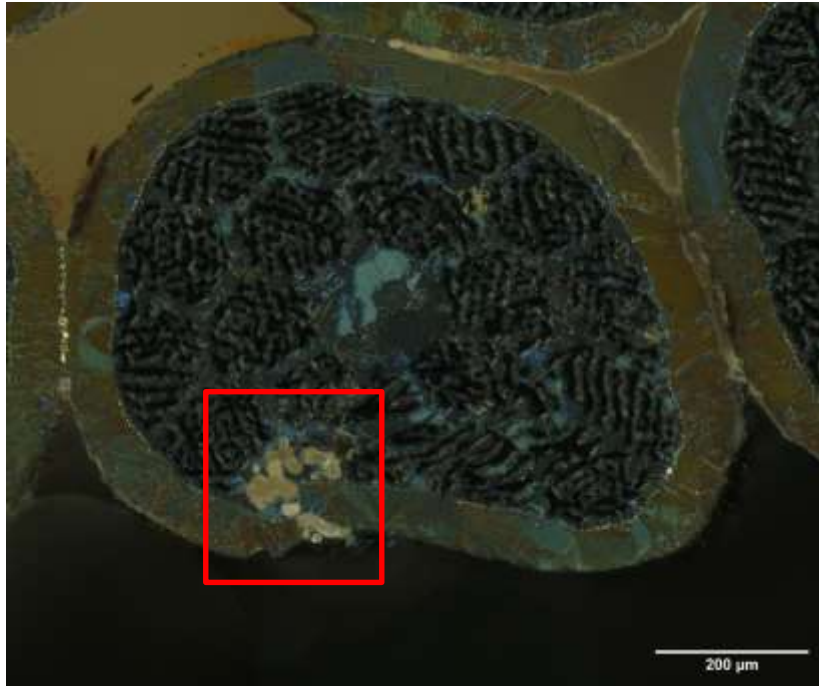
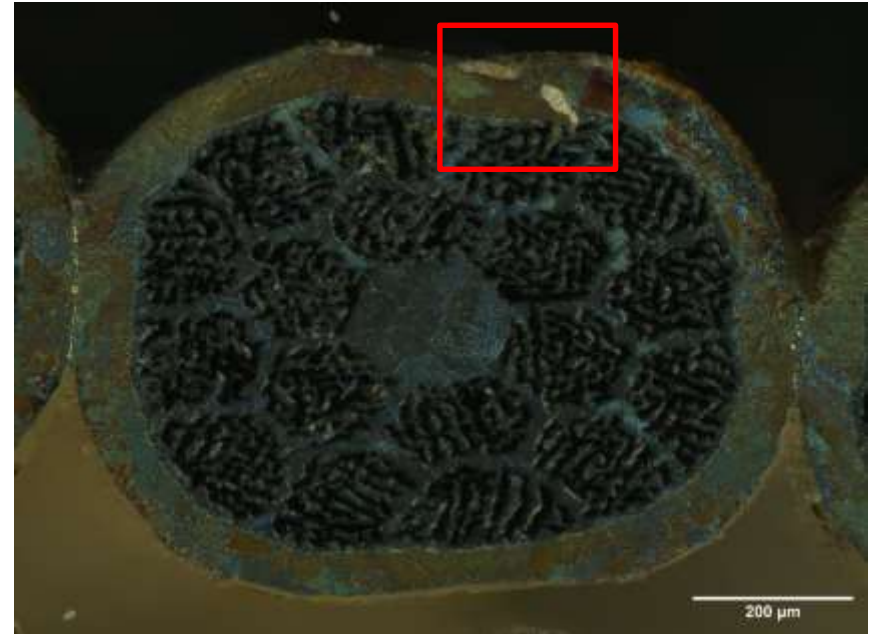
Microstructure of RC4 coil cross-section confirmed large AgMg Grain Growths connected with sheath ruptures

- Grain Size analysis of sheath rupture regions of the RC4 coil strands

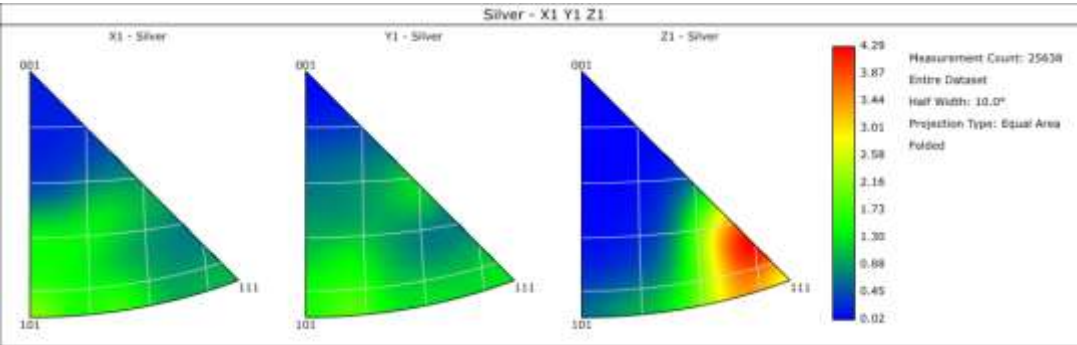
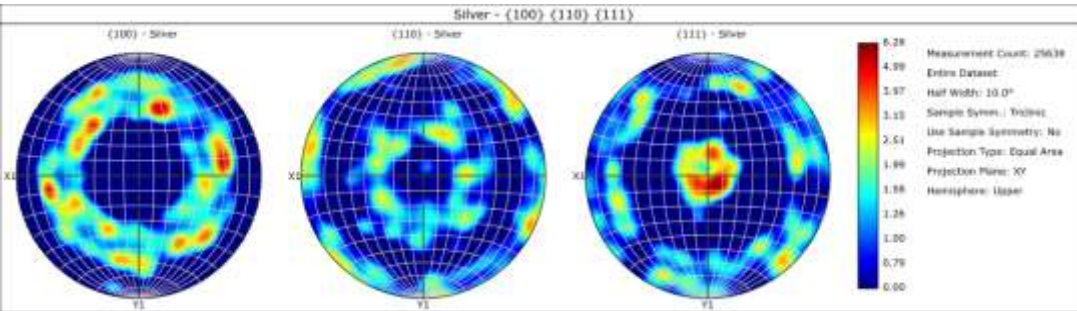
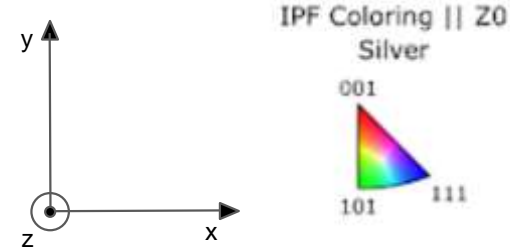
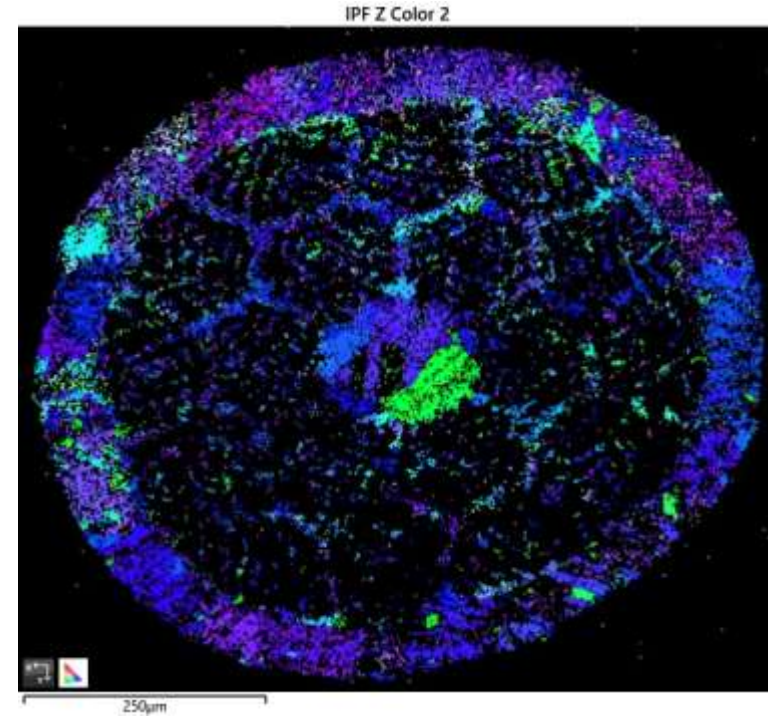
RC4 RW: OPHT Round Wire

- We hypothesize that the leakage discrepancy is a result of large grains that are formed or already exist in the Ag-Mg sheath.
- RC4 OPHT shown in the next slide
