Analyses of the plastic deformation of coated conductors deconstructed from ultra-high field test coils

Xinbo Hu, Michael Small, Kwanglok Kim, Kwangmin Kim, Kabindra Bhattarai, Anatolii Polyanskii, Kyle Radcliff, Jan Jaroszynski, Uijong Bong, Jeong Hwan Park, Seungyong Hahn and David Larbalestier

Aug 05, 2020

The Little Big Coil NI coil went through 3 iterations..(LBC1-3)

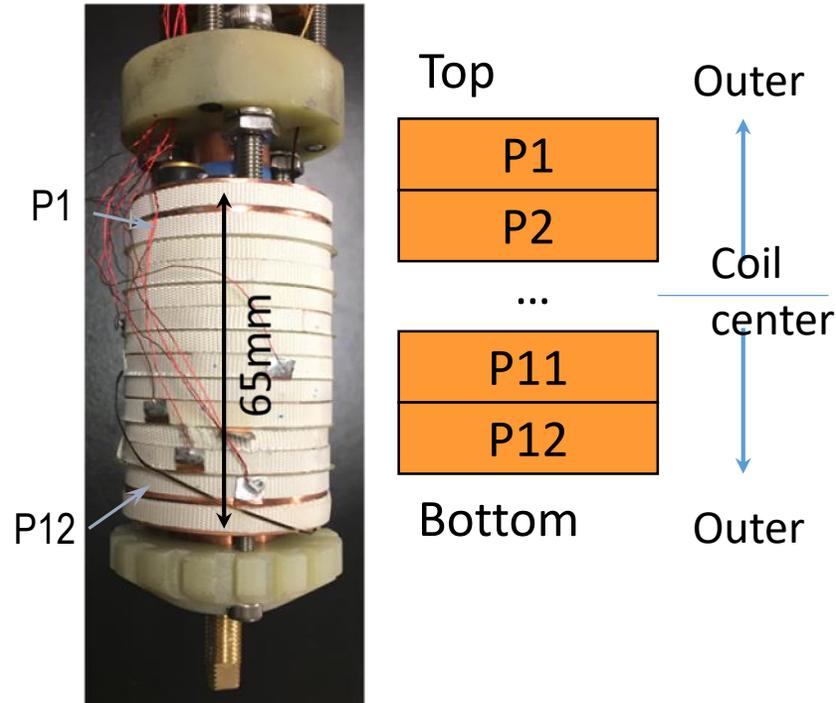
Multiple pancakes showed rippling (permanent plastic deformation of the tape ($Y_S \sim 1$ GPa, ~ 2 x nominal JBr stress

- One edge of the tape is stretched longer than the other.

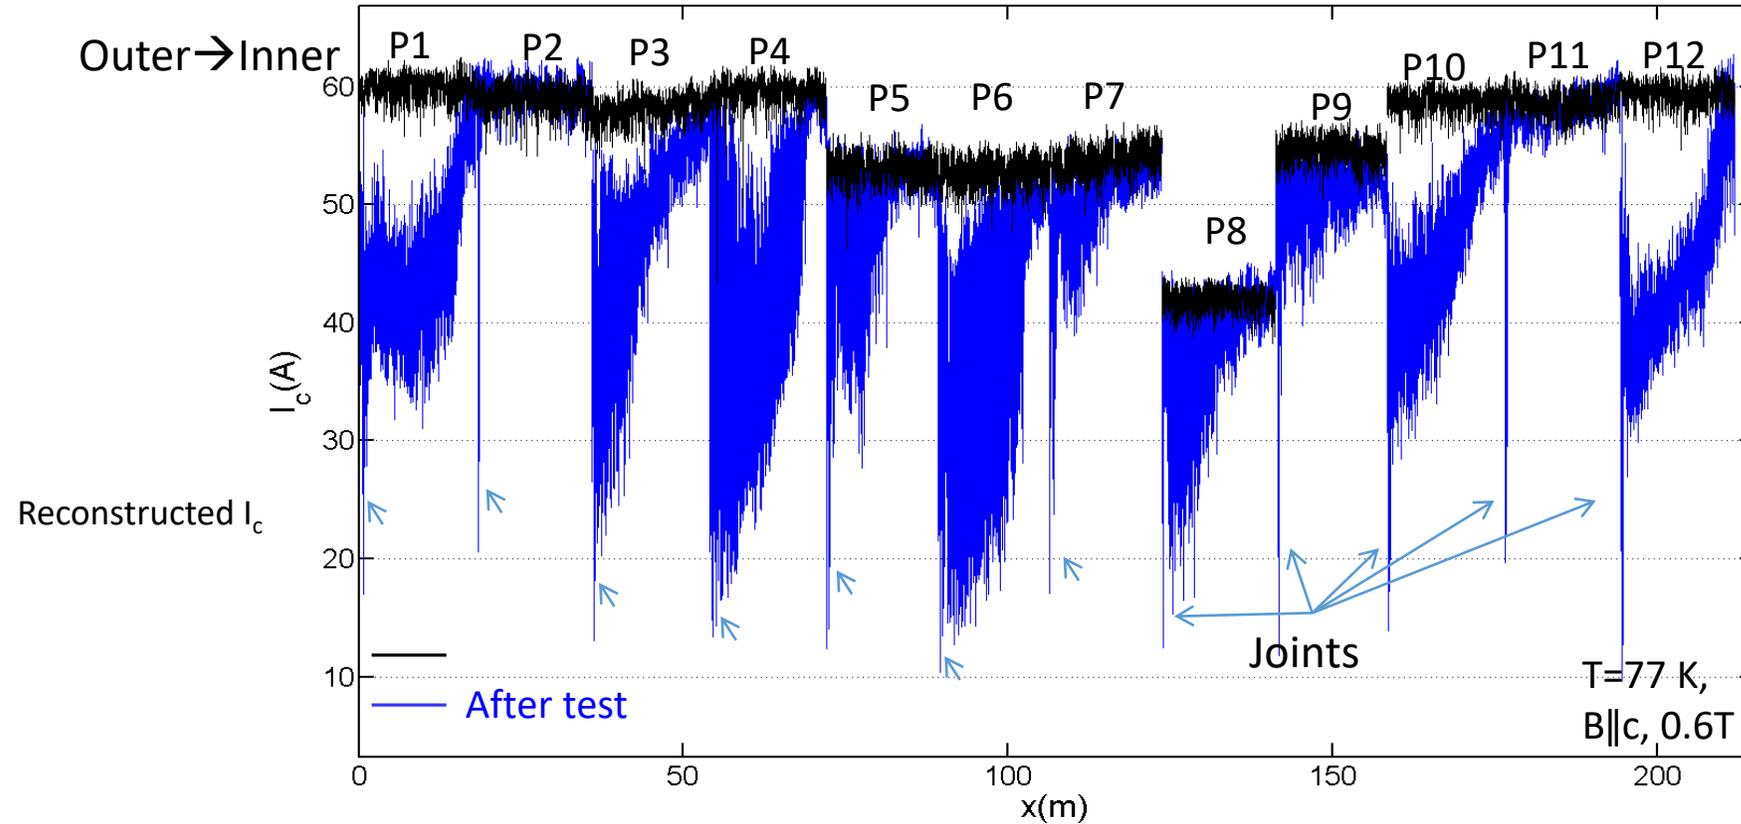
Using our transport and Hall array in-line measurement system (YateStar) we found clear evidence of conductor damage AFTER test for all pancakes EXCEPT P2 and P11

- The big dropouts on outer turns came from outer solder joints.
- Maximum degradations are close to the outmost turns but not on them.
- Indications of hoop stress occur on outer turns which we believe occurred during quench rather than from energization to field (Note that PC 2 and 11 do NOT have this damage).

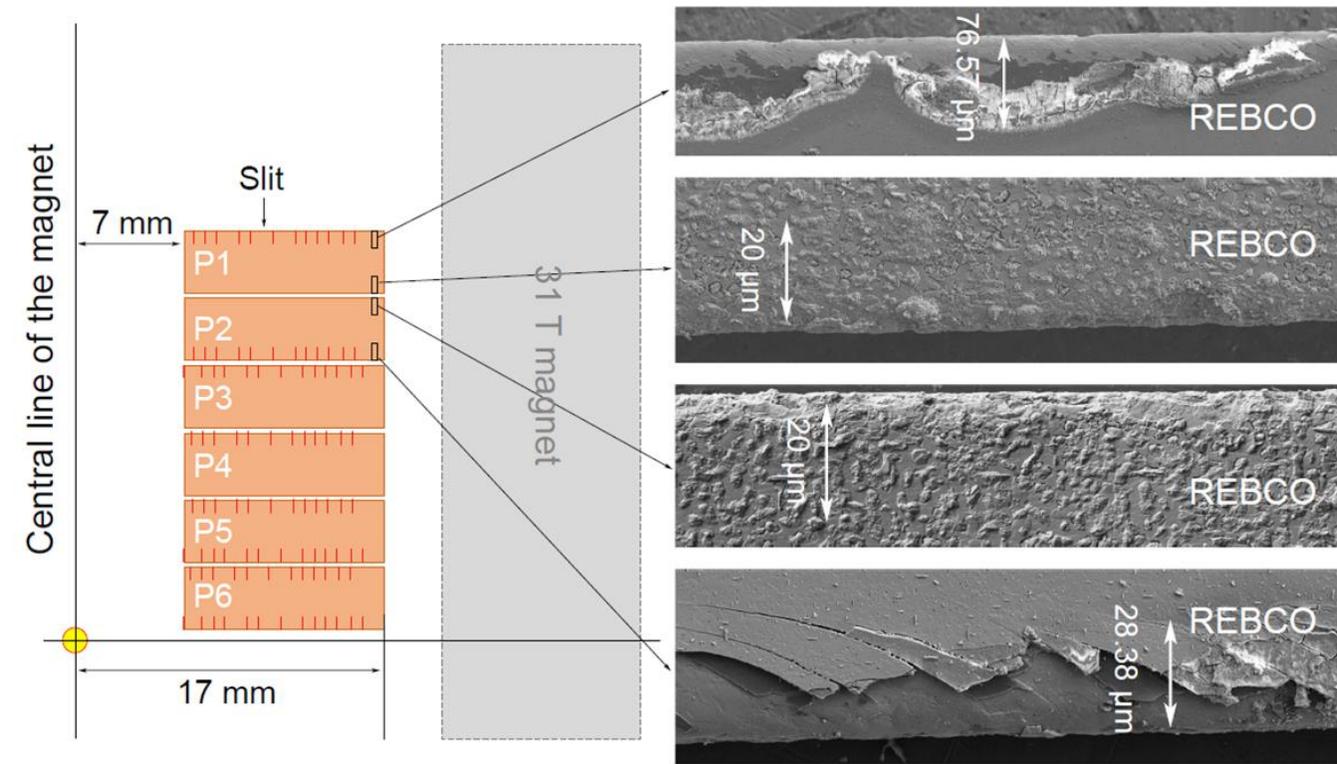
An important observation is that the slit edge is more easily damaged when placed towards the outside of the magnet

Delamination on the slit edge

No damage on not-slit edge

Delamination on the slit edge associated with slitting cracks

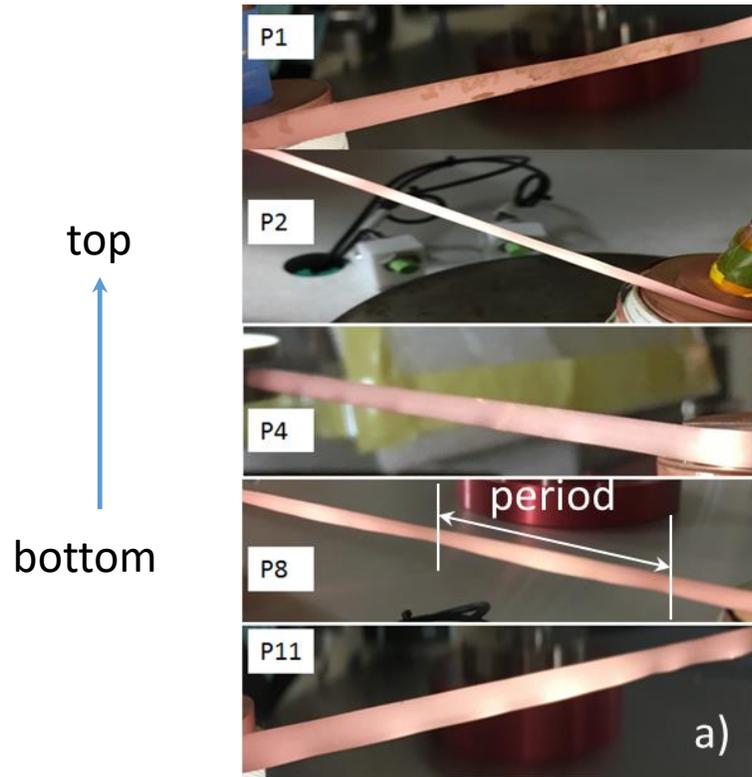
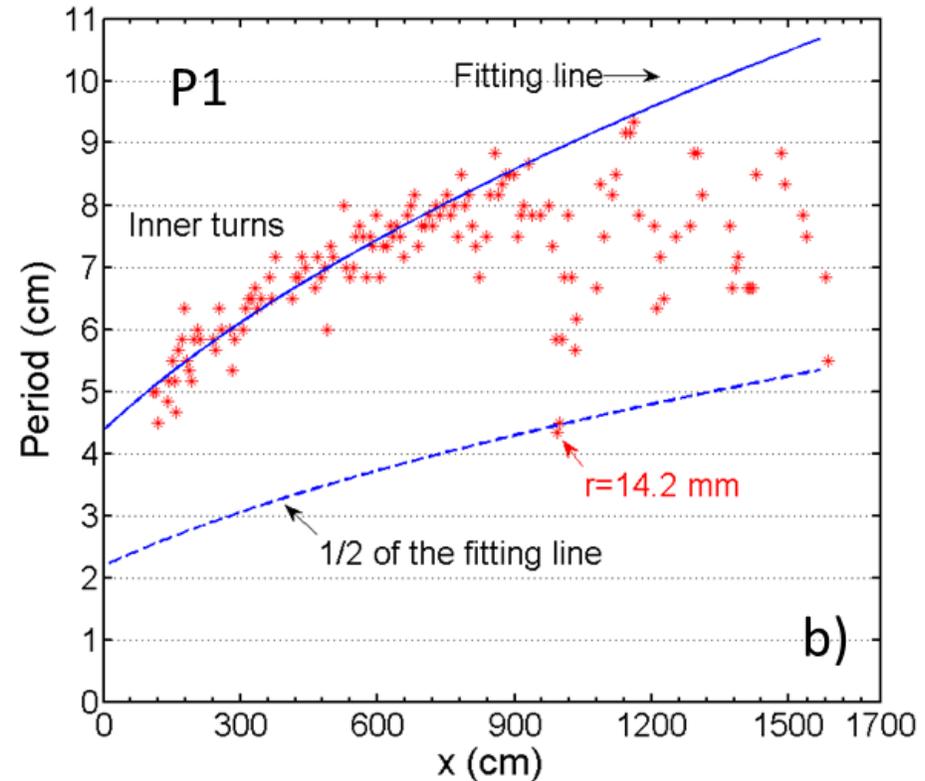
LBC2

The plastic deformation is periodic in the middle turns but not the outermost turns

- Ripple period versus tape position from the inner to the outer turns of P1, LBC2. The fitting line is the circumference of inner to outer turns versus tape position.
- Outermost turns have more random ripples. Innermost turns have no rippling. Joint heating is probably not the reason.

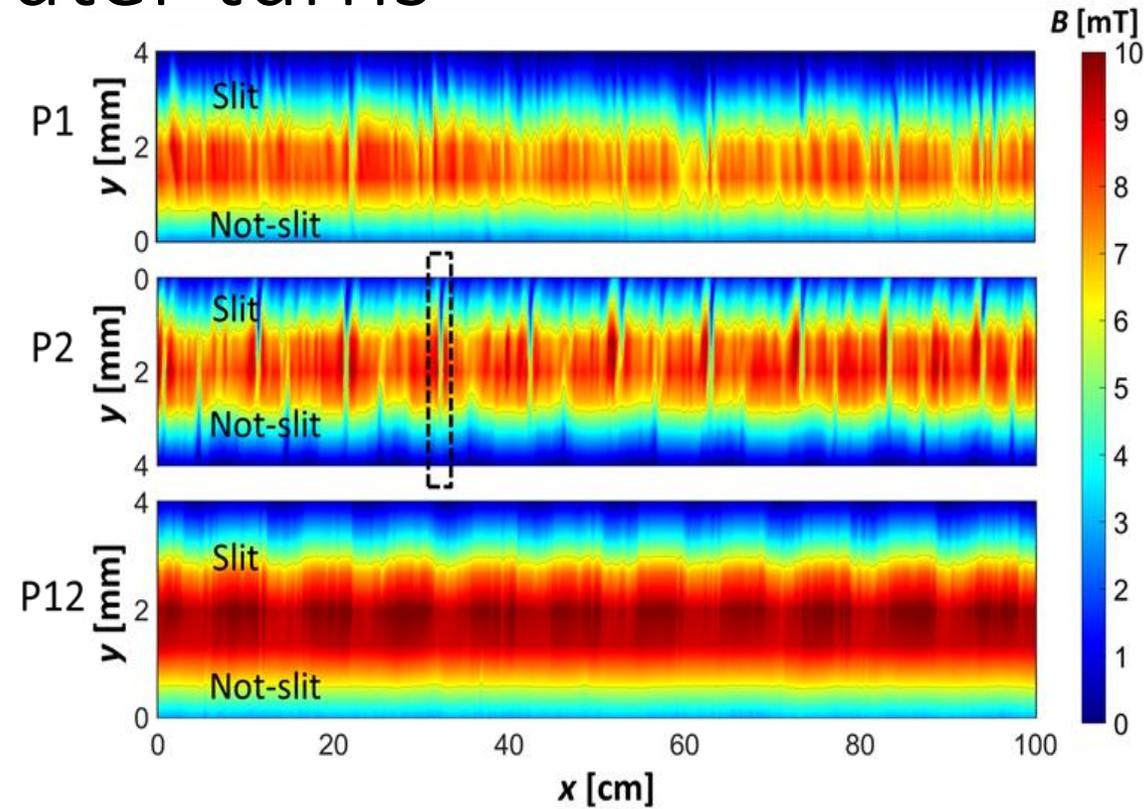
LBC2

Buckling-like defects are associated with the rippling in outer turns

- Two dimensional magnetization maps of one meter lengths of outer turns of pancakes P1 and P2 of LBC2. The dashed rectangular box is the region cut out for Magneto-optical Imaging. Evident transverse and longitudinal damage is present.

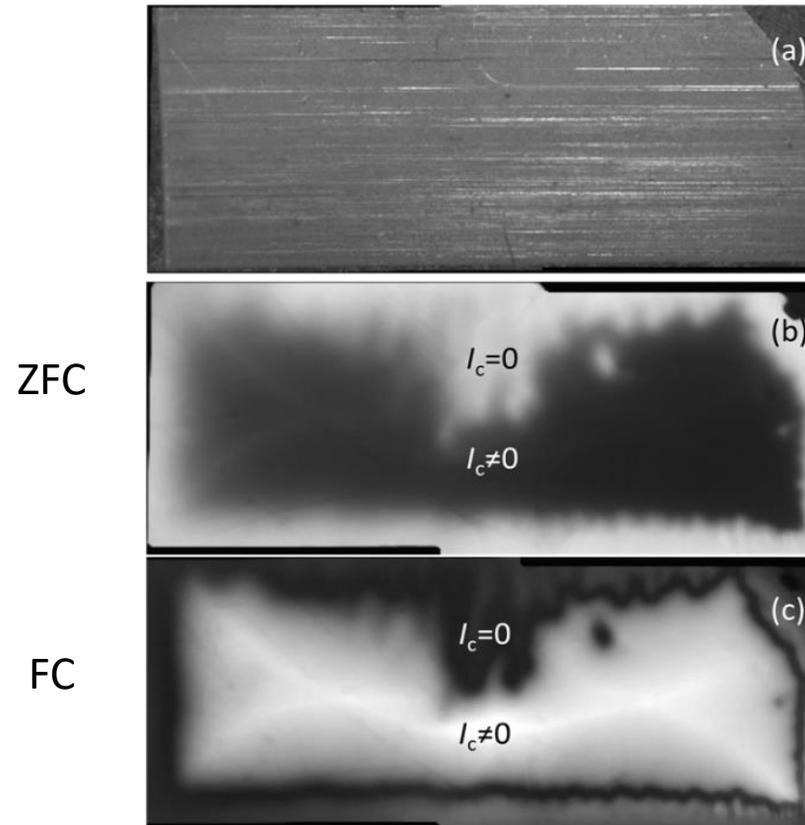
LBC2

The slit edge has a non-uniform penetration of magnetic flux in MO images

- Magneto-optical (MO) image of the sample shows clear evidence of easy flux penetration at multiple places on the upper edge, which reaches approximately half of the tape width in the central region.

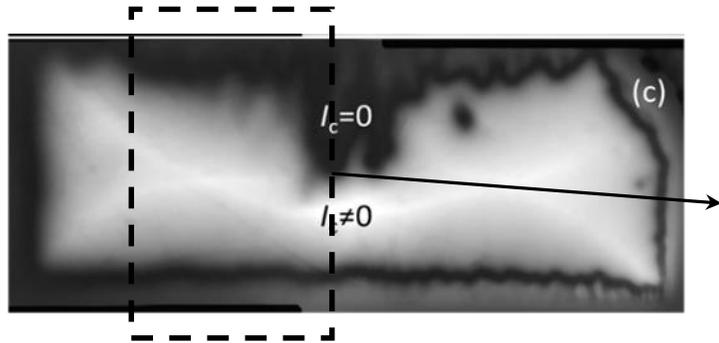
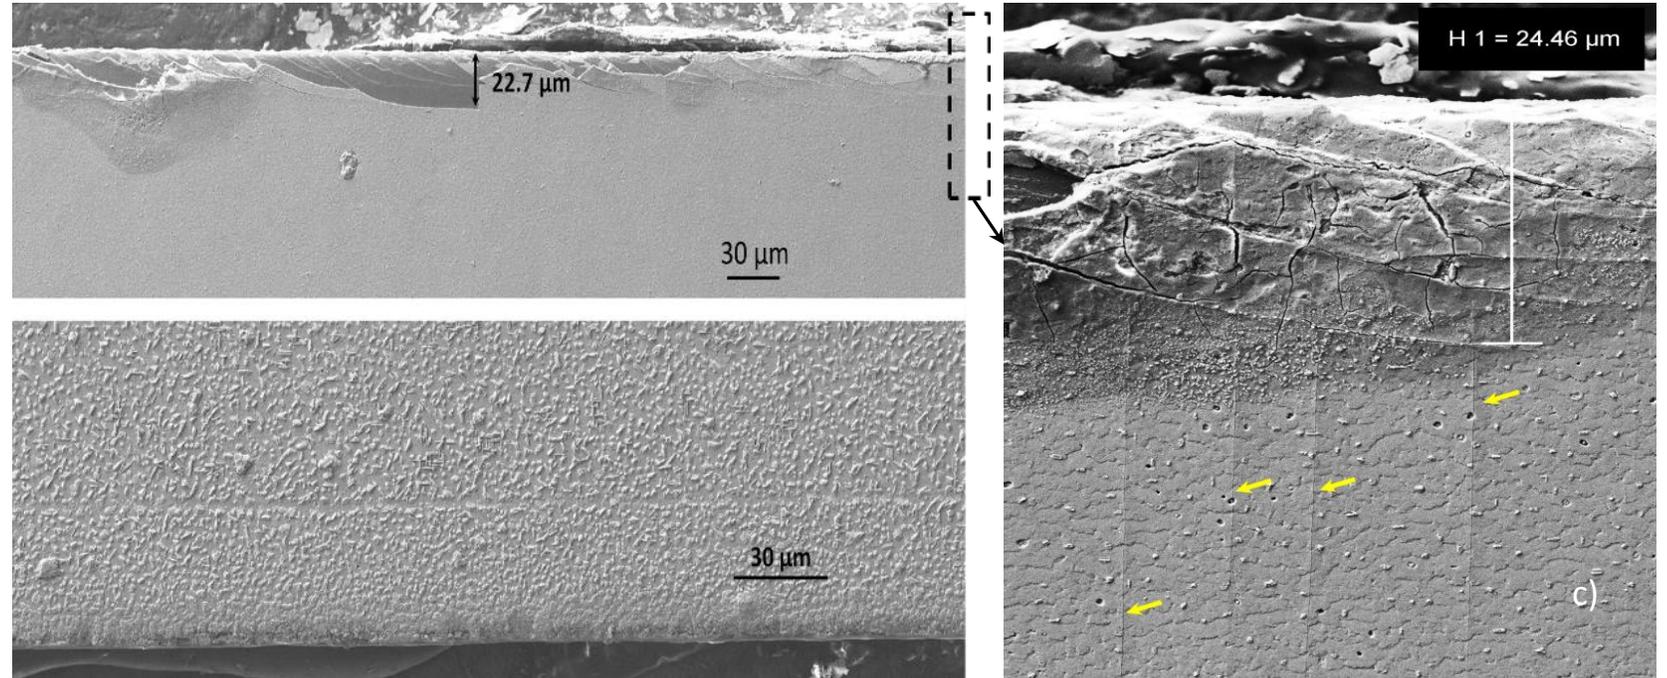
LBC2

The transverse cracks may be associated with delamination

- Top views of the upper (slit) and lower (not-slit) edge of the tape after removing Cu and Ag.
- Transverse cracks on the slit edge which might be caused by stress-concentration. The slitting cracks can be clearly seen in both the REBCO and buffer layers, and are usually 20-25 mm in depth from the edge. The not-slit edge presents large amount of a-axis grains, but no cracks.
- The transverse cracks are only hundreds of microns in SEM image.
- The screening current or the quench current?

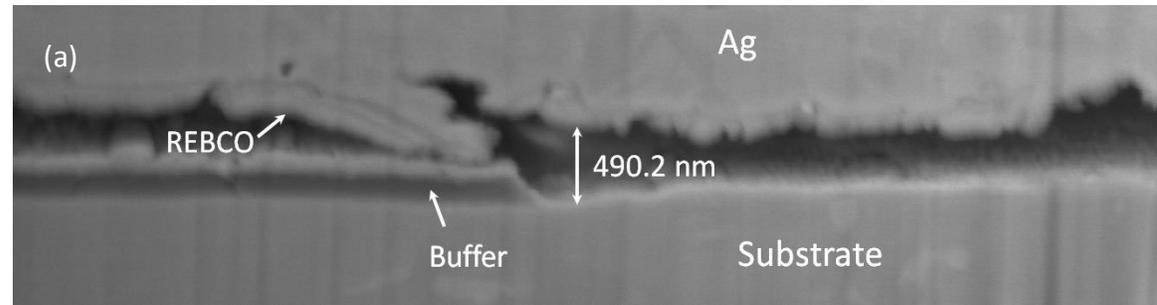
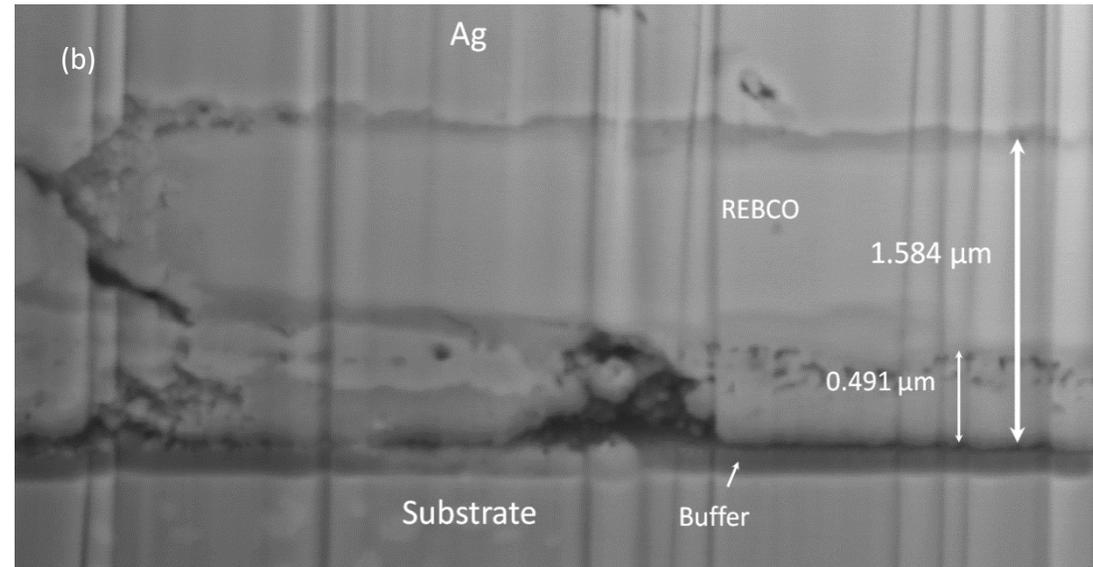
Longitudinal cross-section

Delamination is observed in the slit edge of P1

- Longitudinal cross-sectional views (a) 10 μm and (b) 15 μm away from the damaged, slit edge. REBCO is clearly delaminated from the buffer at 10 μm from the edge. The bottom of REBCO layer is porous, while the top is more compact.

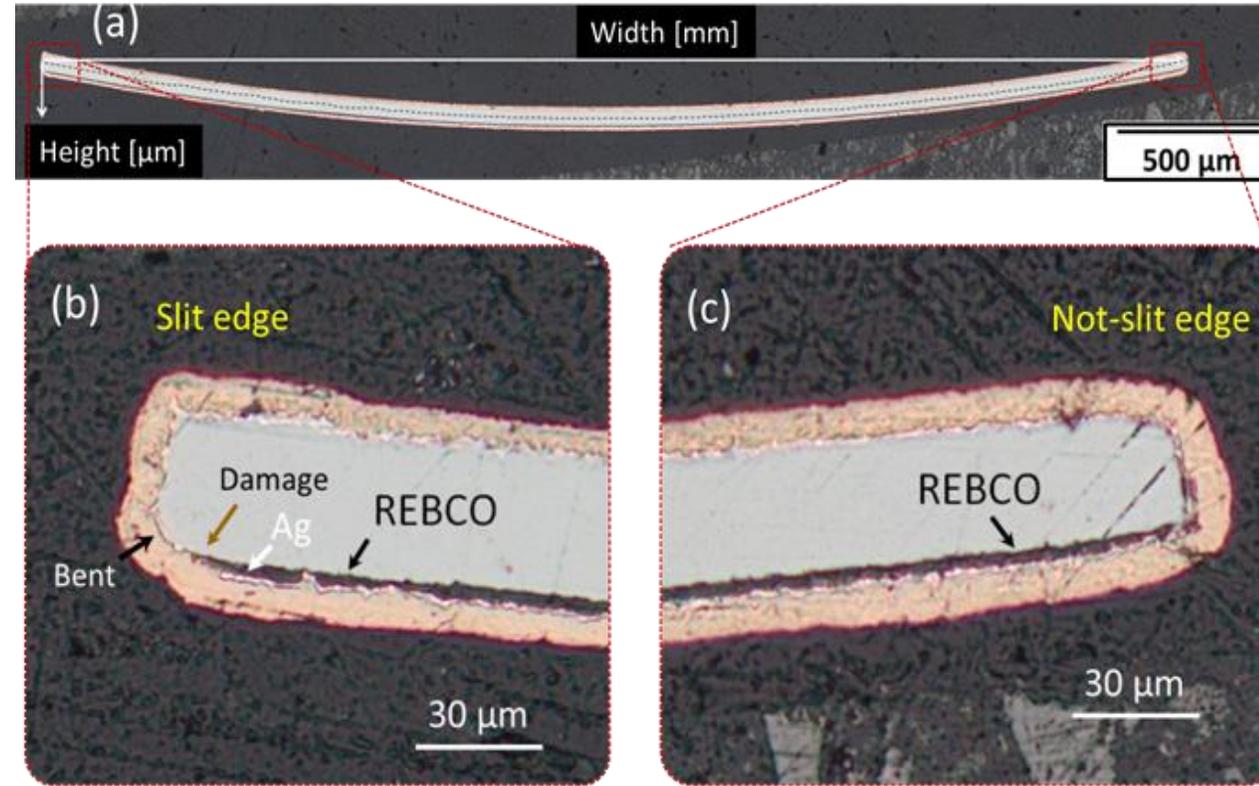
Cross-section of the as-received (AR) tapes for LBC3

- All the tapes of the LBC series have the same specification.
- The tapes have a camber.
- There is pre-existing damage due to the mechanical slitting.

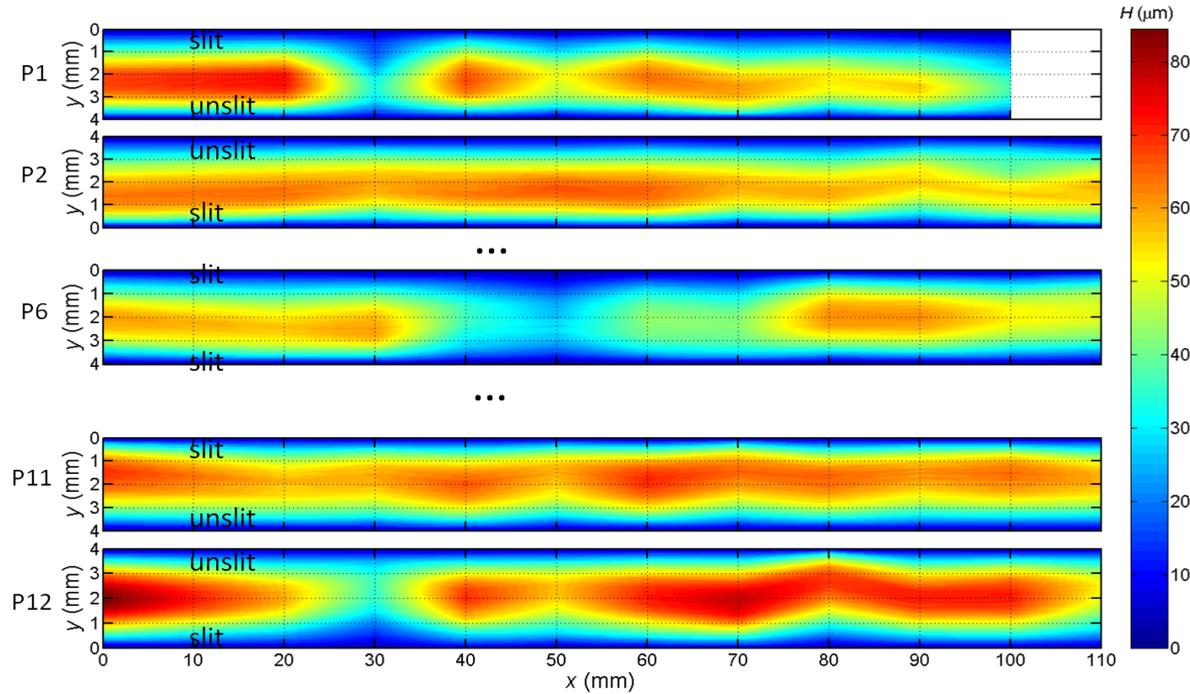
LBC3

Contour map reconstructed from the 10 mm-spaced cross-sectional views

- Tapes were flattened after test, especially the outer edges. Tape centers shifted.
- The middle pancake has been flattened most, but symmetrically.

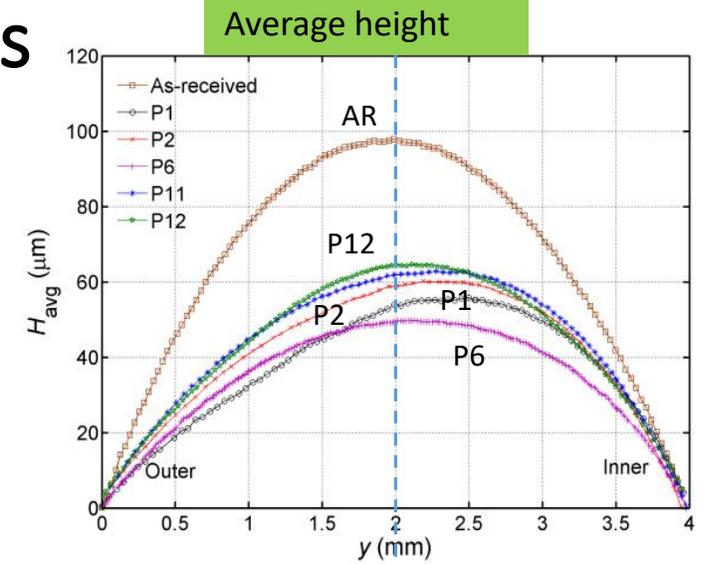
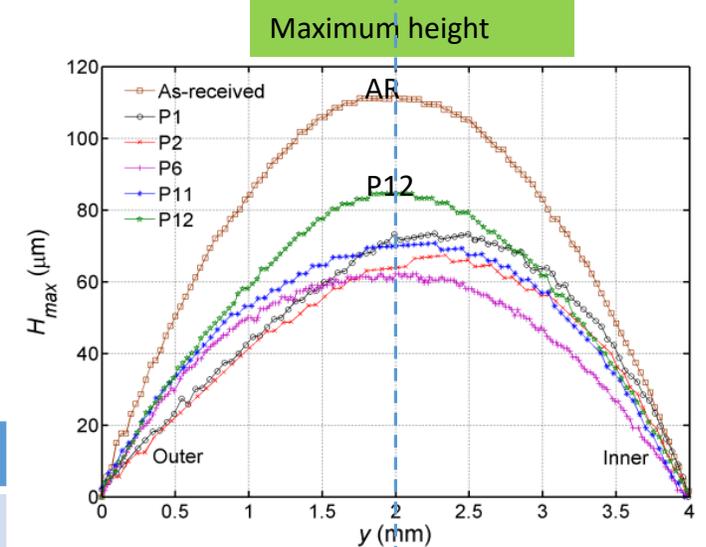
The center has been shifted by the screening current ¹²

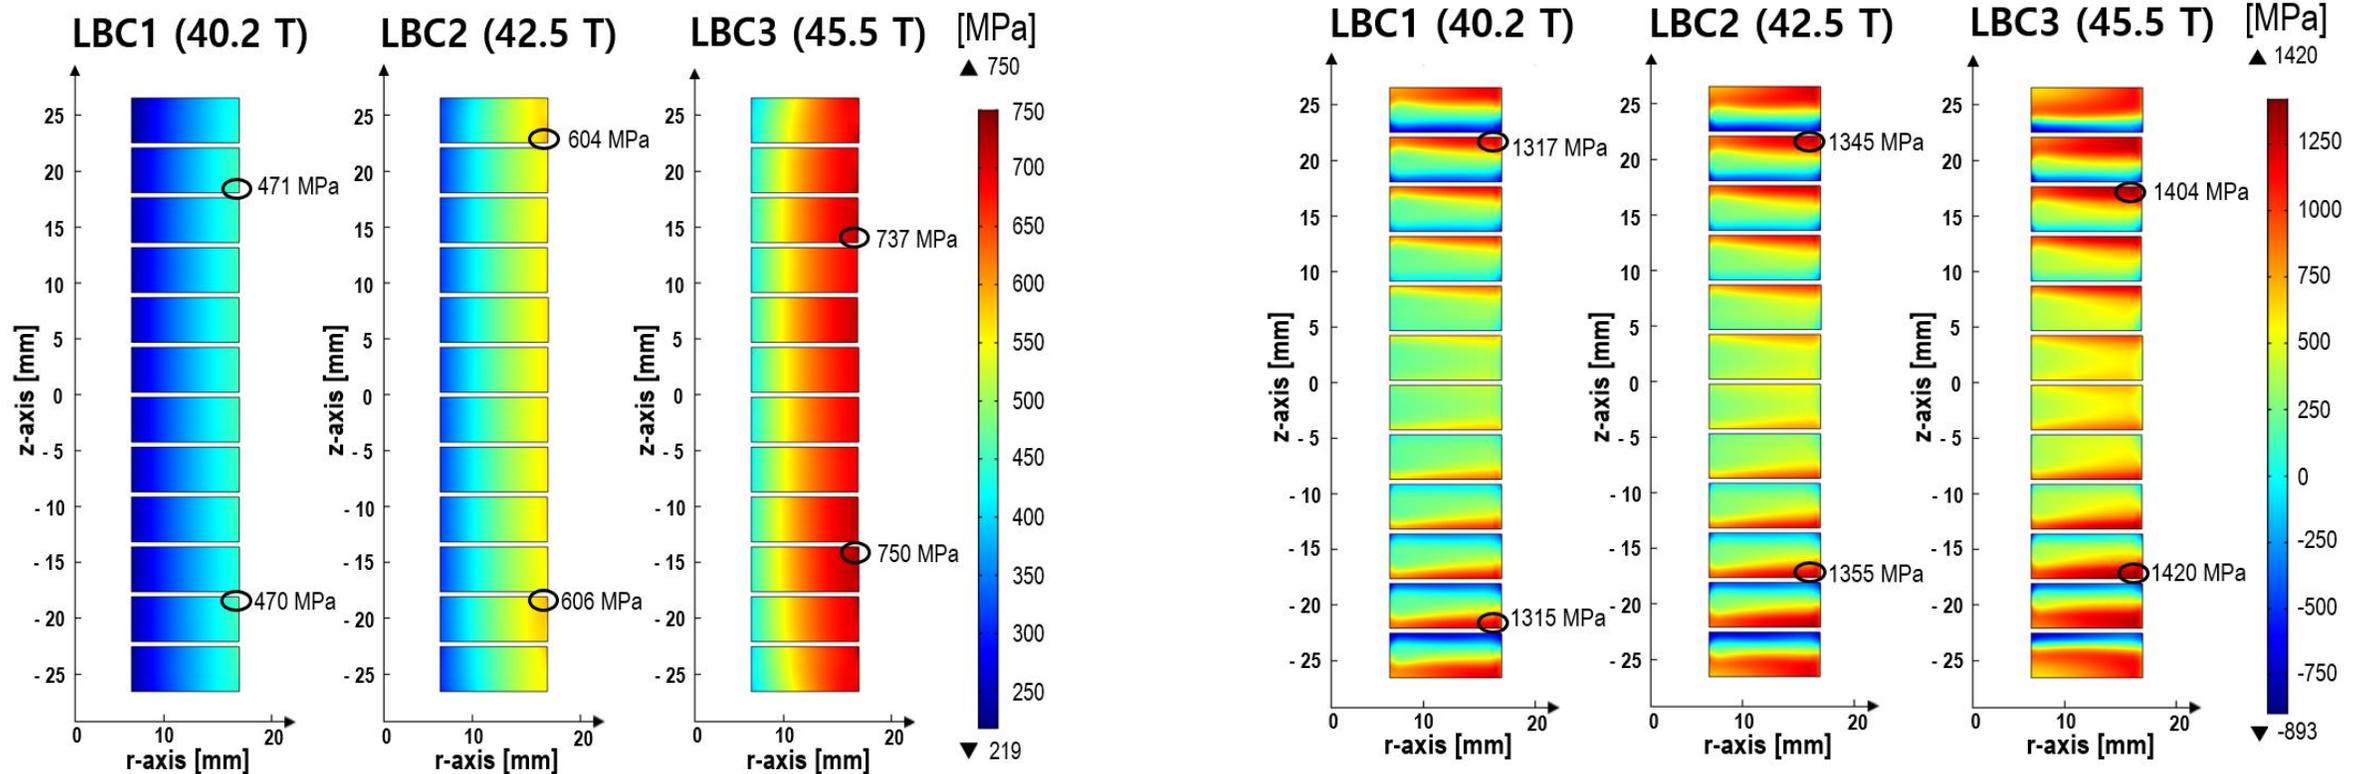
No simulation yet can explain the survival of some pancakes in LBC series

No screening current

With screening current, $n=21$
