Analysis of "15 T" quench data

US Magnet Development Program
Fermi National Accelerator Laboratory

MDPCT1 ("15 T") tests

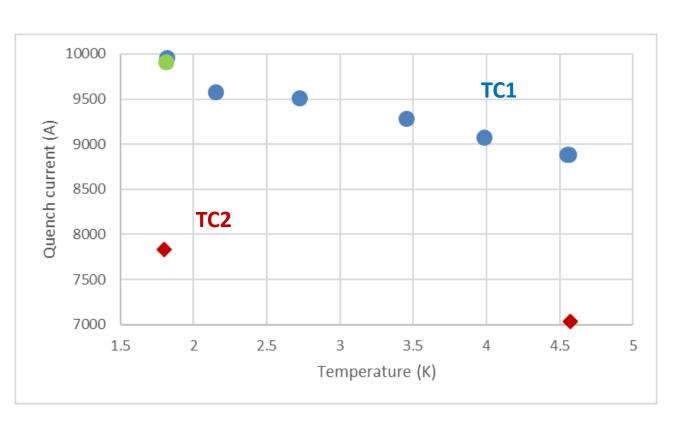
Temperature dependence

In TC2 all 1.9 K quenches were at ~7.82 kA and 4.5 K quenches at 7.03 kA (20 A/s).

All quenches started in 5c6_c7 with a familiar pattern to some TC1 quenches.

The quench current dropped from ~69% SSL (coil5) to ~54% SSL suggesting significant conductor degradation after the TC.

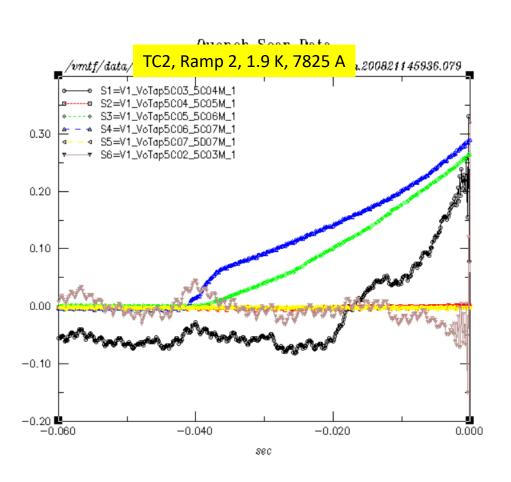
TC2 quench pattern

In TC2 all 1.9 K quenches were at ~7.82 kA and 4.5 K quenches at 7.03 kA (20 A/s).

All quenches started in 5c6_c7 with a familiar pattern to some TC1 quenches.

In TC1 this pattern was seen in the very beginning of training at 1.9 K as well as in all > 2.2 K quenches and high ramp rate quenches.

So the quenching segment (and pattern) changed from 5c5_c6 in the end of training at 1.9 K to 5c6_c7 in TC2 but remain the same at 4.5 K.

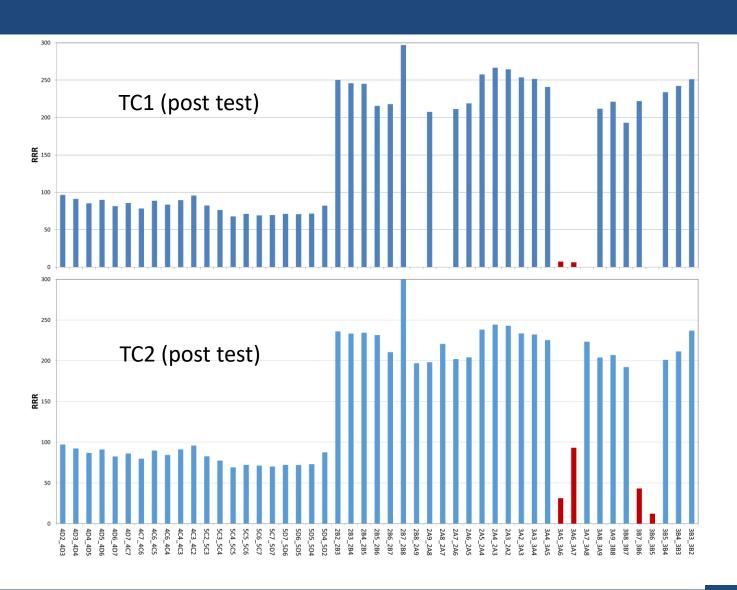
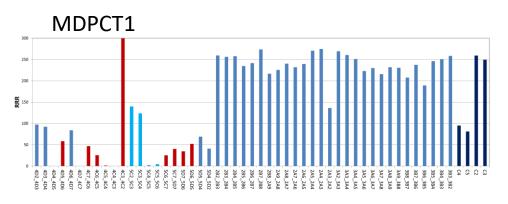
MDPCT1b RRR

No abnormal RRR behavior in TC2

(sometimes we don't measure a segment resistance for technical reasons or segments are "bad" /lost connectivity/)

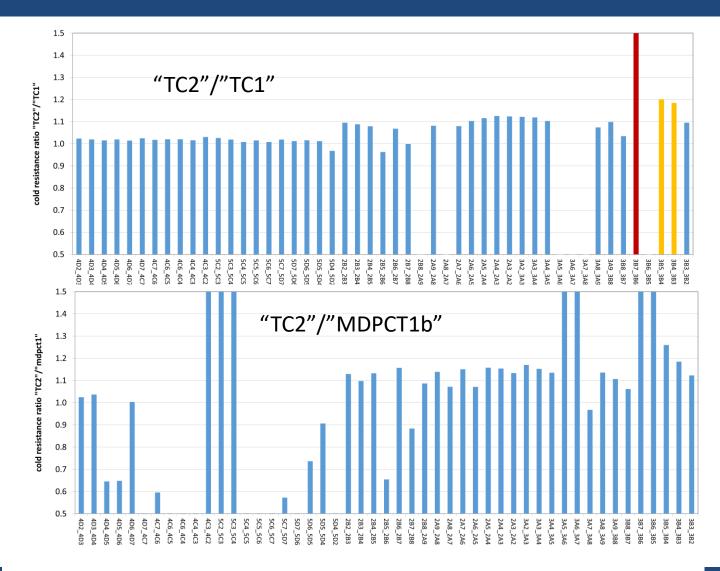
MDPCT1b cold resistance ratio

No abnormal behavior in TC2 except 10% higher resistance in inner coils (which don't quench)

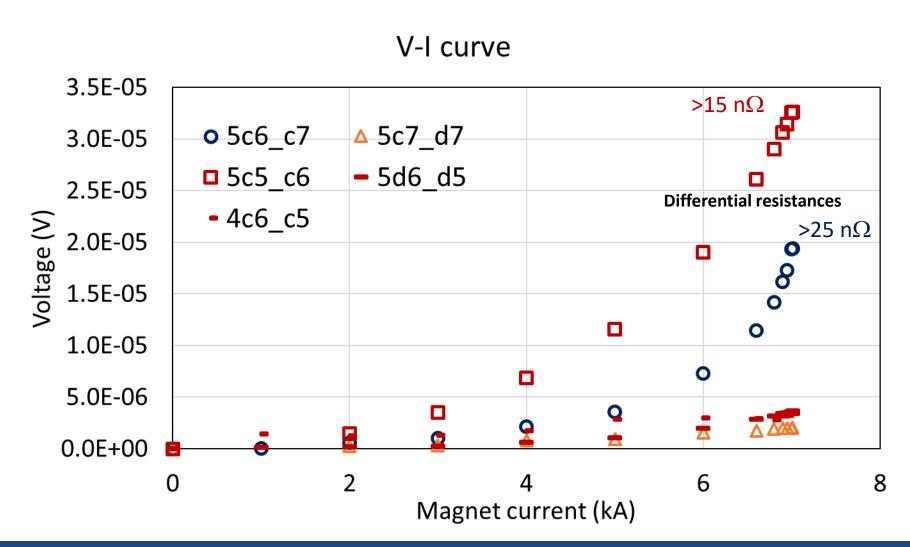
MDPCT1b V-I measurements

... and we see resistance in some segments starting to grow with current as low as 2 kA

A characteristic V-I curve is observed in the two segments quenching most (would result in a very bad n-value) with the limiting one showing faster growth.

Some other segments are showing similar signs but at much lower level.

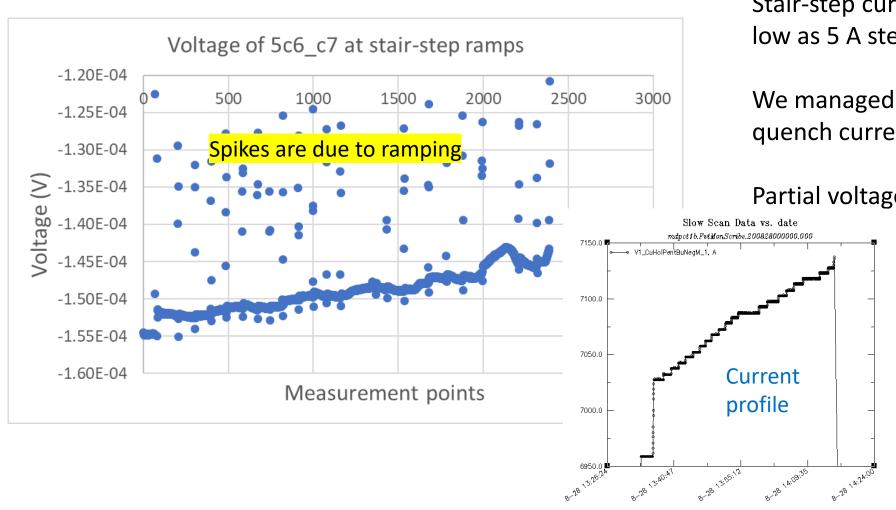
Voltage rise and behavior before quench

Stair-step current measurements, as low as 5 A step.

We managed to reach > 100 A higher quench current in that way.

Partial voltage "run-aways" are visible.

We quenched trying to increase current by 10 A instead of 5 A (same ramp rate).

Those indicate we are close to the critical surface and the AC heating is tilting the balance.

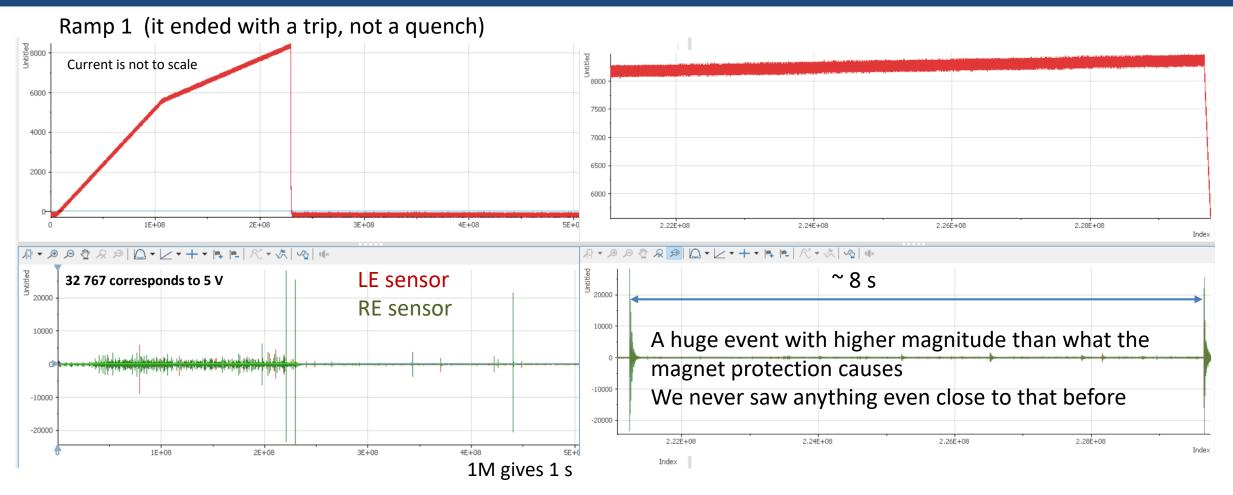
This huge acoustic event is seen at this magnitude at the return end only

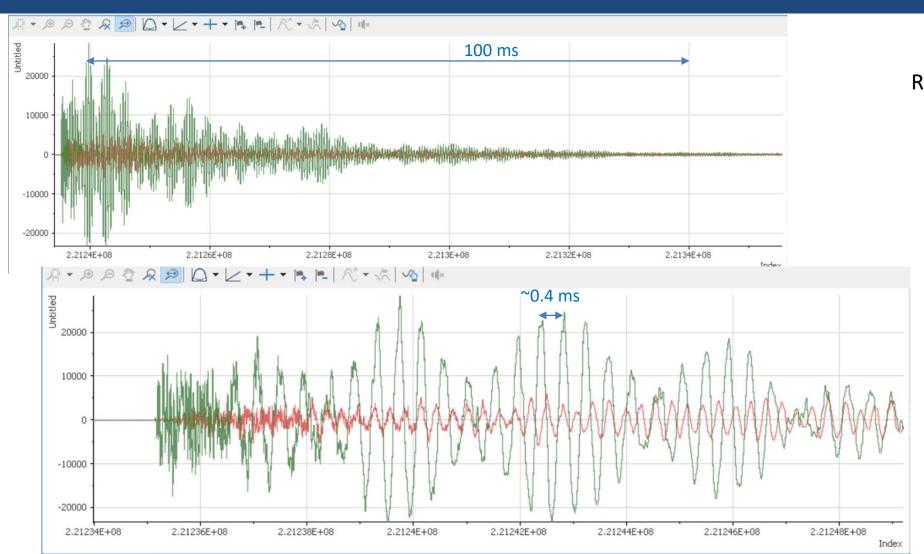
Ramp 1

The magnet (shell) rings at ~2.5 kHz for about 100 ms

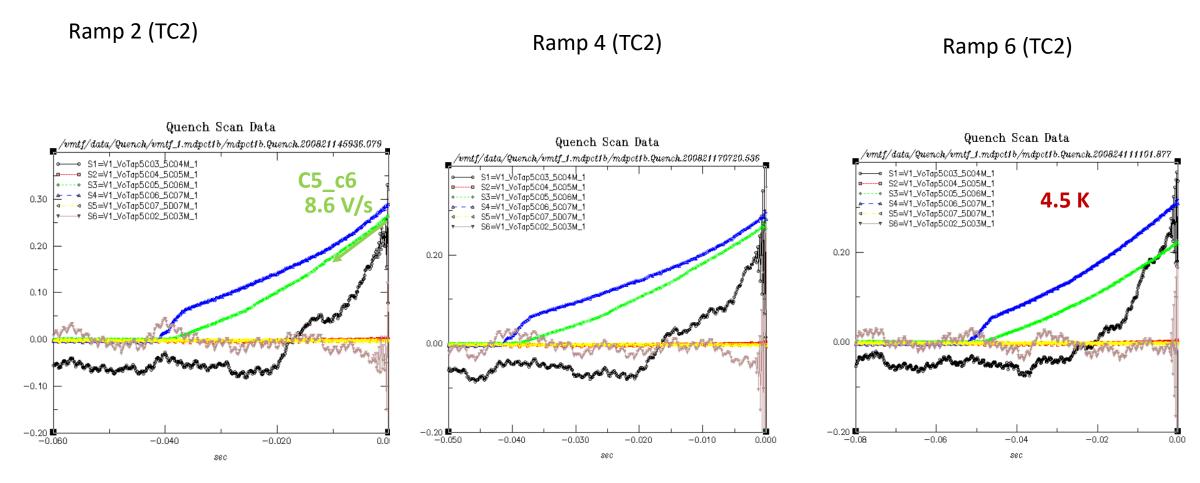
Quench profiles in TC2

Unlike TC1, the pattern for 1.9 K and 4.5 K is the same (c6_c7 is the quenching segment at high current)

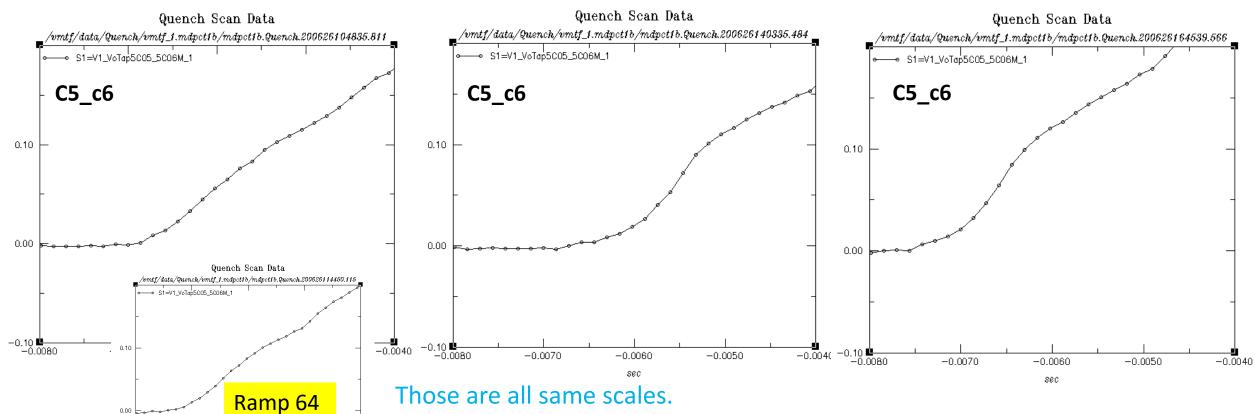
From Ramp 66 on the profile changed, a non-linear initial expansion is visible.

It suggests much higher quench propagation than in other quenches in the same segment (but different location, see ramp 62 which is also similar to 67).

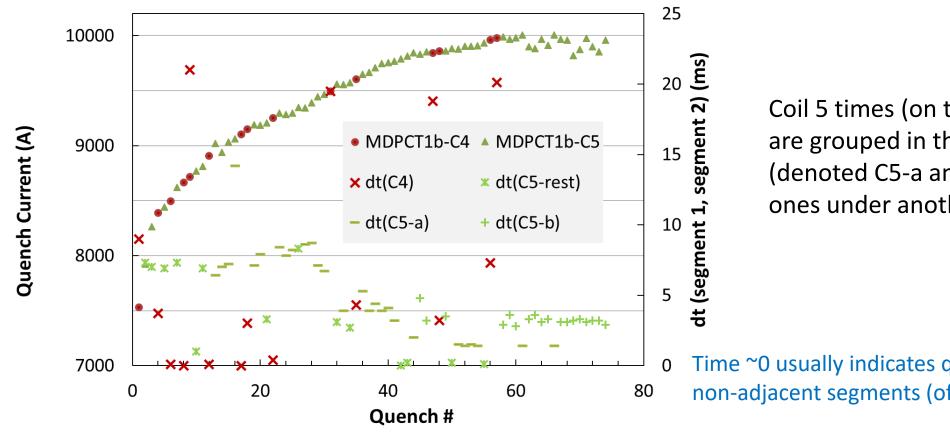
Time between first two segments quenching

Coil 5 times (on the right vertical axis) are grouped in the main two "patterns" (denoted C5-a and C5-b) with remaining ones under another group (C5-rest).

Time ~0 usually indicates quenches in two non-adjacent segments (often in different layers or coils)

The time difference relates to "patterns" discussed. It is seen however that for one of the main pattern Δt changes significantly (after \sim quench #30). The other main pattern (where the limiting quenches are) shows consistent nearly constant times despite the short non-linear quench/voltage expansion discussed.
