U.S. MAGNET
DEVELOPMENT
PROGRAM

MDPCT1b Magnet Disassembly

MDP general meeting

March 31, 2021

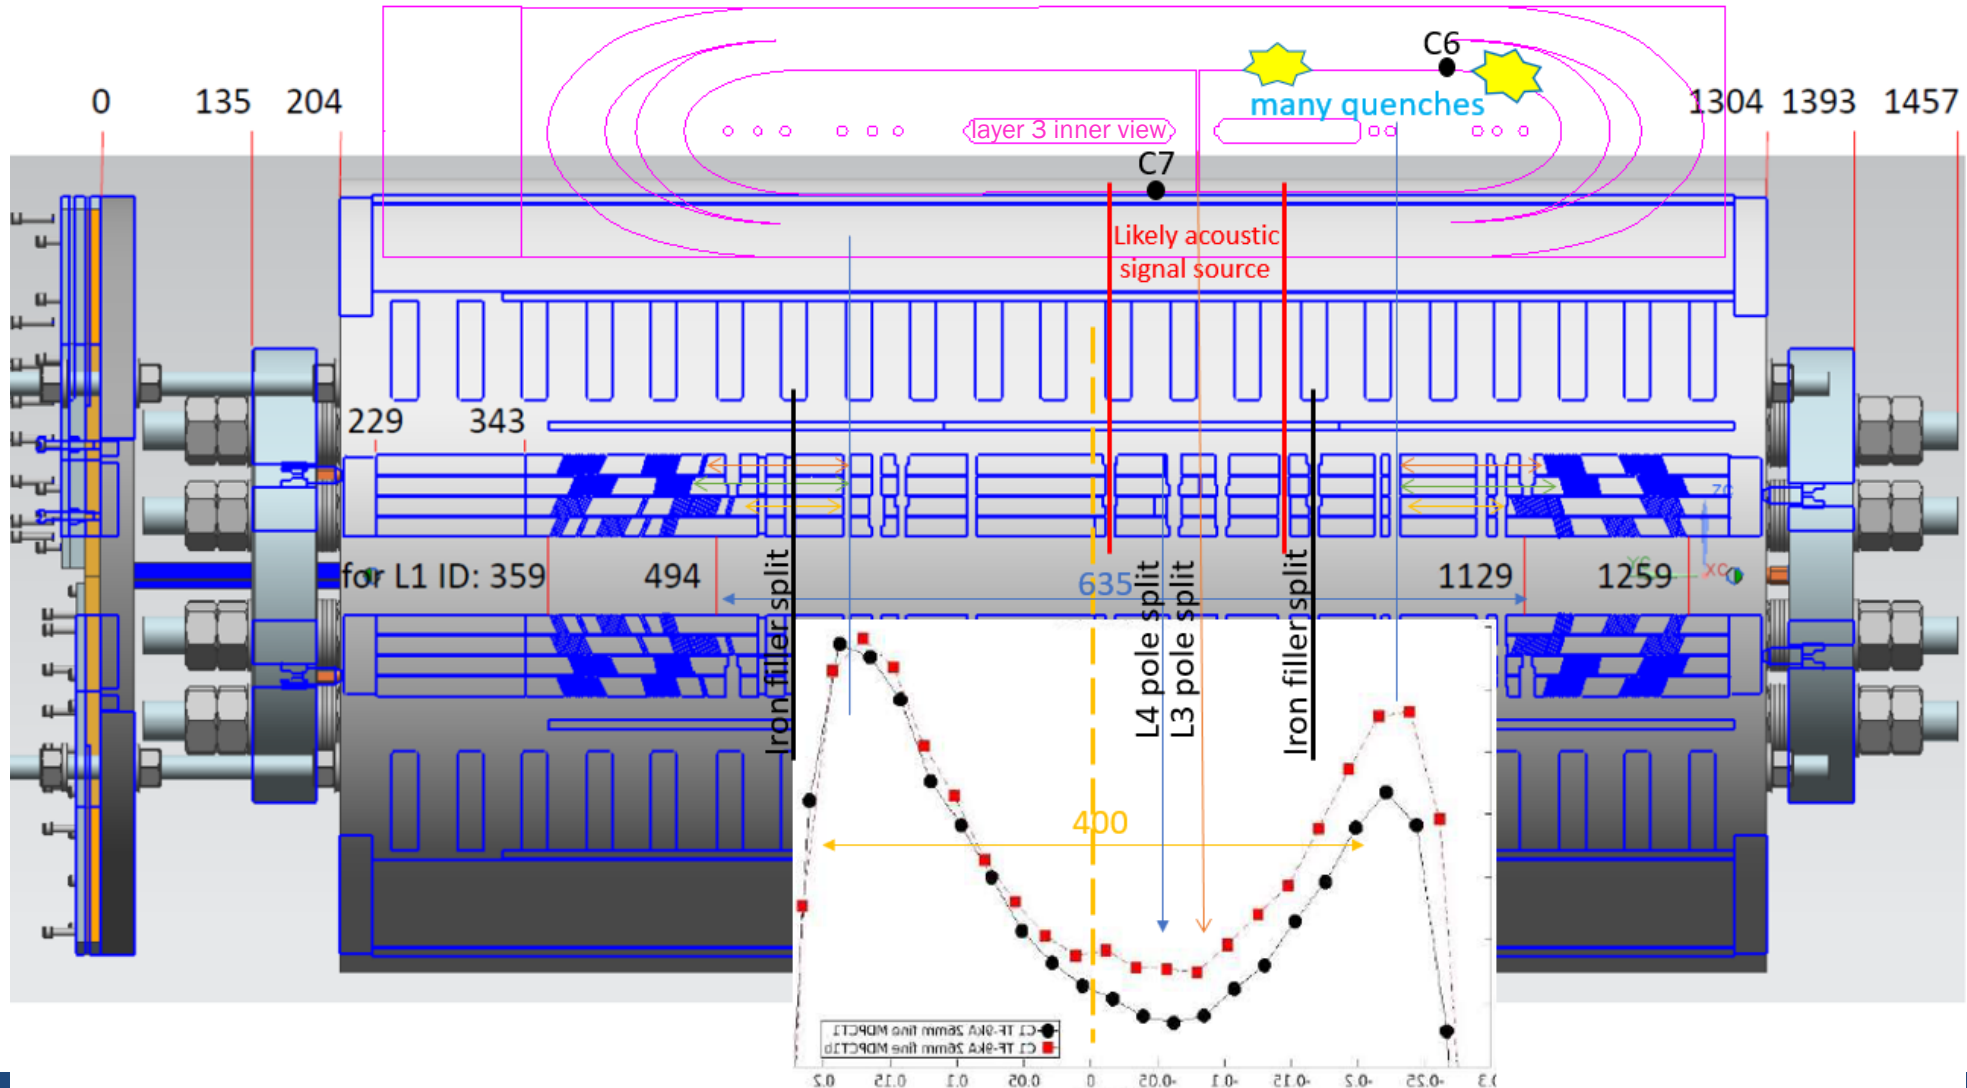
TF Difference for Two Last Cold Measurements, test 1 and test 2

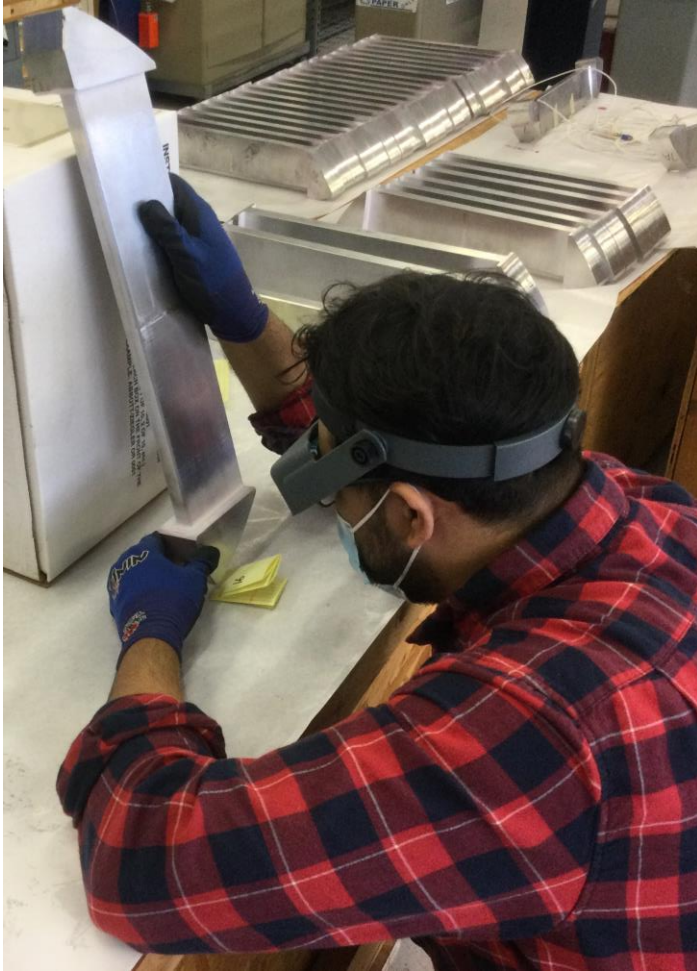
Visual inspection of the clamp

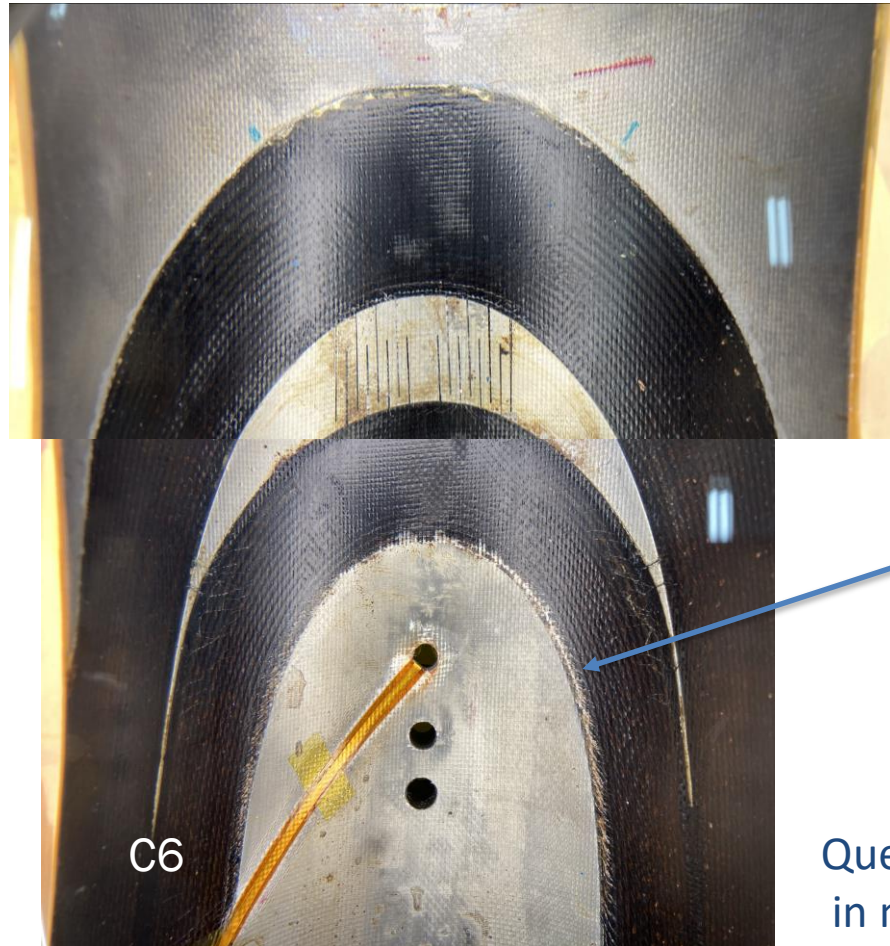
Coil 4

Outer Coils #4/5 – Inner Layer View, RE after Test 2

Pole turn
whitening

Quench locations
in many ramps

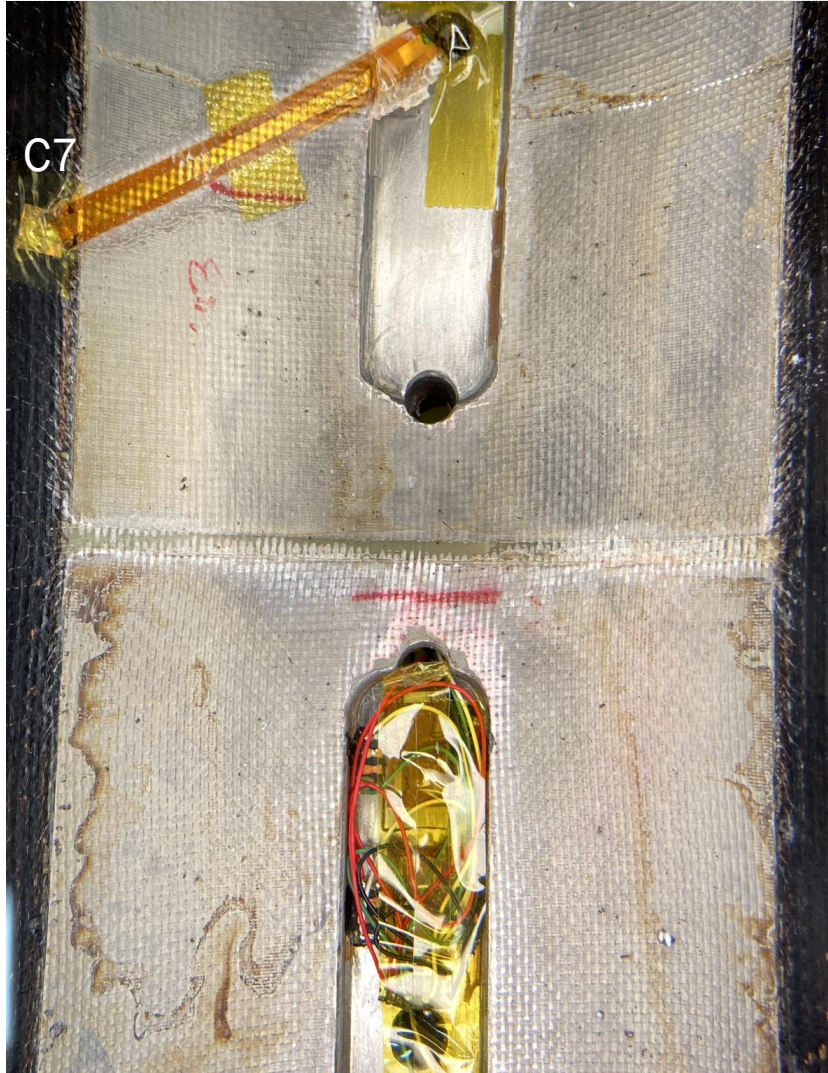
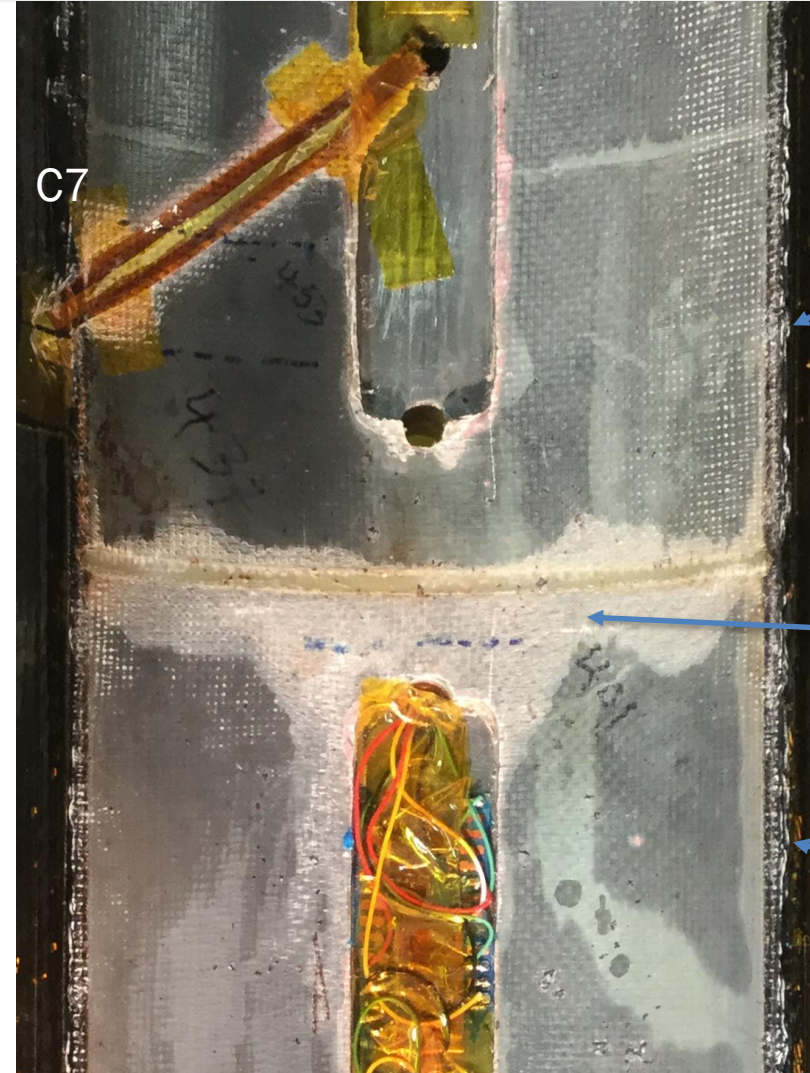
Outer Coil #4/5 – Inner Layer View, Pole Split after Test 2

Pole turn
whitening

delamination

Quench locations
in many ramps

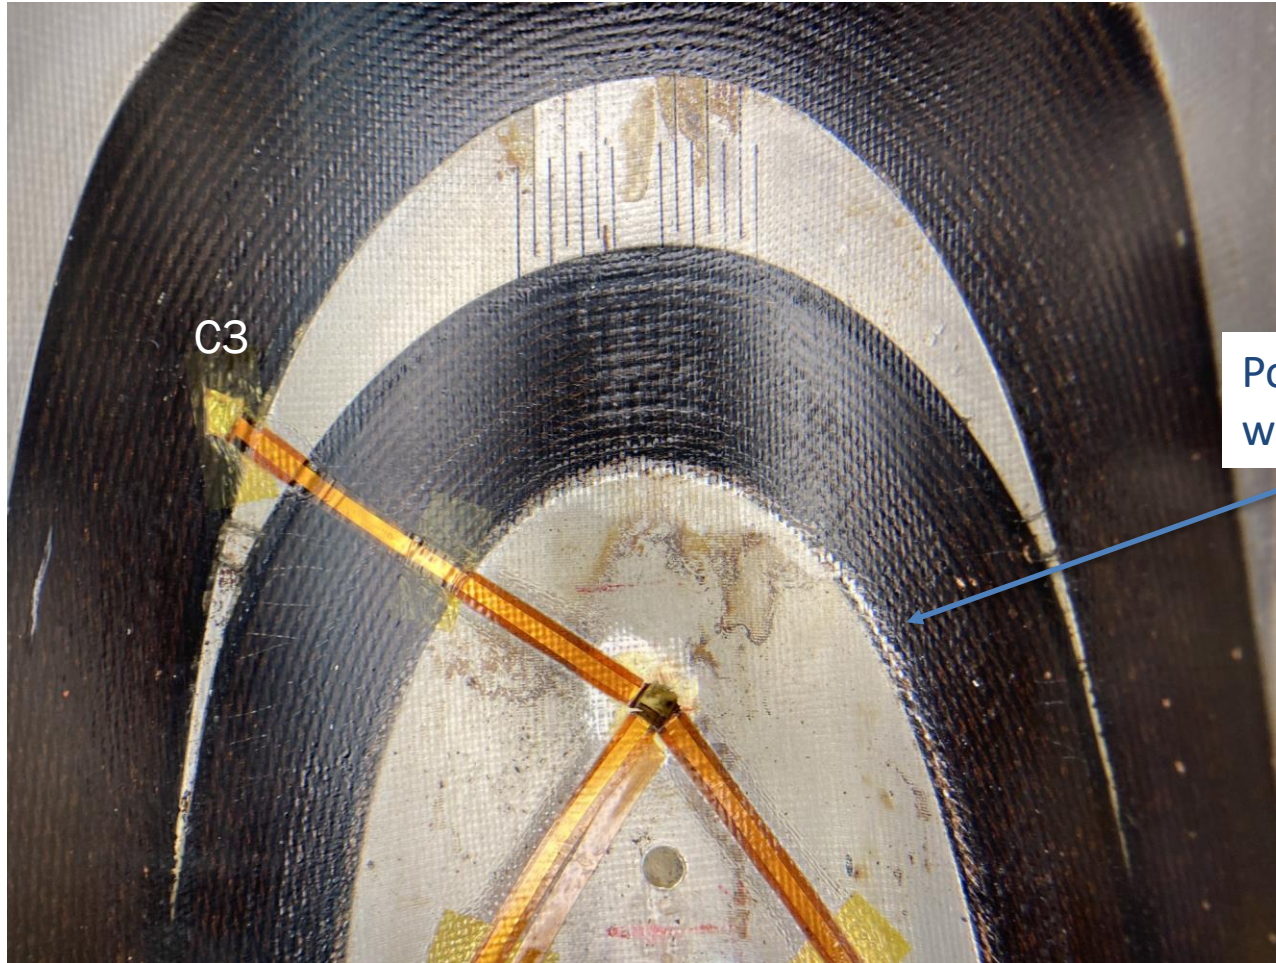
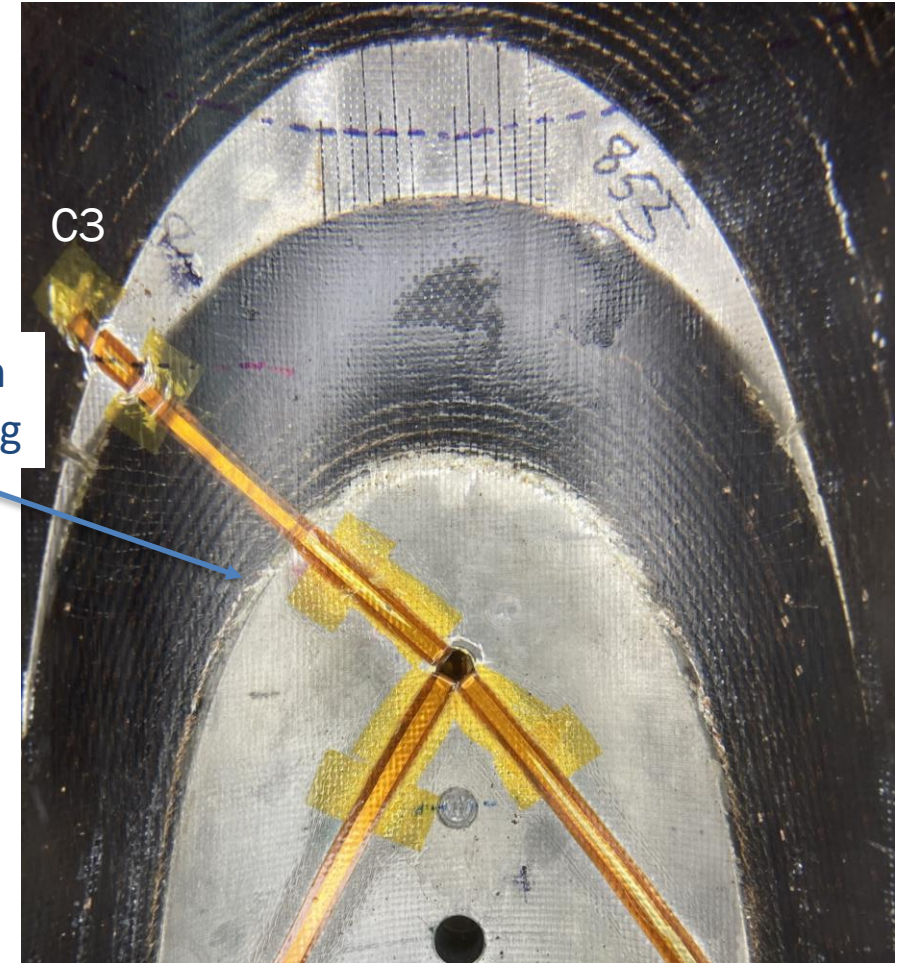
Outer Coils #4/5 – Inner Layer View, LE after Test 2

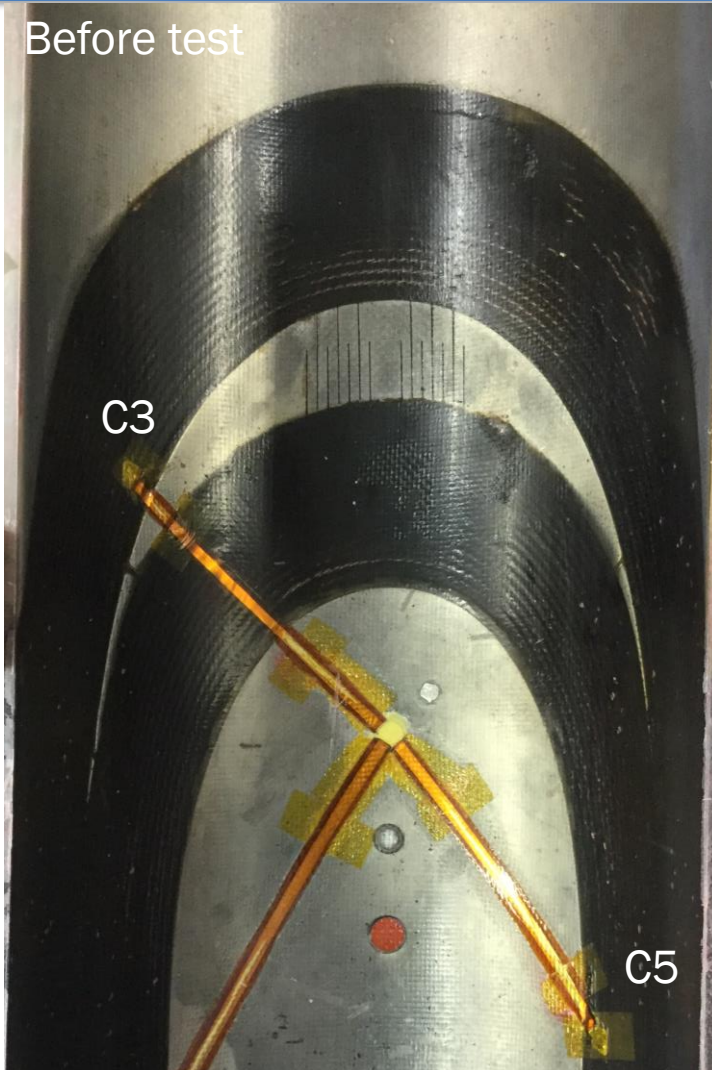
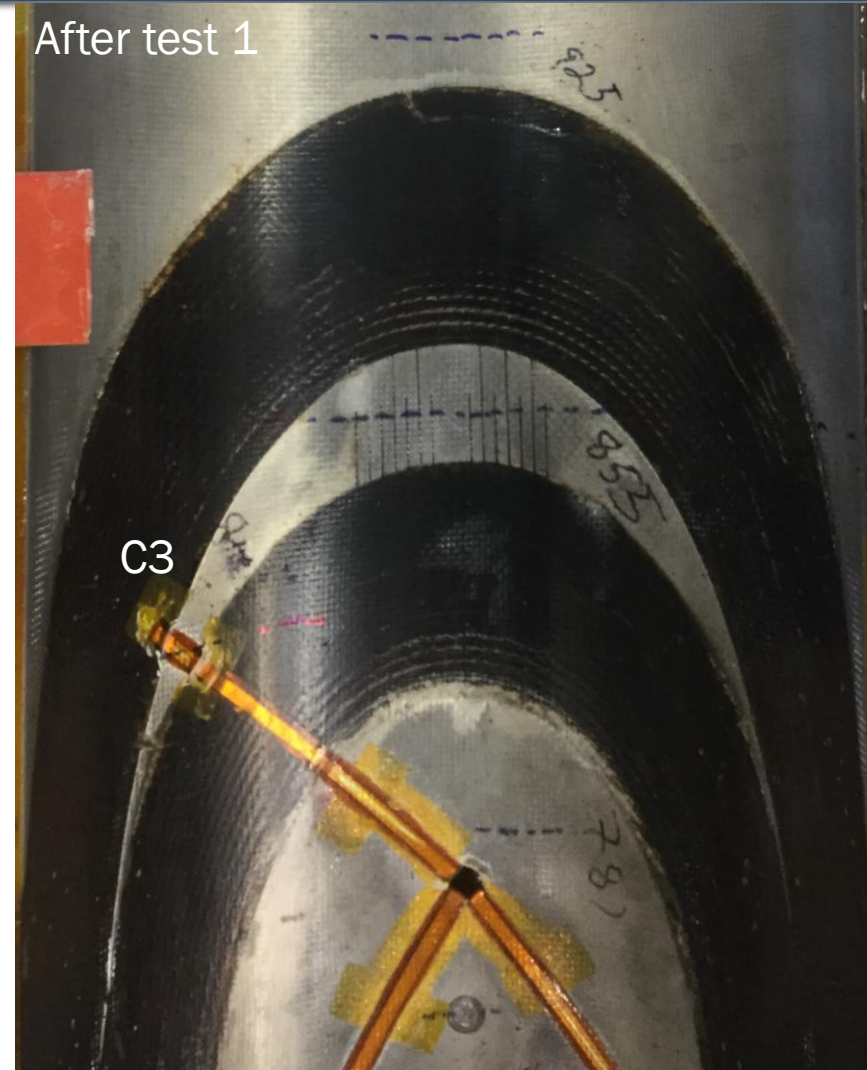
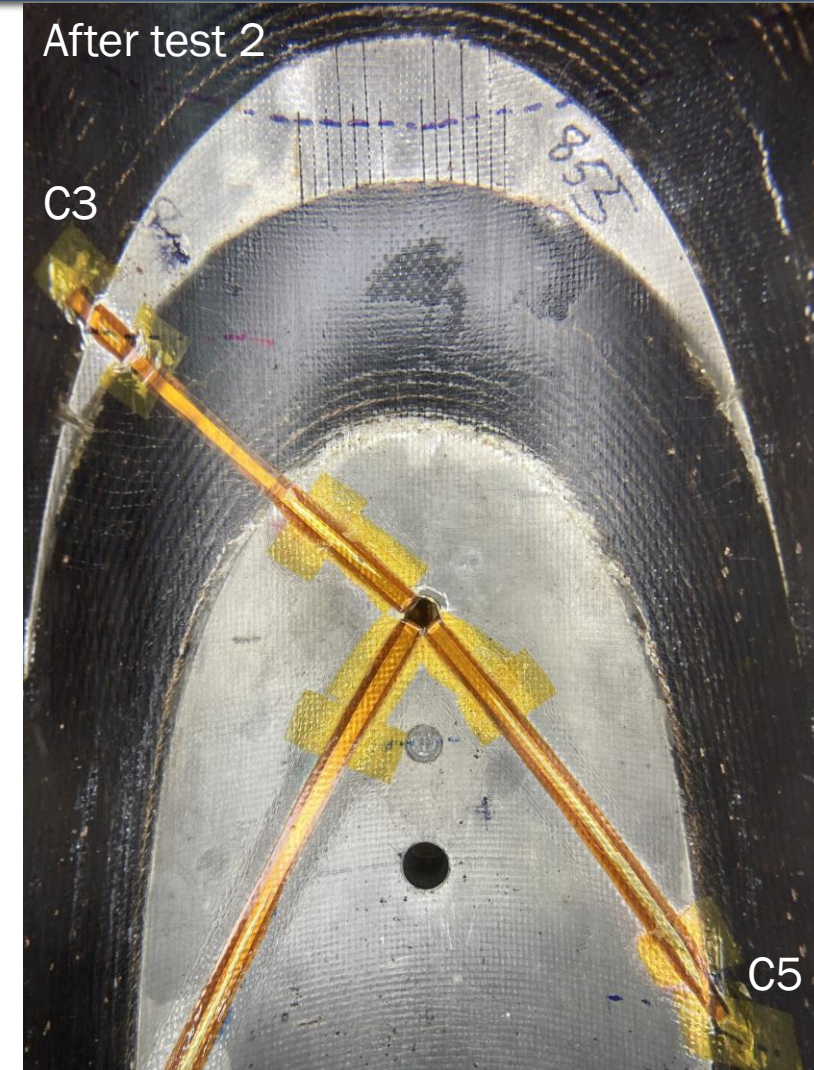
Outer Coil #5 - Inner Layer View, LE

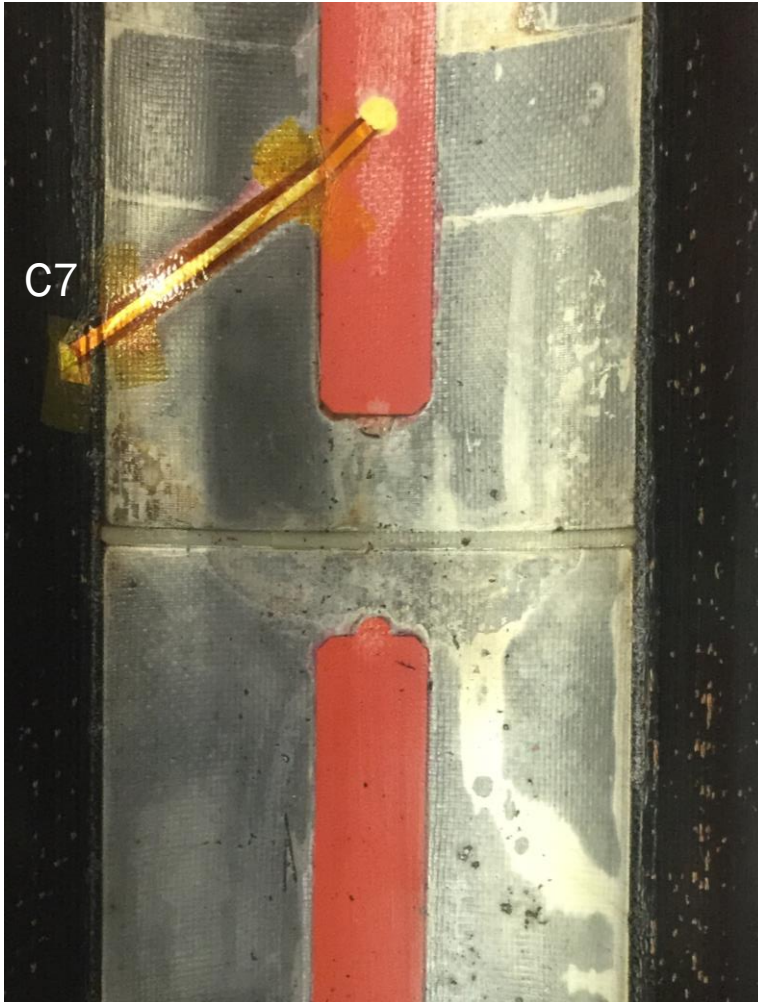
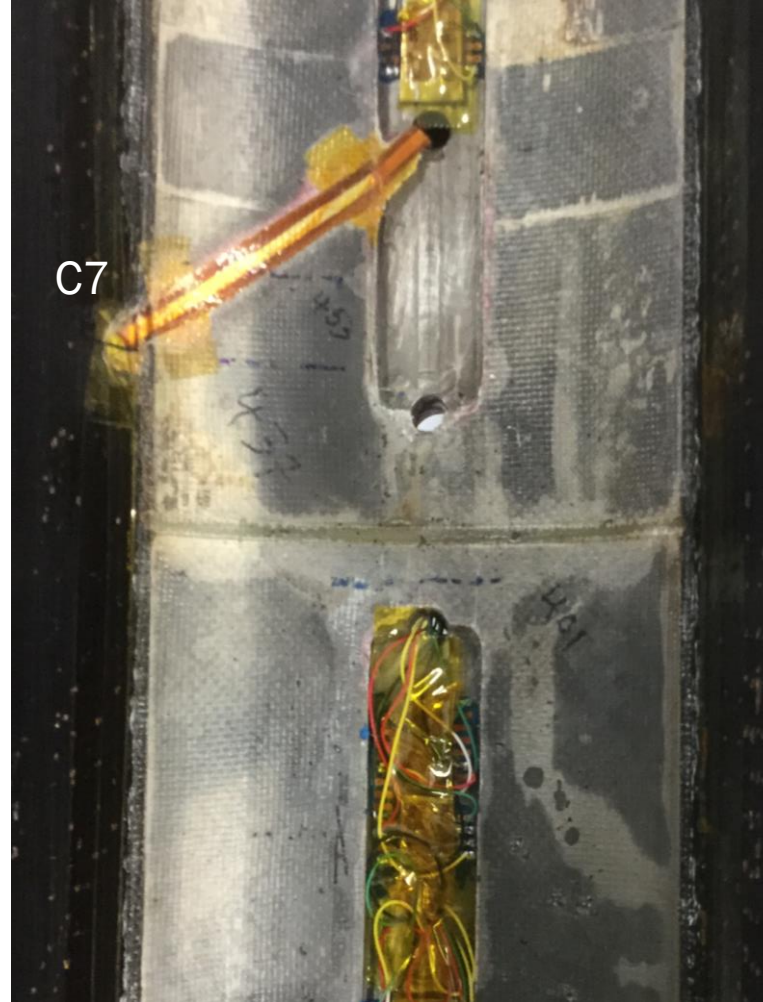
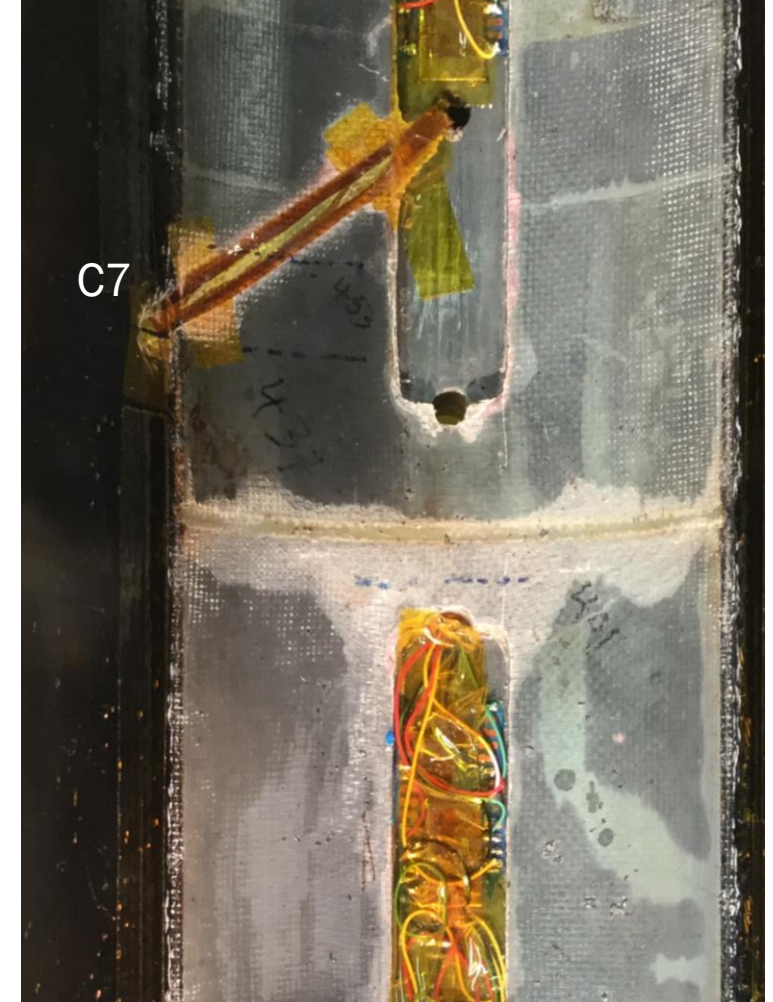
Outer Coil #5 – Inner Layer View, Pole Split
