**U.S. MAGNET  
DEVELOPMENT  
PROGRAM**

# CCT Progress Update

04/19/2017

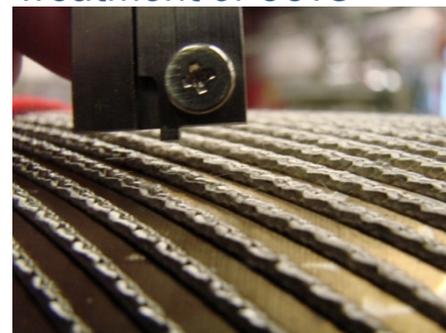
Cable Position After Heat Treatment of CCT3

- Coil was wrapped with perforated stainless steel sheet and secured with hose clamps
- CCT3 Cable protrudes from the surface of the mandrel after heat treatment by ~1.5 mm
- Mandrel distortion could not be measured accurately due to cable protrusion
- Resistance from coil to mandrel after heat treatment is on the order of a few hundred  $\Omega$  due to Carbon residue on the glass braid

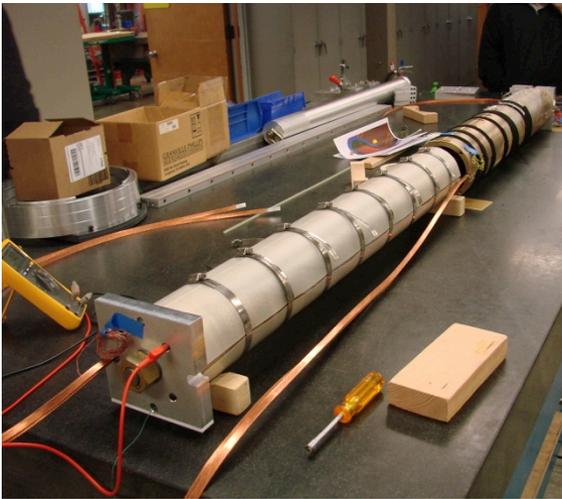
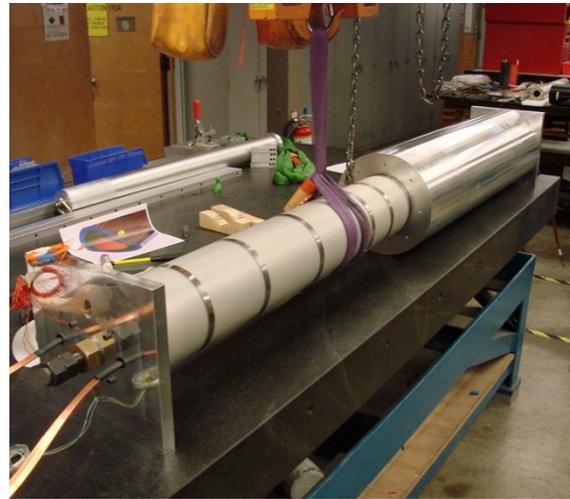
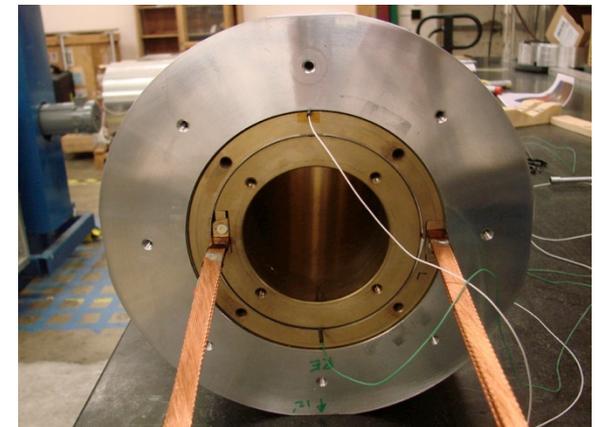
- Layers are wrapped with G10 sheet before assembly
- Assembly of layer 1 / layer 2 was difficult
  - Cable was above surface increasing friction
  - Mandrel distortion leads to high friction points
- Cable is forced into the groove by assembly process
  - Possible source of conductor damage

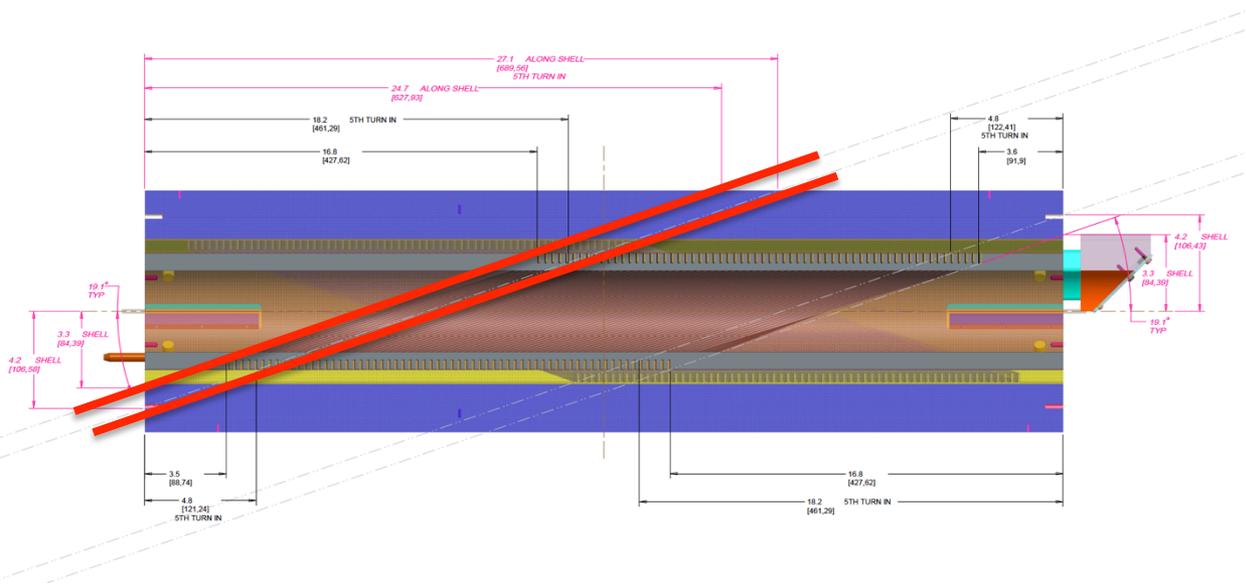
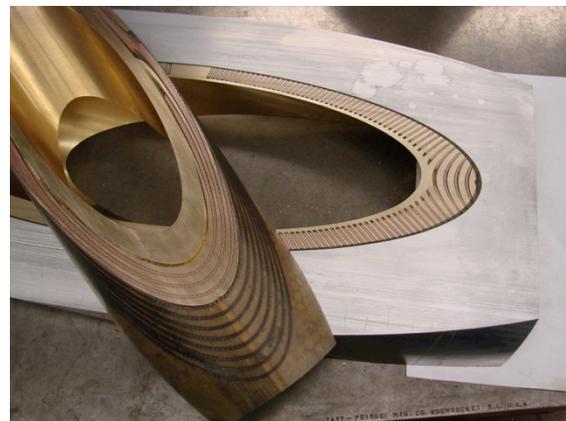
- Extracted first five turns where the quenches were detected (see talk by M. Martchevskii)
- Inner layer de-bonded from outer layer after cutting

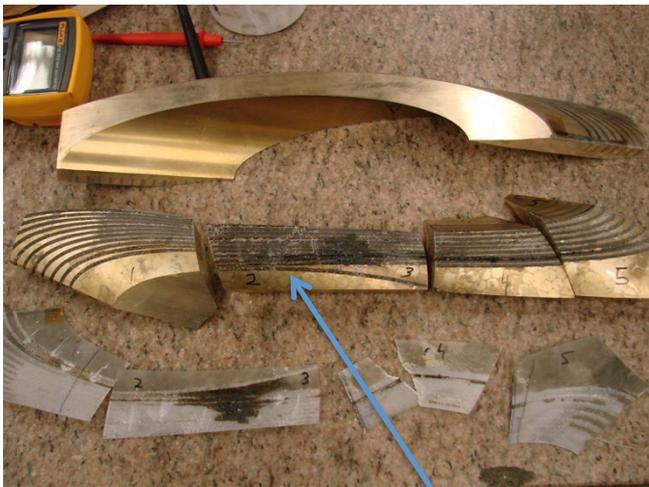
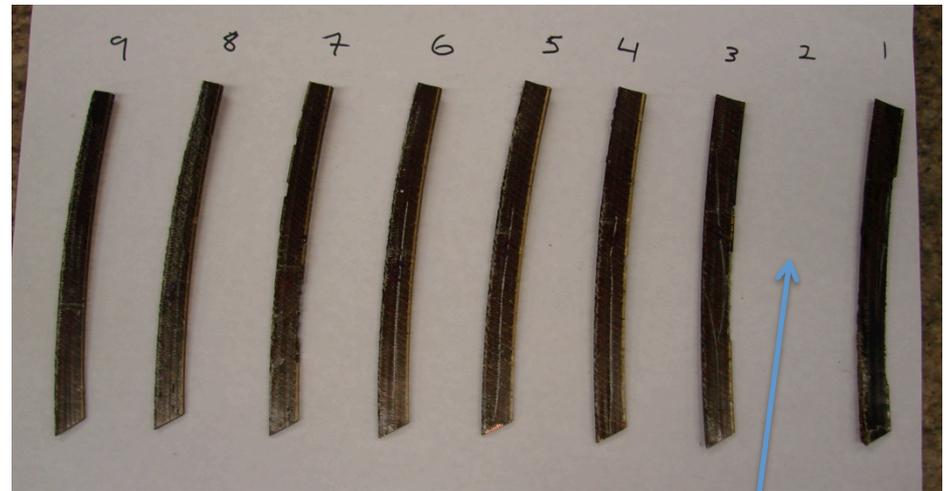
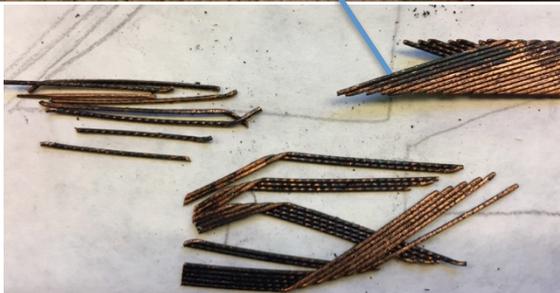
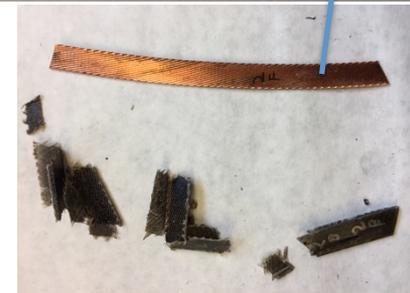
- Burned epoxy segment was found
  - On last CCT3 quench the quench protection did not activate
  - High MIITS quench without dump resistor
- Broken wires were found in transition region

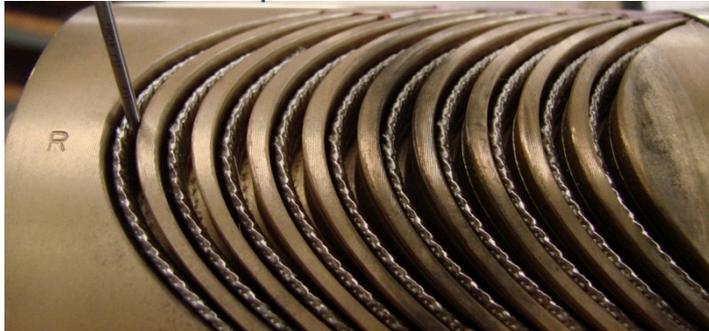
Measured Gaps After Heat Treatment

- Need to avoid conductor damage during heat treatment and assembly
- Test mandrel with large gaps at the pole was machined to further understanding
- Cable is removed and etched down to the sub-elements to inspect for damage
- No apparent damage was seen after initial test with added pole expansion space

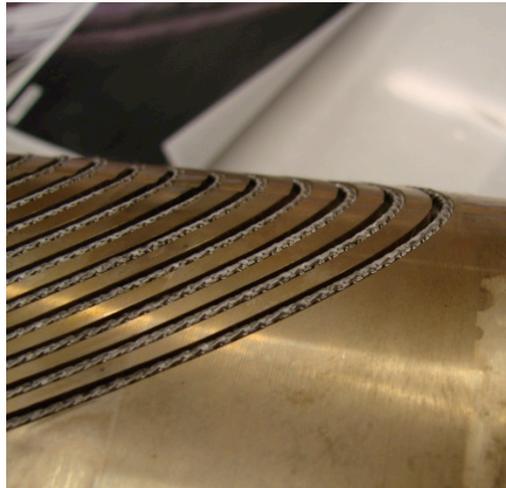
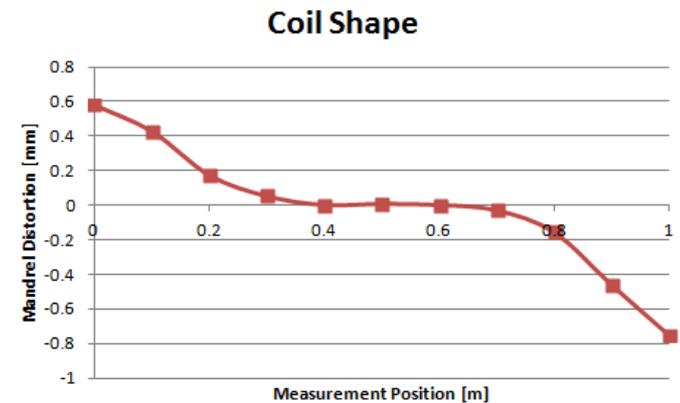
Cable Position After Heat Treatment of CCT4

- Copper wire was inserted into groove to force the cable to the bottom of the channel (same as 10-turn tests)
- Mandrel is wrapped with hose clamps
- Cable stays in channel after heat treatment
- Mandrels distort 0.5 – 1 mm after heat treatment in the N/S orientation
  - Not yet clear how much influence cable has on distortion as opposed to machining stress
  - May require additional annealing step after grooves are machined to avoid distortions

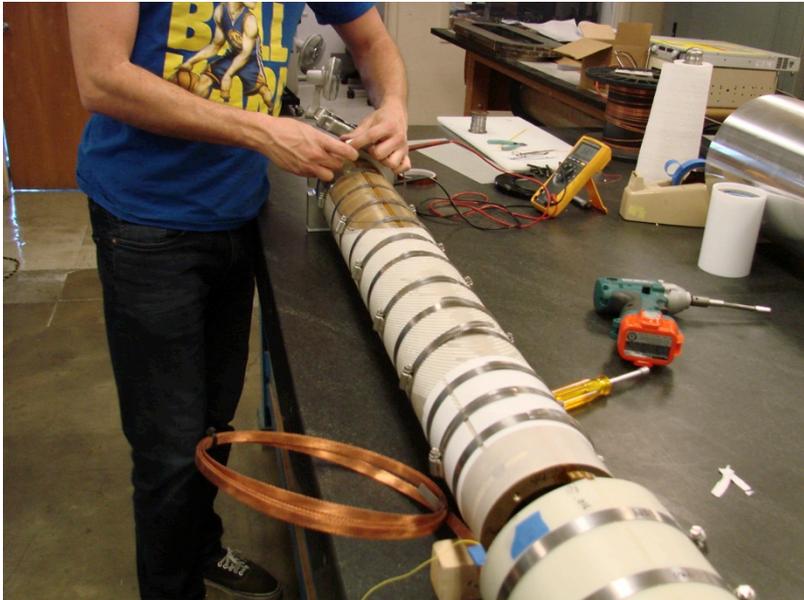
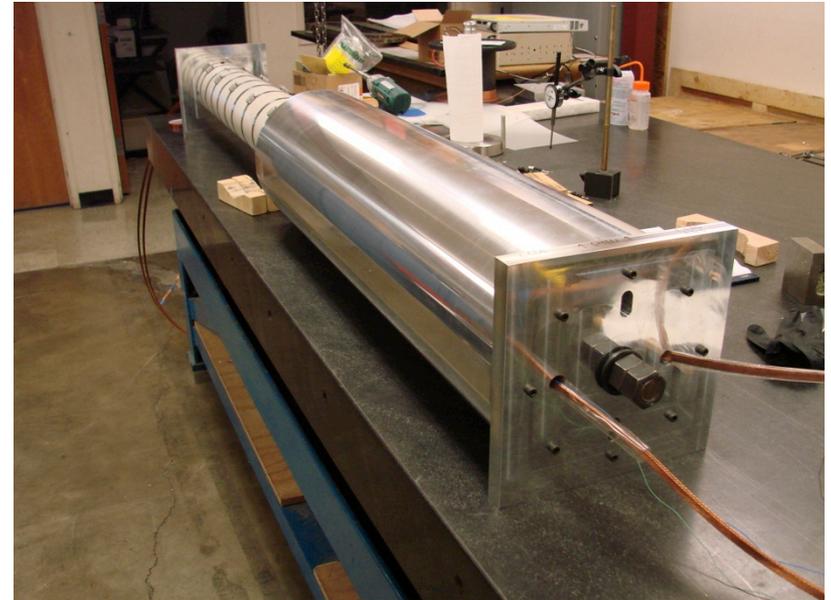
- Layers are wrapped with G10 sheet before assembly
- Assembly of layer 1 / layer 2 was difficult due to amount of mandrel distortion
- Cable is protected by mandrel since it is below the surface
