U.S. MAGNET
DEVELOPMENT
PROGRAM

C3 status

MDP bi-weekly meeting, 21 August 2024

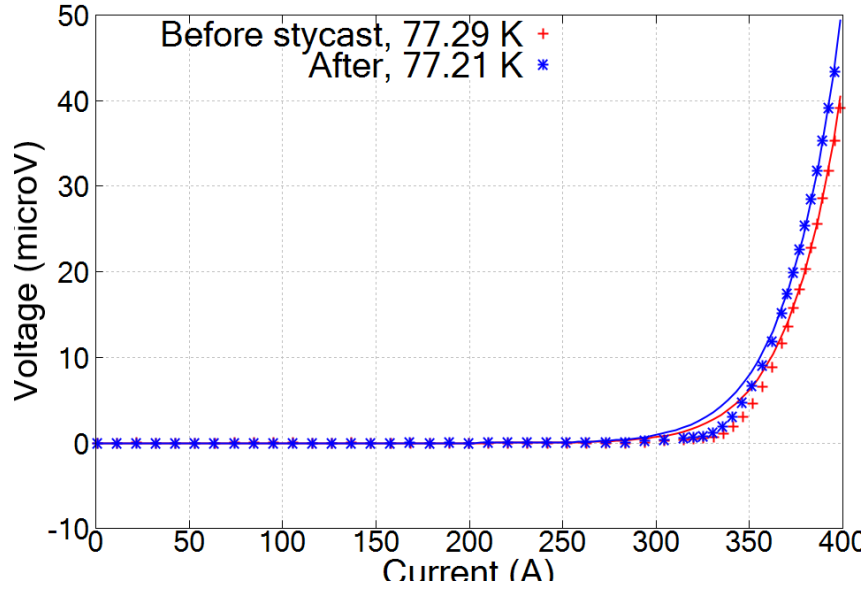
I_c reduced by 2% after painting Stycast for Layer 1, consistent with the previous coils in C2 and C3a

I_c (A)	n
Before painting	380	14.3
After	374	13.9

- Skip the measurement before painting Stycast for the remaining layers

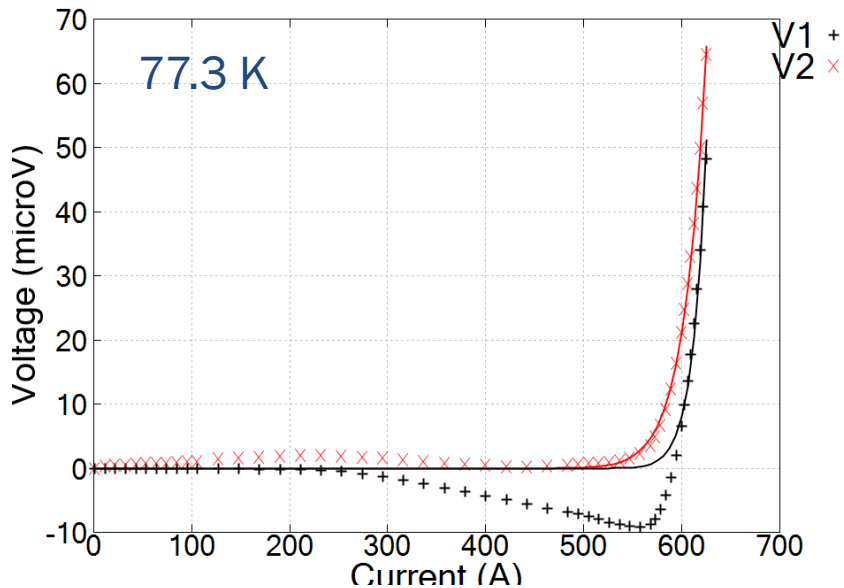
Layer 3 showed an unusual V(I) behavior

- Strong negative voltage in V1 before transition
- V1 and V2 transitioned at similar current
- V2 wire insulation can be damaged and made a contact near V1
- $I_c \sim 607$ A at $20 \mu\text{V}$ criterion
- $n = 35.2$

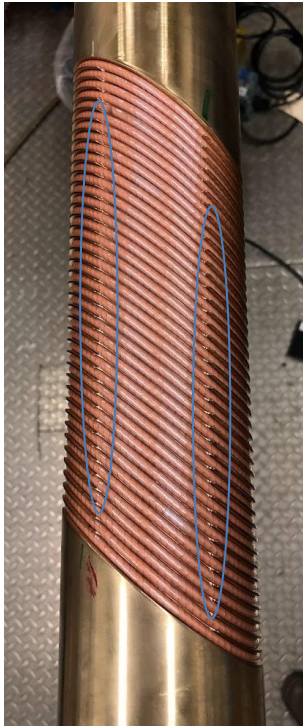
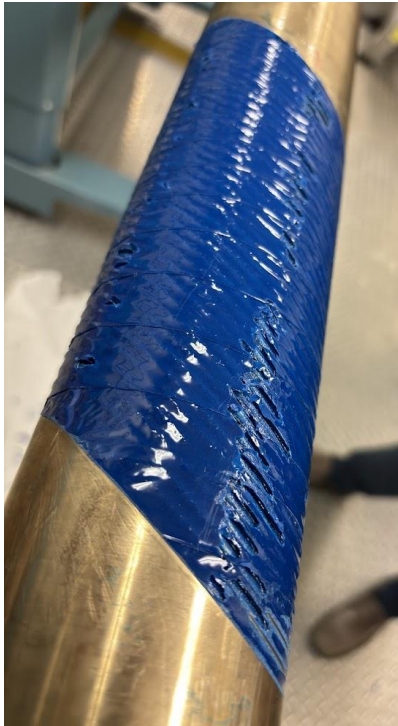
Layer 1: a surprising number of voids appeared after the Stycast cures

- Addressed by the second filling
- Also started using a professional mixing machine to mix and degas Stycast/catalyst.
 - Thanks to Tom Johnson at the Composite Shop for loaning us a Thinky machine and Ian/Jean-Francois/Andy ordering the supplies.
- Clustered around the edge of the discontinued ribs
- Another reason to have continuous ribs?

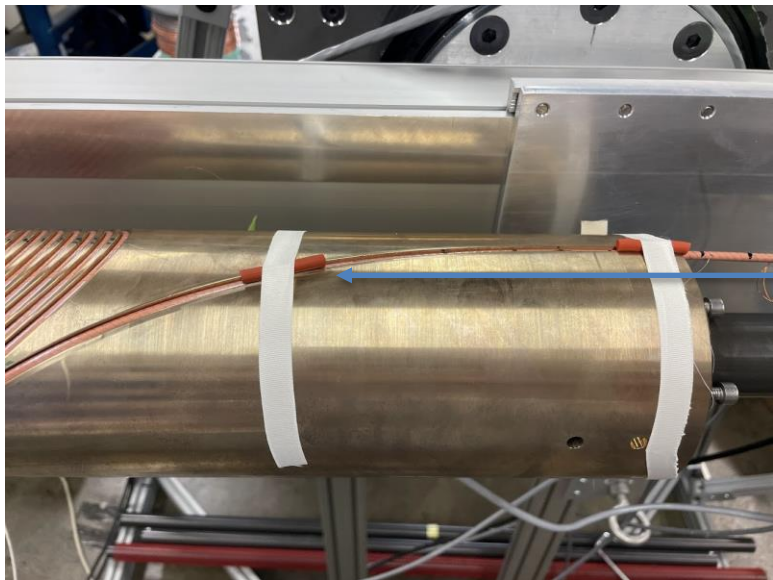
Layer 3: wire detached from the groove at the exit

- The gradual curve at the exit does not constrain the wire that is under tension
 - May overbend the wire
- Need external force to keep the wire in the groove
- It was in the procedure but was not followed...

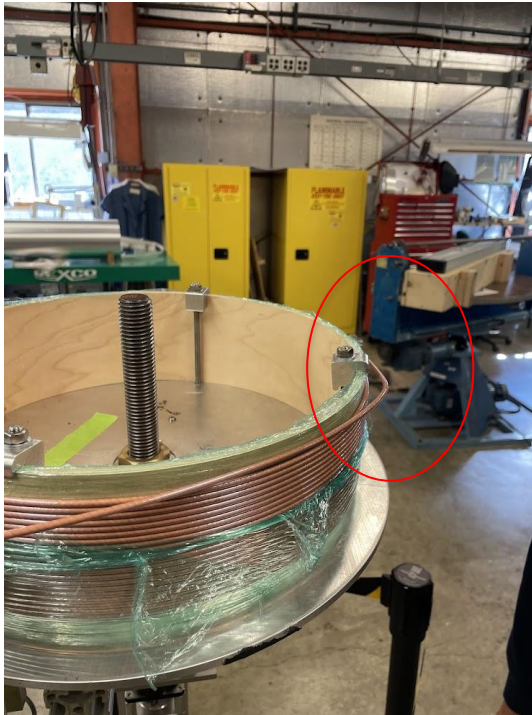
Layer 4: wire badly kinked by accident

- Wire detached from the return end groove under tension before we got a chance to apply the rubber stopper
- The wire on the far end popped out of the spool and got caught and bent by the nut
- We started from the end of the wire on the spool. Thanks to Hugh for the idea. The additional wire length helped.
