Long length properties before and after test of REBCO coated conductors

X. Hu, L. Rossi, A. Stangl, A.A. Polyanskii, D.V. Abraimov, J. Jaroszynski,
and D.C. Larbalestier.

Applied Superconductivity Center,
National High Magnetic Field Laboratory, Florida State University

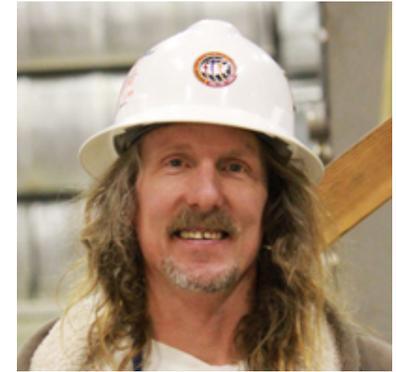
Reel-to-reel current and magnetization measurement

- Transport device invented by Yates Coulter, LANL, NHMFL
- Further developed with magnetization at ASC, NHMFL

- Transport
 - Current goes from one pulley to the other
 - biangular vs. position
 - or vs. angle, field
- Magnetization
 - Remnant field
 - Hall probe array with 7 sensors
- Transport sensitivity with ~ 2 cm resolution with B parallel and perpendicular
- Magnetization sensitivity with mm resolution in remanent field

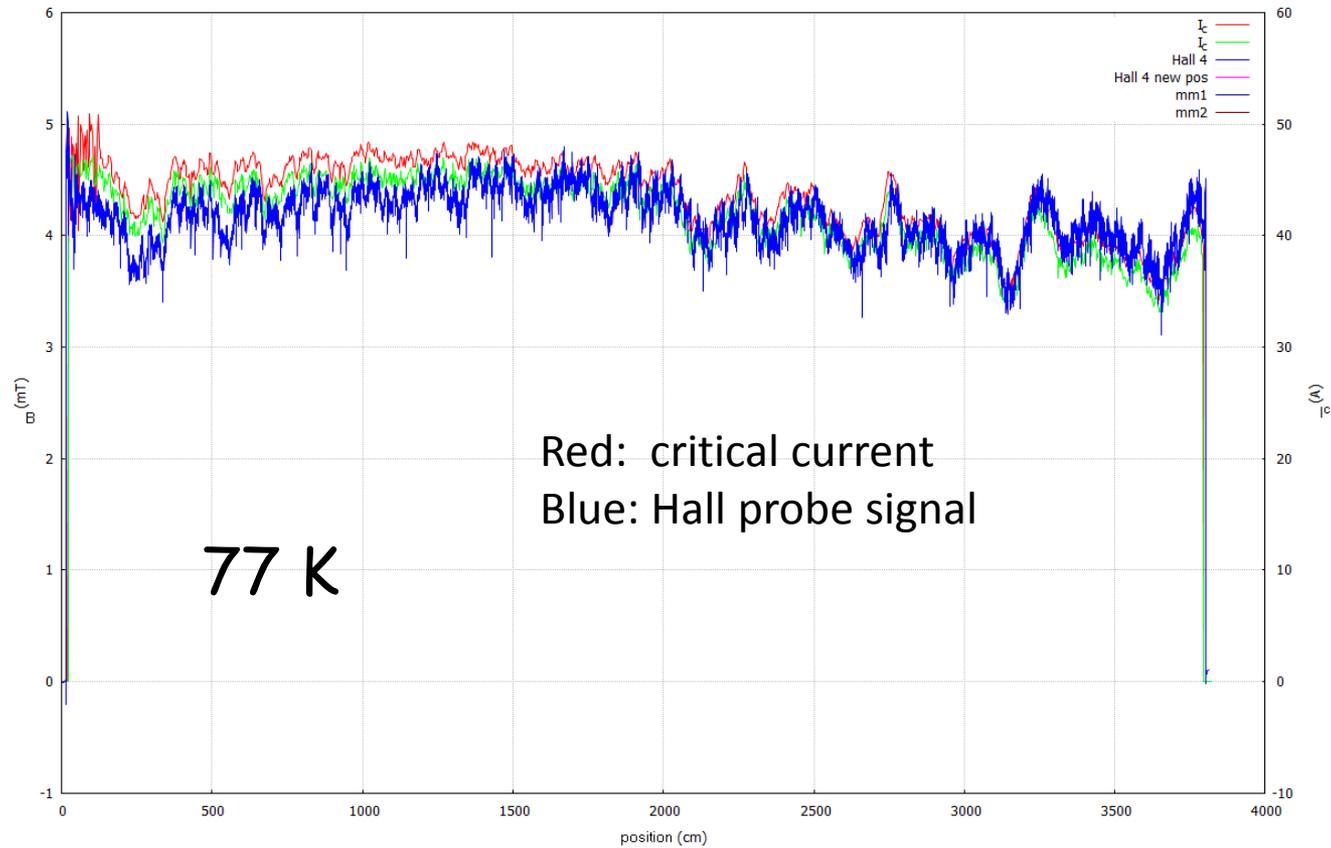
Good correlation I_c and M

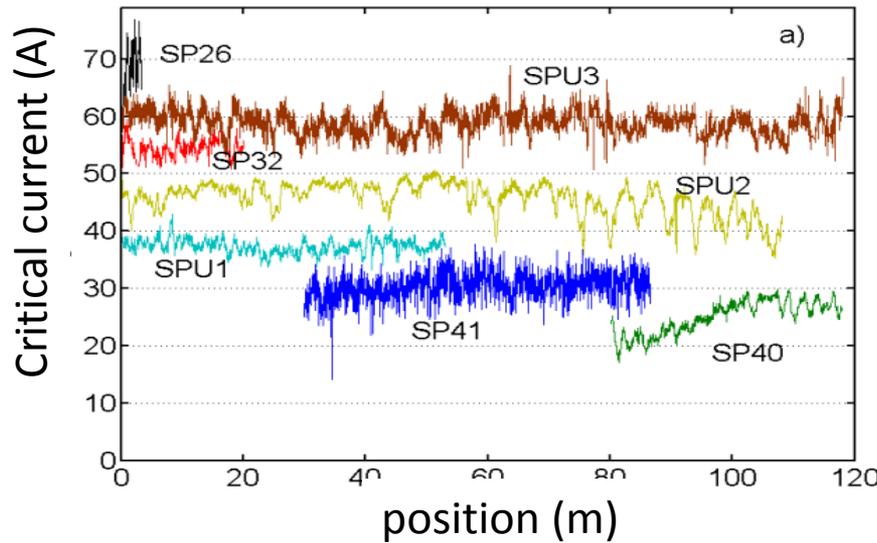
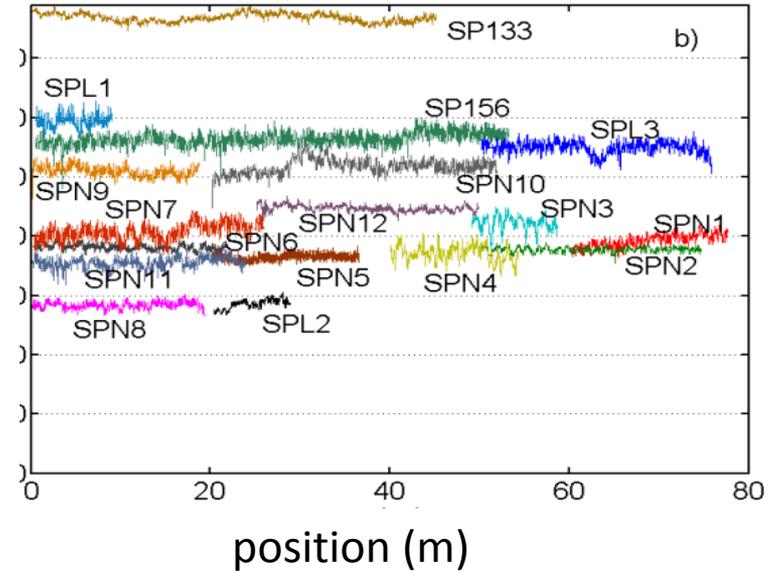
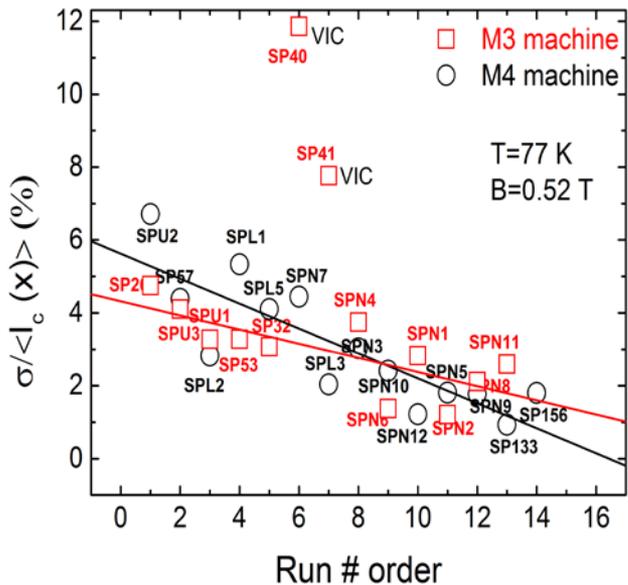
Critical current vs. position on tape

Standard deviation decreased from 5 % to 1-2%
But variation between tapes still present

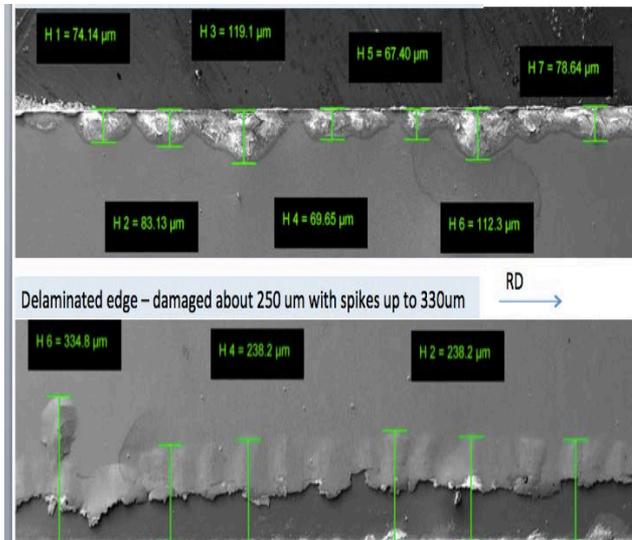
Tedious SEM imaging shows width and thickness but not necessarily distinguishes conducting and non-conducting regions

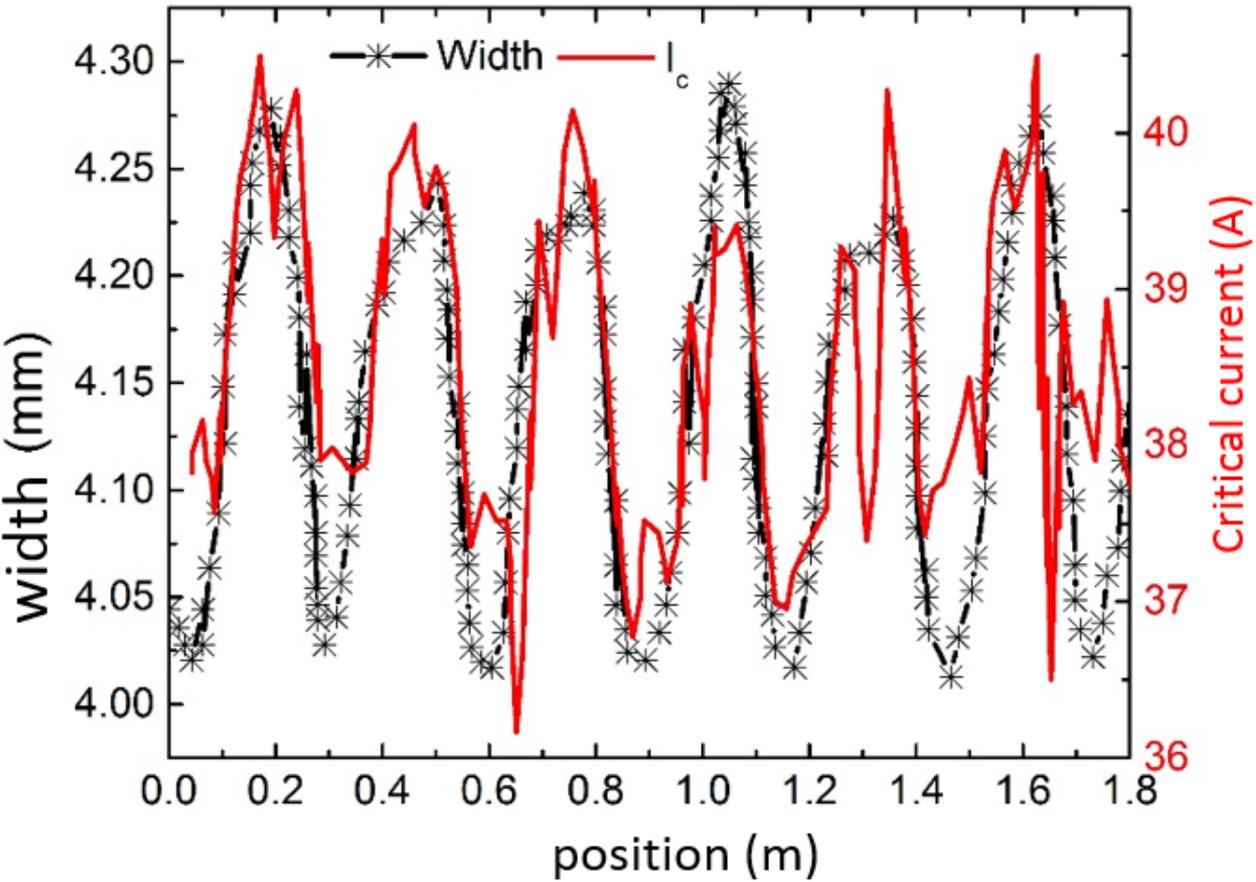
Periodic I_c oscillations because of width variation (trivial)

- slitting process
- residual in recent production
- recently because of HTS film width variation, not the whole tape width changes

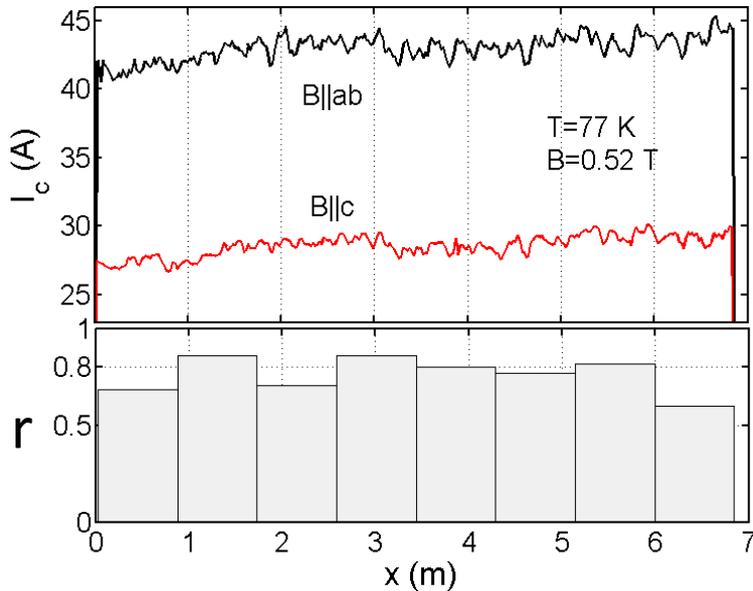
Well correlated (rare)
=> $I_c \sim$ cross section variations

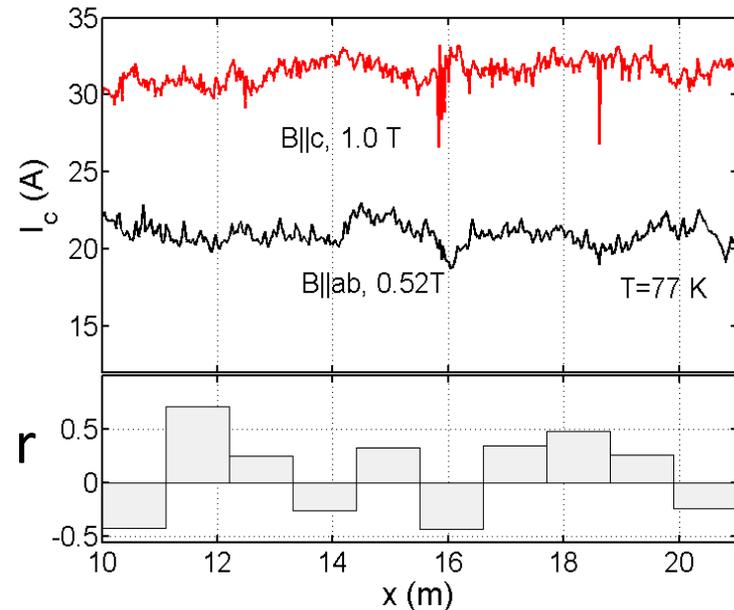
Not correlated (most cases)
=> $I_c \sim$ pinning variations (J_c)

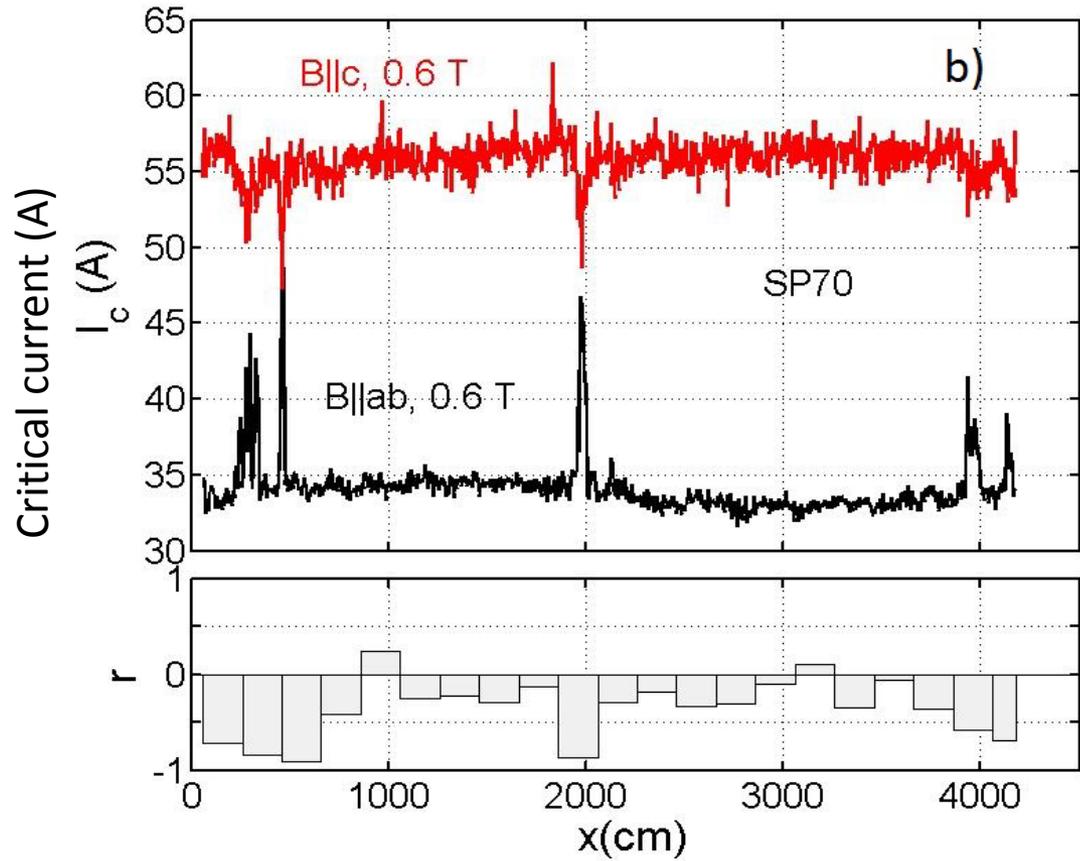
Anti-correlation - obvious result of pinning variations

TEM study reveals that here BZO forms thick BZO column promoting ab-peaks rather than c-peaks

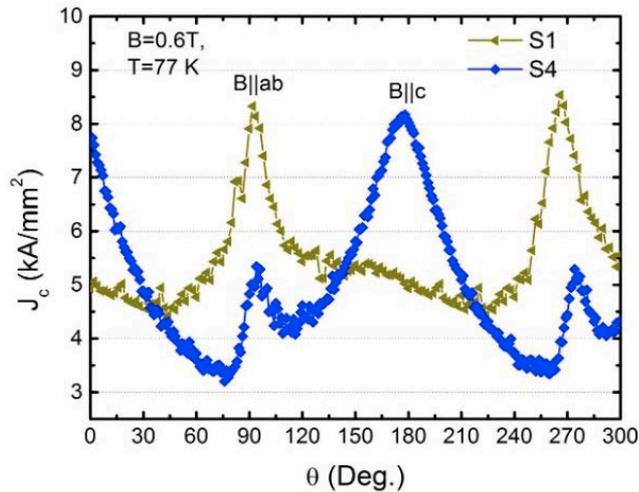
Less BZO => twice lower performance at low temperatures

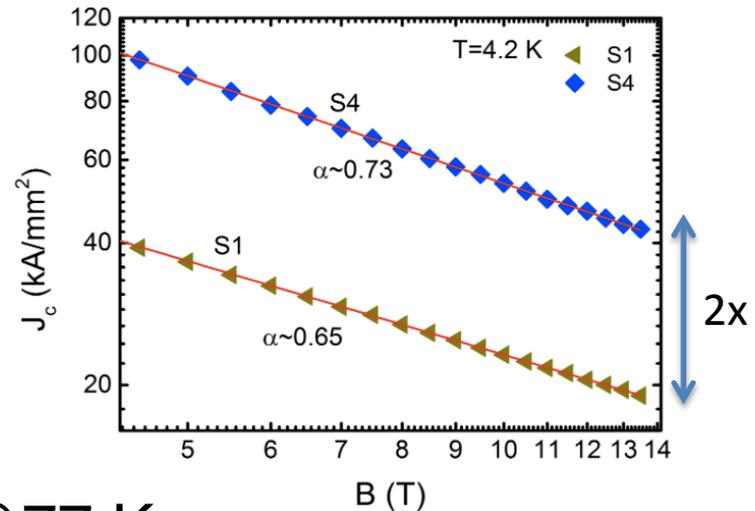
Less c-pinning looks innocent @77 K
=> twice lower performance
at low temperatures, precursor of troubles

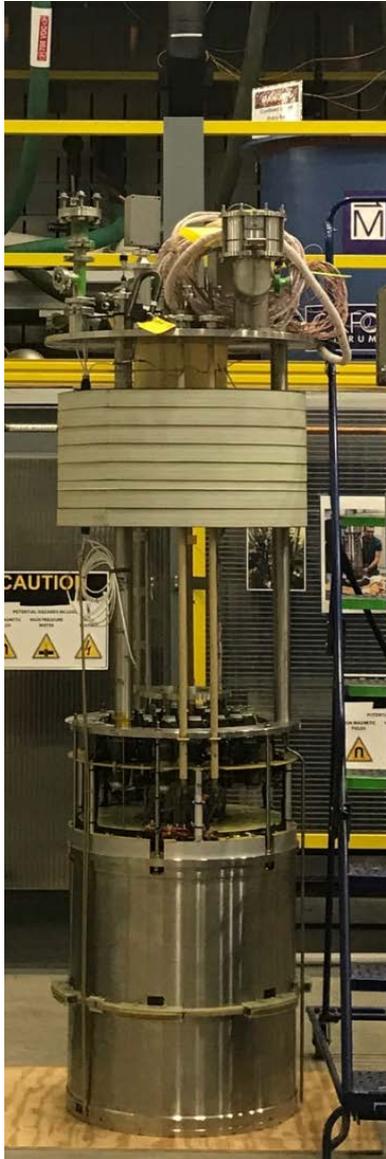
Tapes deconstructed from 32 T and NI
coils

YateStar can localize bad spot in tapes deconstructed from underperformed coils

Cracks responsible for underperformance

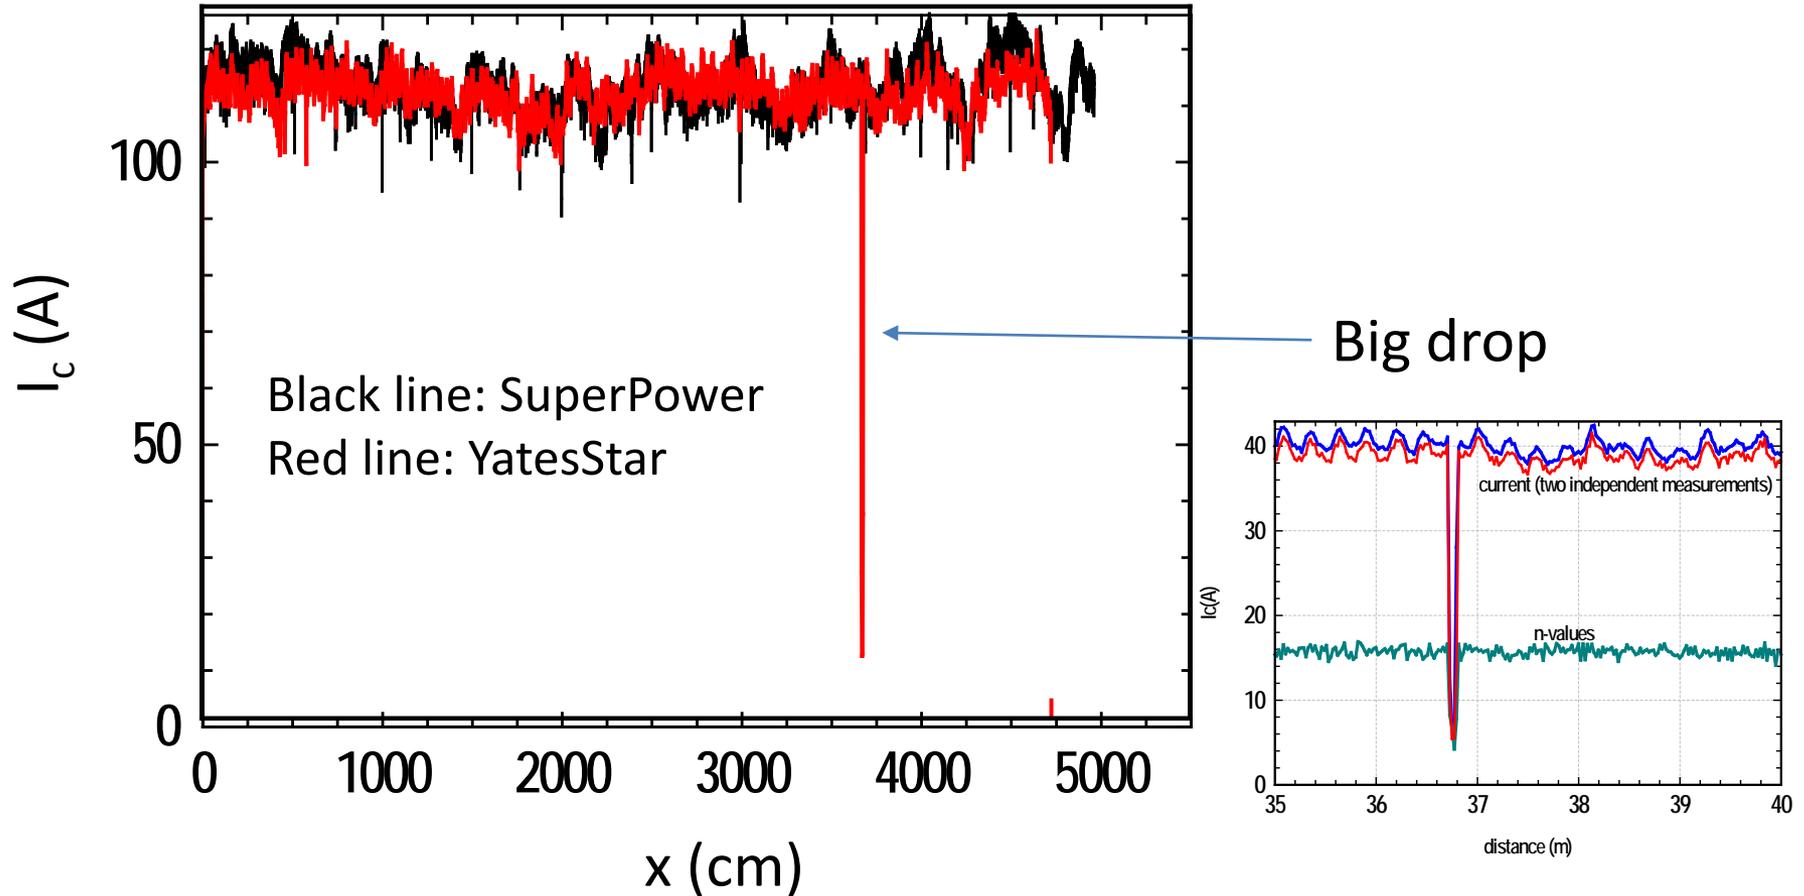
Comparison of I_c results from SuperPower and YatesStar

Our measurement is comparable to SuperPower's ,
except for the big drop. What happened?

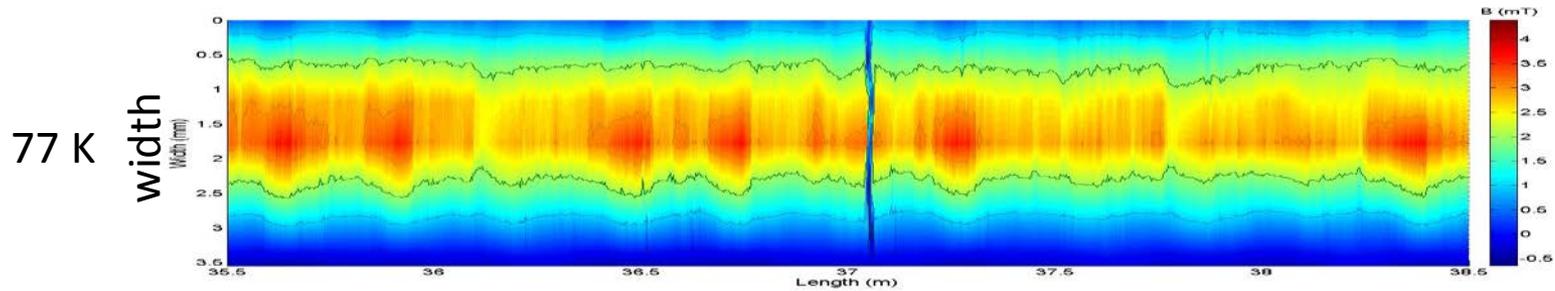
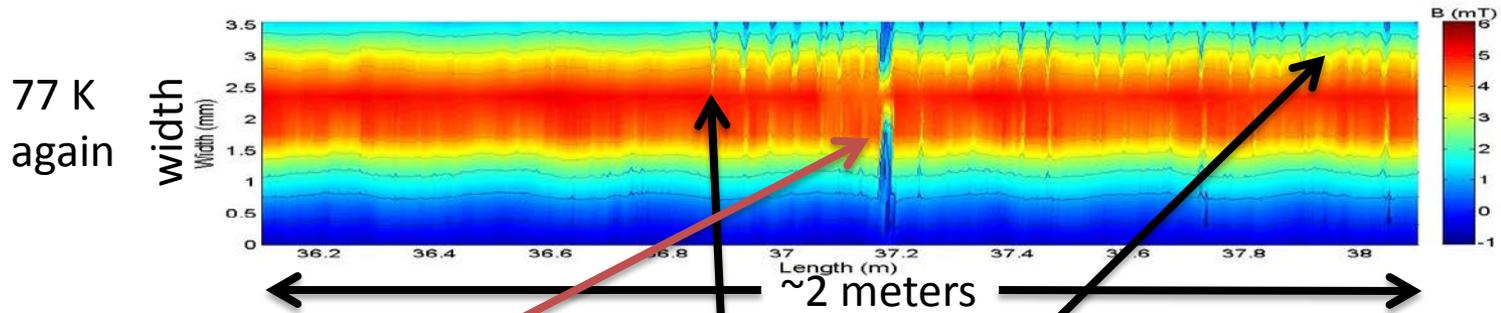
Main dropout

Periodic cracks after fatigue

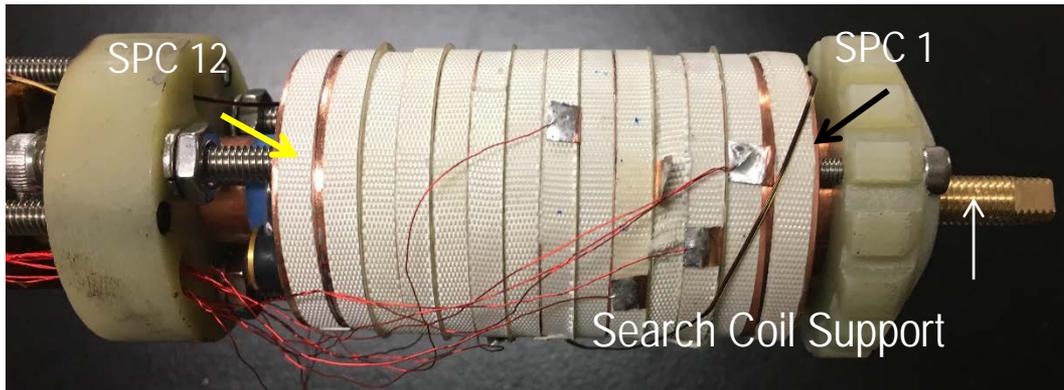
45.5 T Record High Field from All-REBCO NI Insert

- All-REBCO NI Insert
 - Consisted of 12 single pancake coils
 - Wound with the latest 30 μm substrate REBCO tapes manufactured by SuperPower Inc.

6.5 cm long, 3.8 cm DIA, 31.2 T + **14.3 T** !

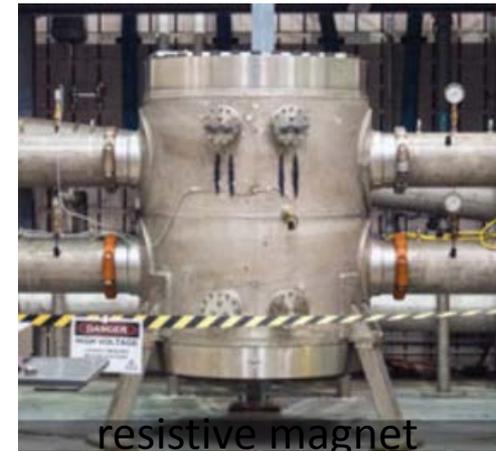
resistive magnet

2 m x 1 m DIA

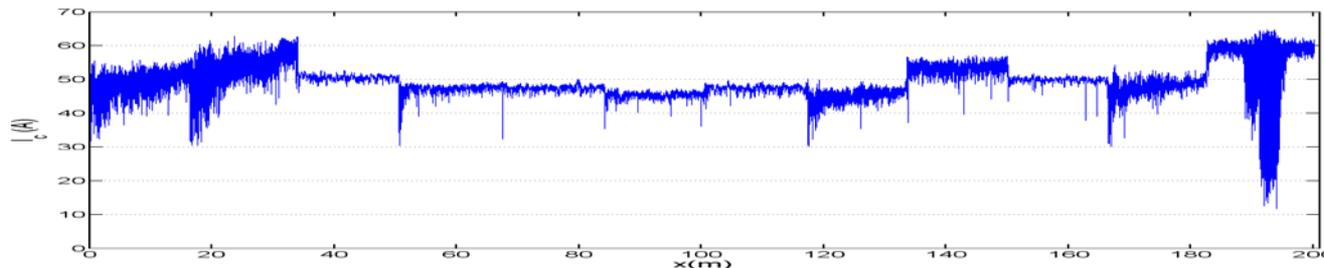
YateStar after quench:

The major defects are caused by transverse cracks

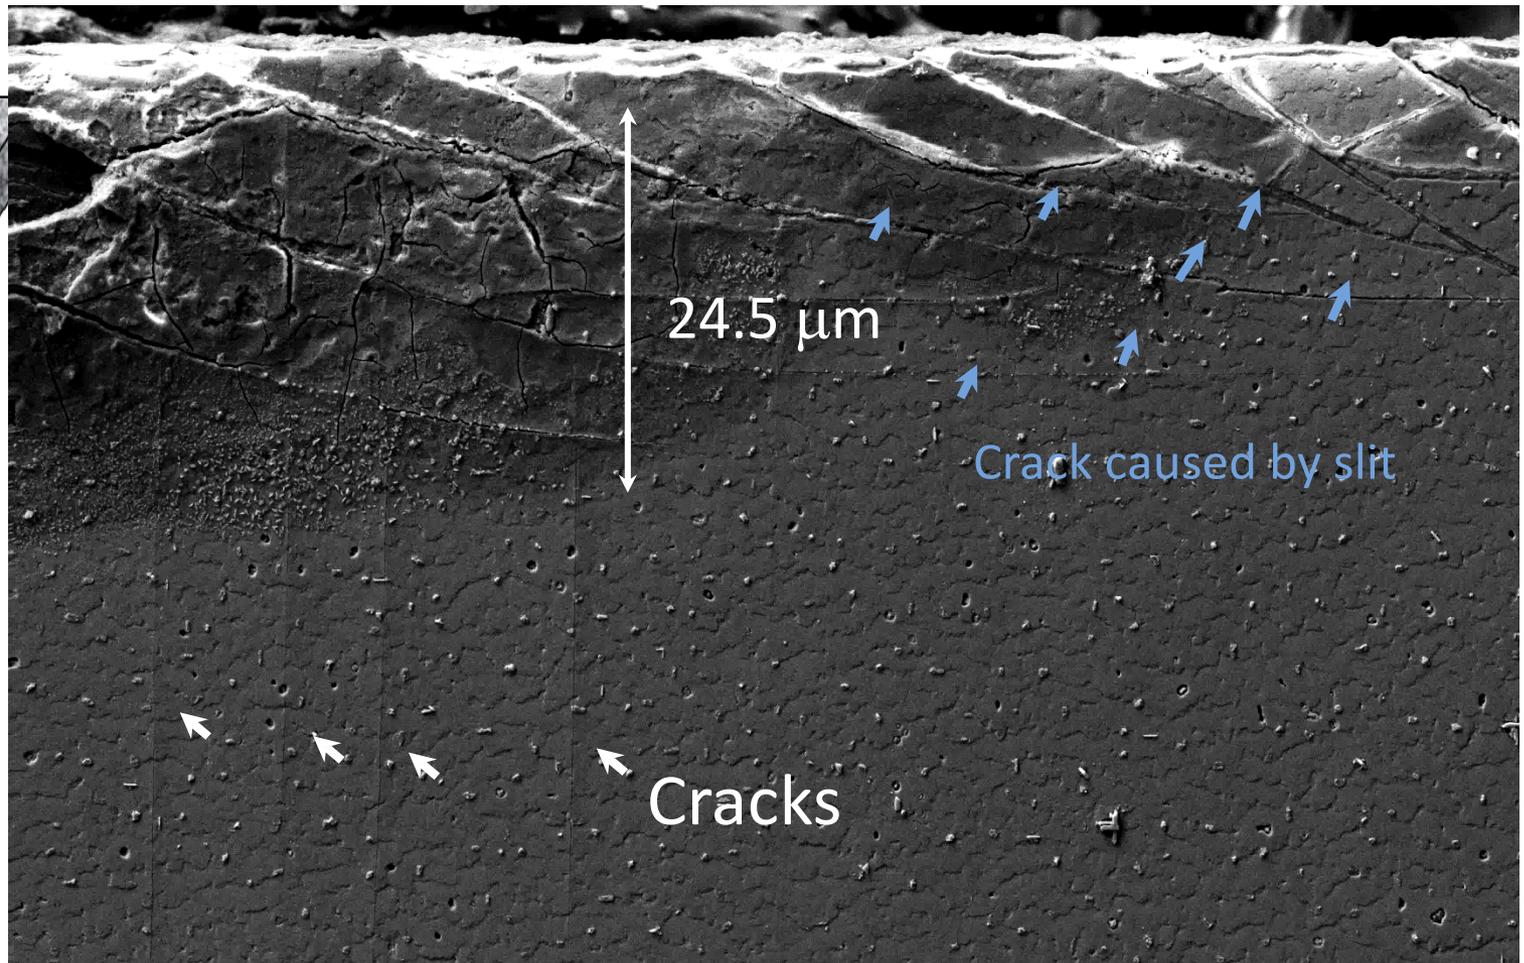
- Transverse cracks are not related to slit cracks.

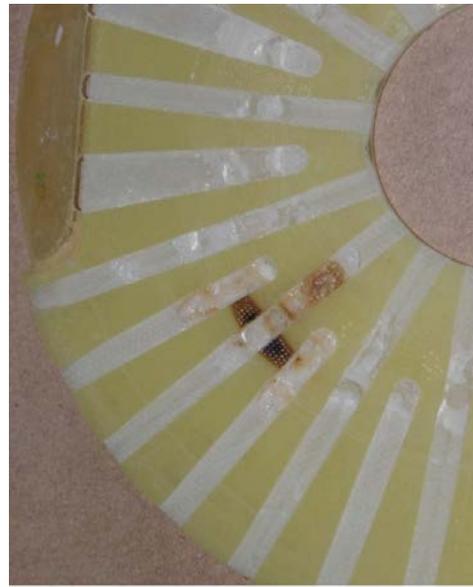
Quenches in 32 T prototype possibly triggered by pinning variations

Three spontaneous quenches caused degradation, after more than 100 safe triggered quenches

Post mortem transport and magnetization, pancake 6 of 32 T prototype

Note that the damage occurred during accelerated fatigue testing at many times the high operational sweep rate

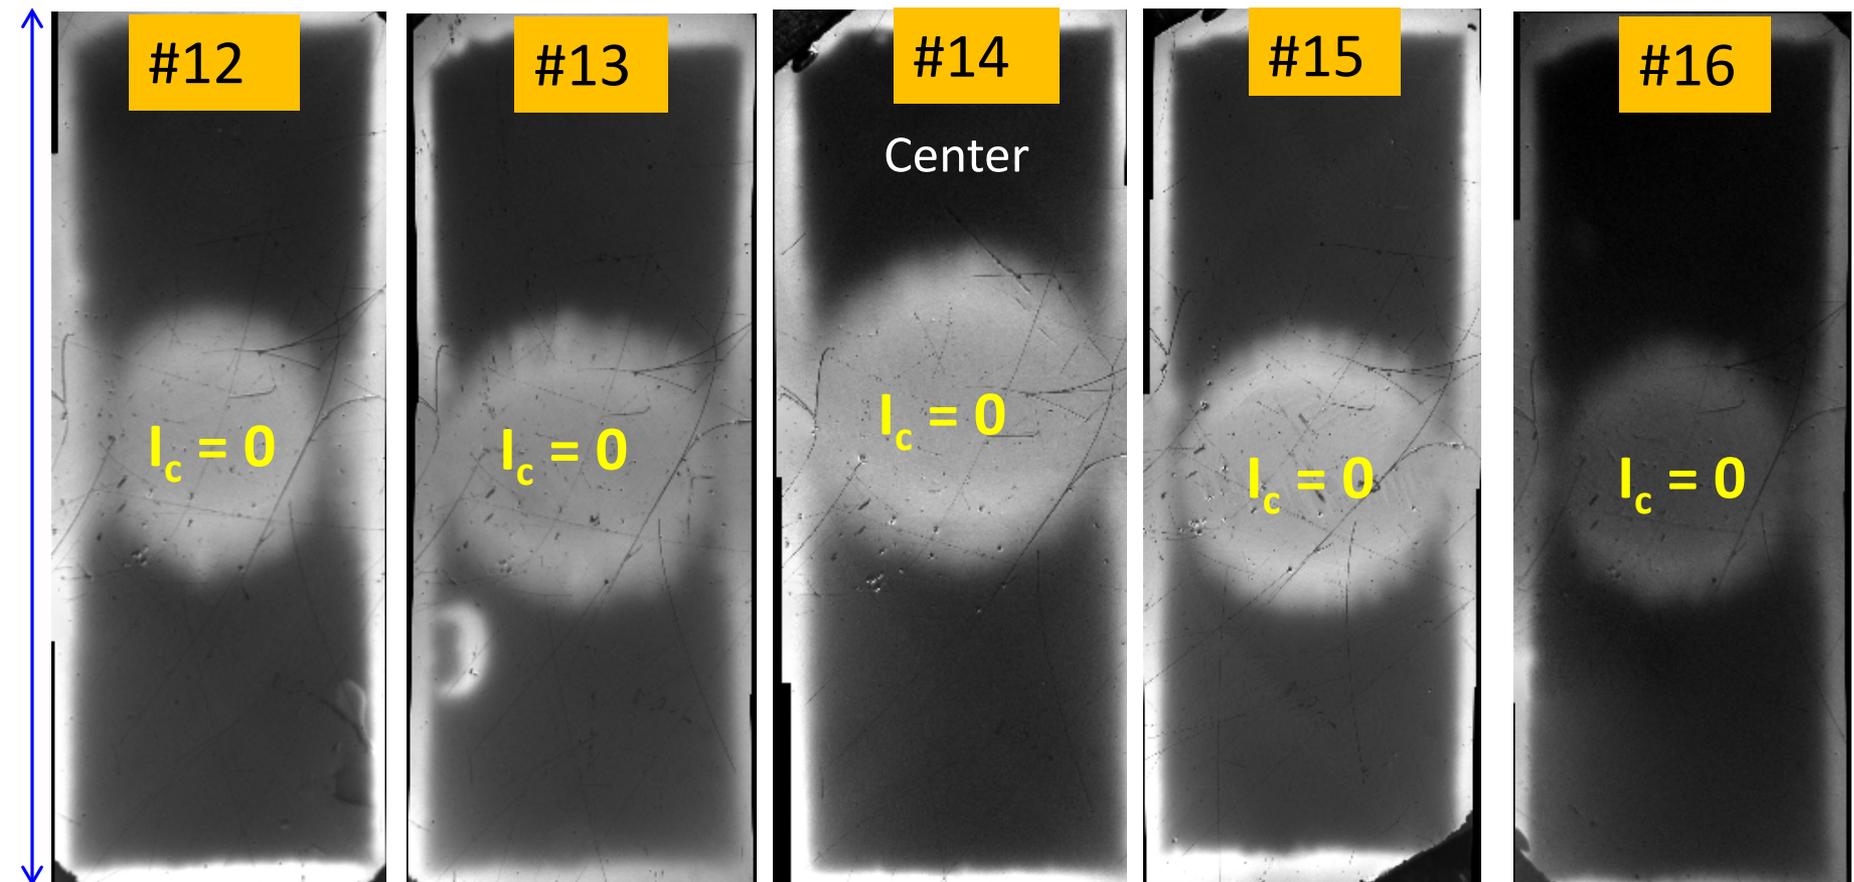
Magneto-optical imaging (MOI) at zone A show turn #14 is the zone center

10 mm $T=10$ K, ZFC, 20 mT

- Quench center is determined by the size of the damaged zone.

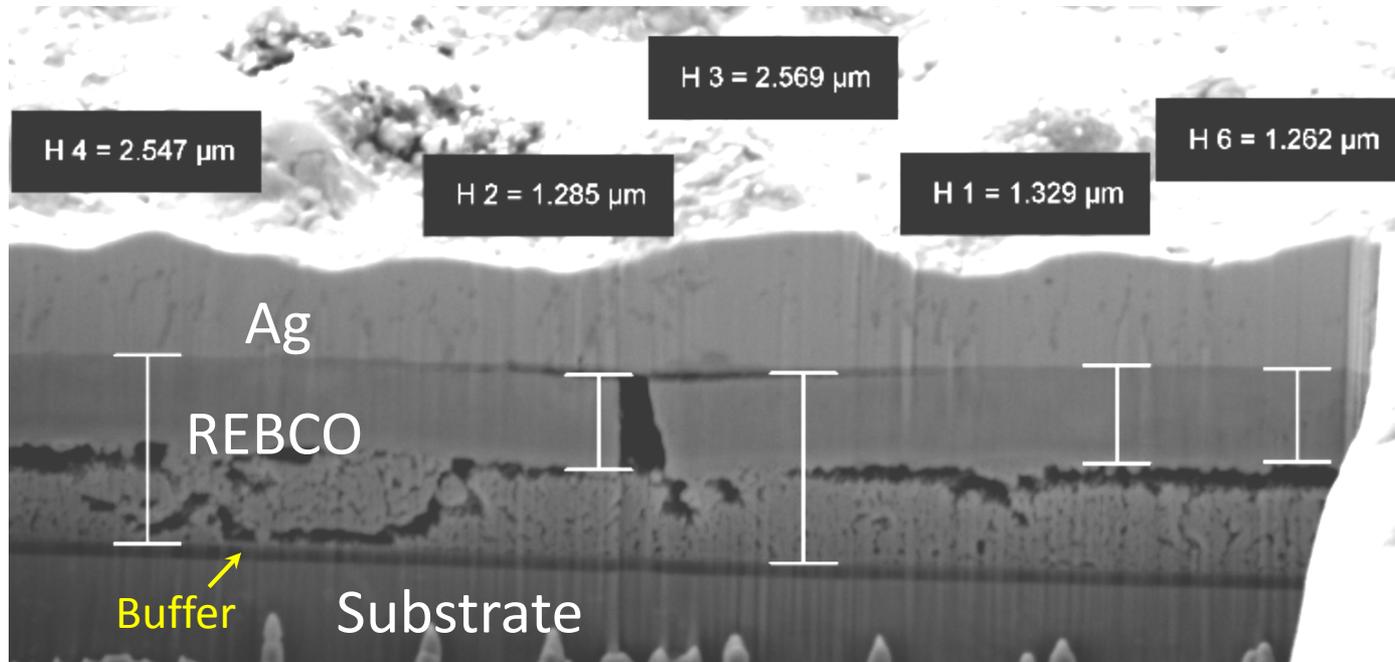
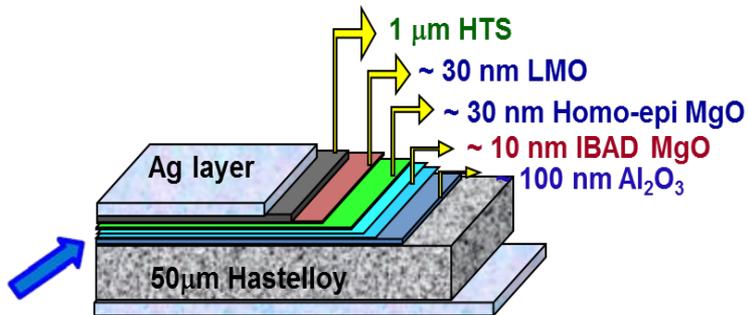
Localized heat blew apart the REBCO layer and introduced planar defects

- REBCO is normally $\sim 1 \mu\text{m}$ thick.
- REBCO thickness is more than tripled on the edge of the black spot.

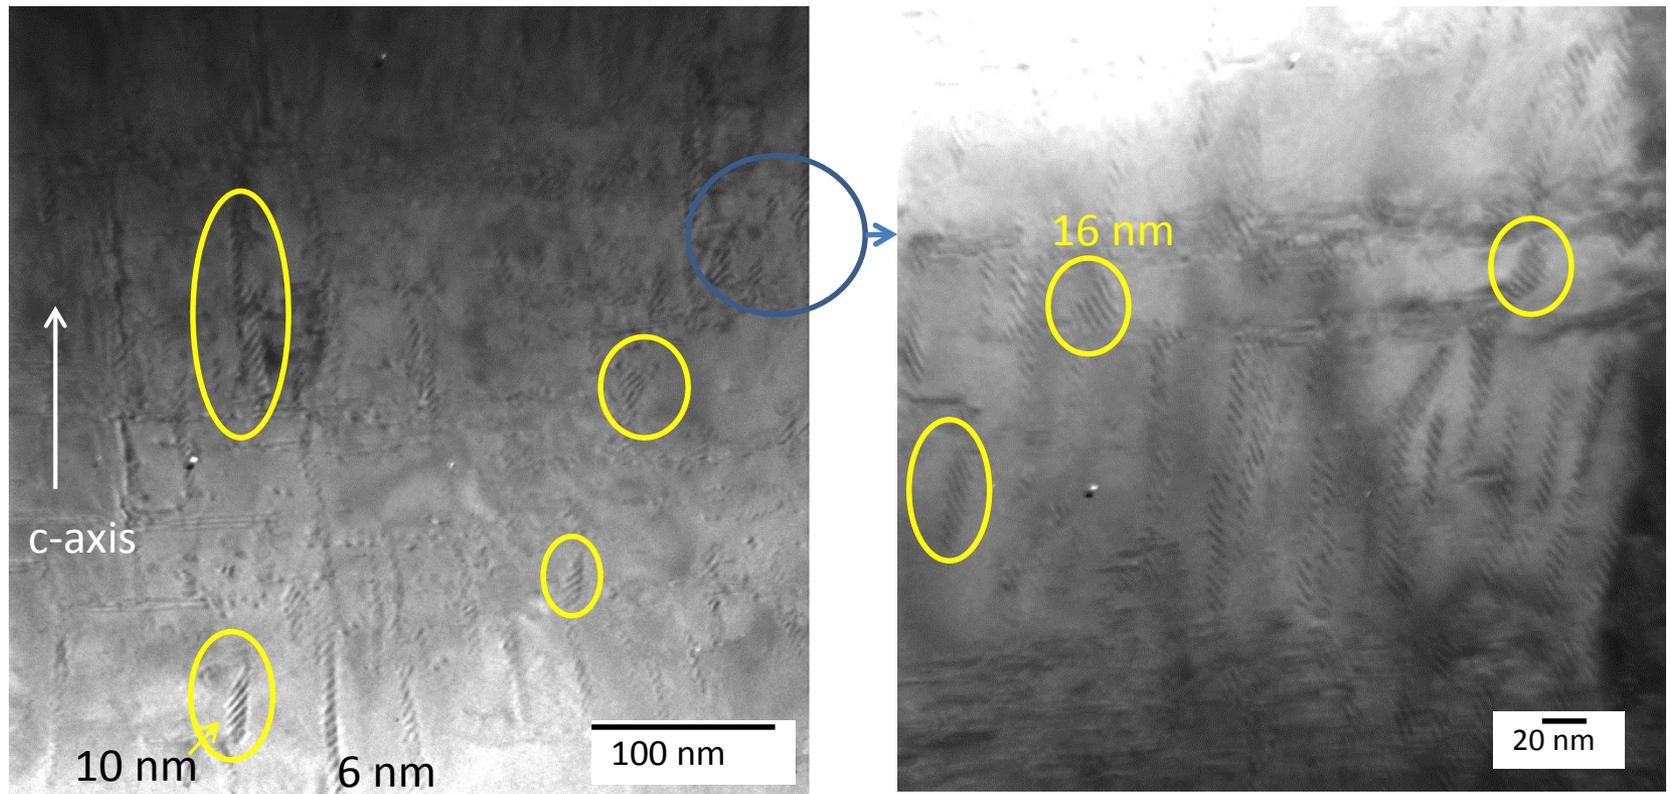
Thicker BZO nanorods found ~ 4 mm away from the hot spot edge of quench A

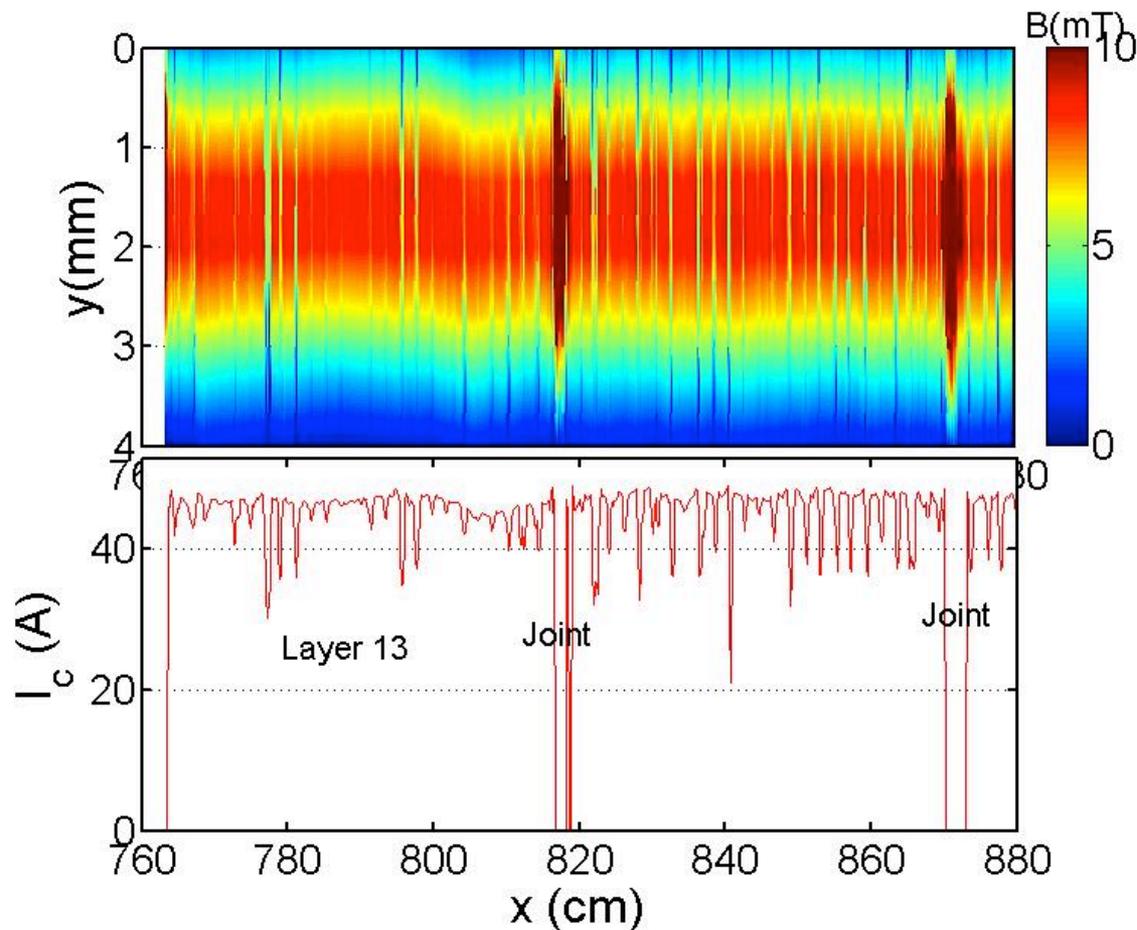
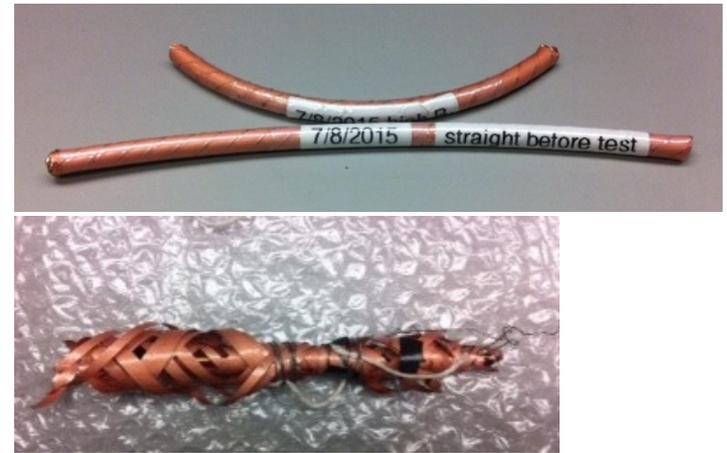
Damage seen in CORC® cables after bending

Period of I_c dropouts
well correspond
to cable circumference
After these tests production
protocol improved

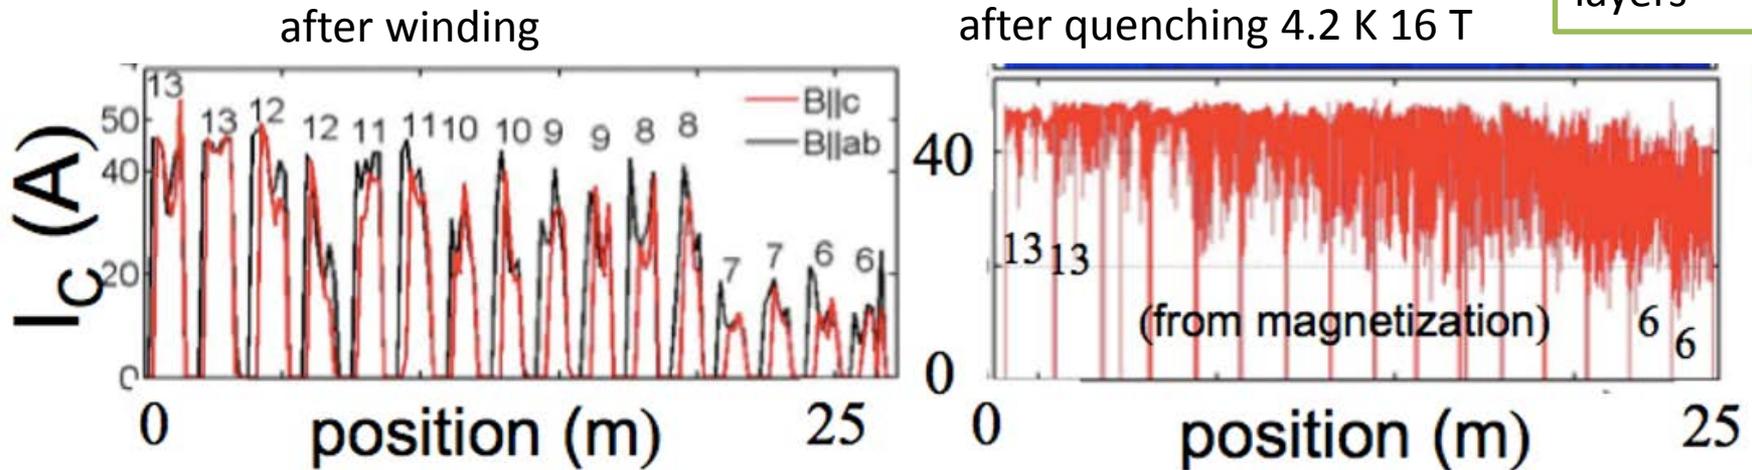
Winding degrades inner layers, quenching at 4.2 K 16 T degrades further

Damage increases from outer to inner layers

Layers	1-5 (inner)	6-13 (middle)	14-20 (outer)
# of tapes each layer	2	2	3
Tape width	3mm	4mm	3mm
Substrate thickness(μm)	50	50	50
Cu thickness each side (μm)	5	5	5

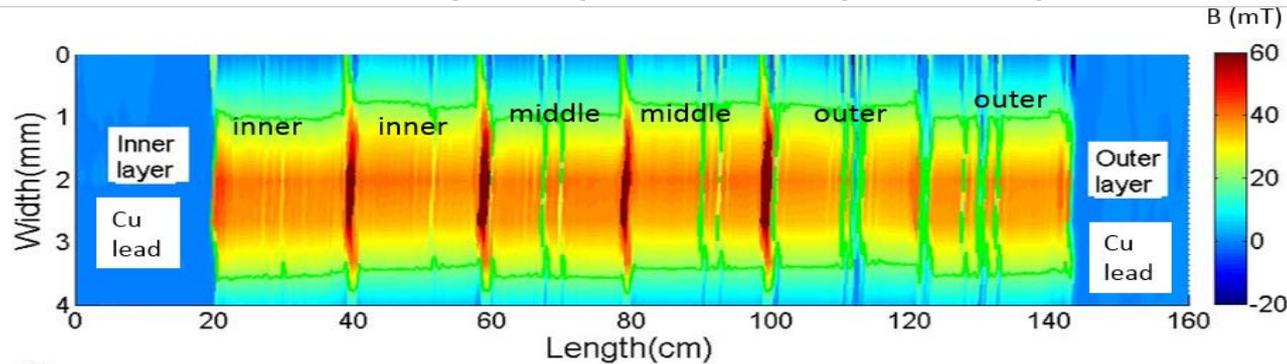
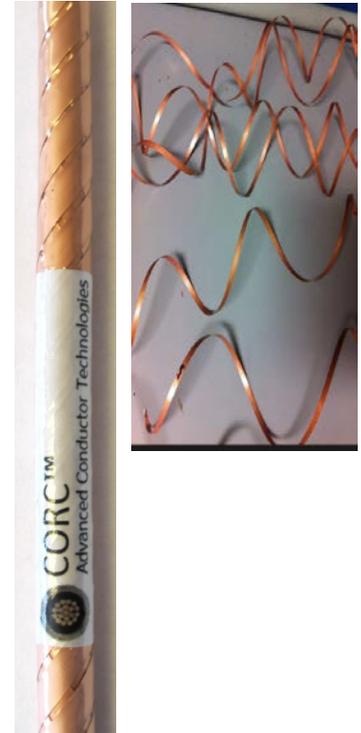
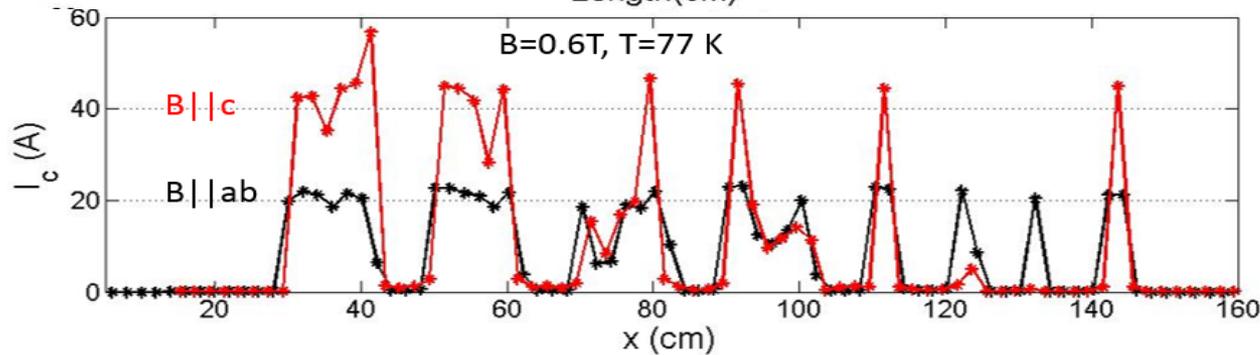
- CORC deliberately compressed 3 layers, 2 tapes for each layer.

- The strongest damage in the outer layers
- c-peak is strongly depressed, ab – no change
- apparent change of vortex pinning

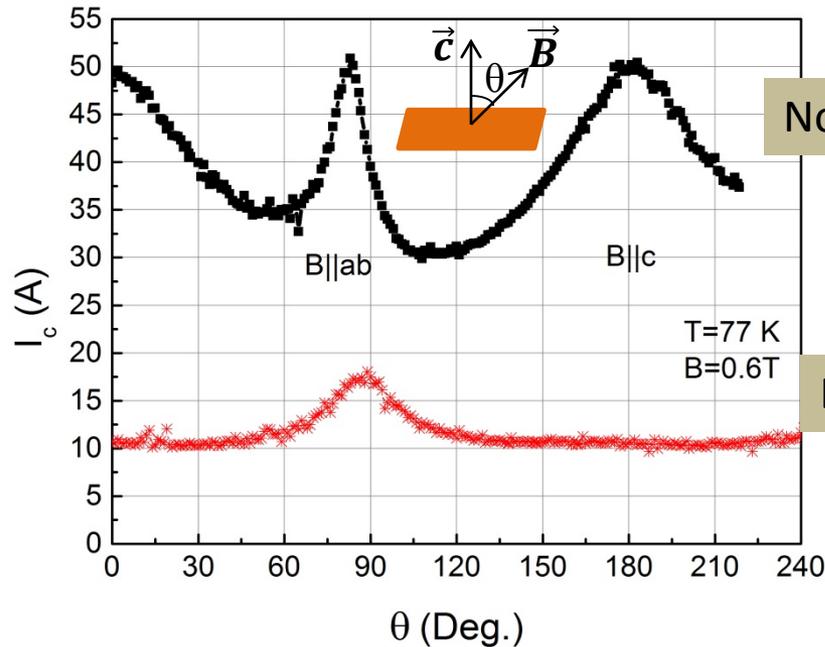
Pinning changes seen in cables after **being** quenched in high-field (**17 T**) tests

c -peak disappears totally!
Special case \rightarrow TEM

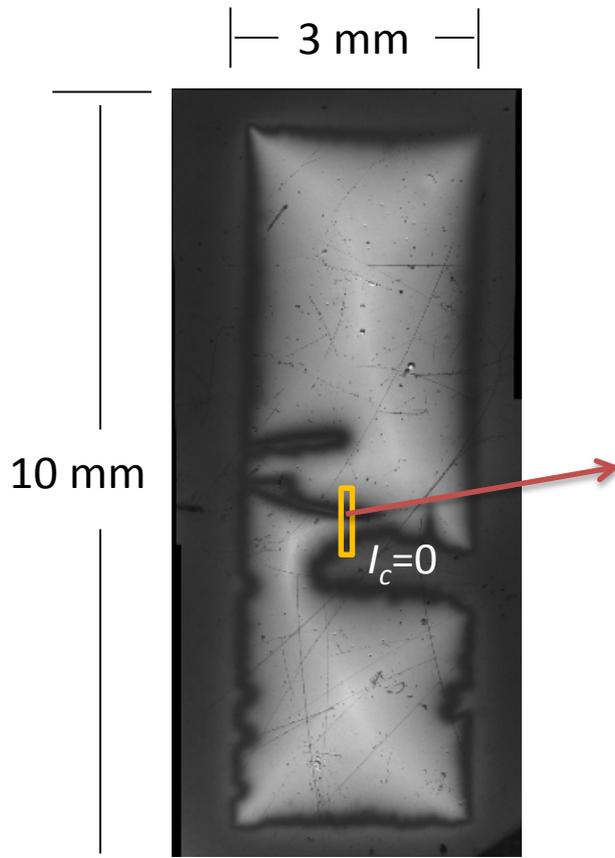
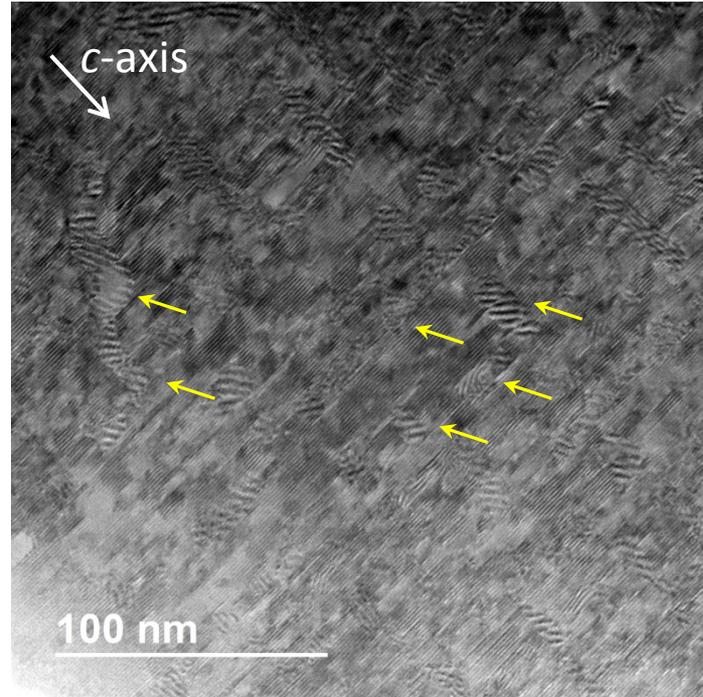
Degraded region

In this region of anomalous pinning TEM shows abnormal microstructure

- BZO nanorods random, short
- High density of stacking faults.
- PREEXISTING!
