Long length properties before and after test of REBCO coated conductors

X. Hu, L. Rossi, A. Stangl, A.A. Polyanskii, D.V. Abraimov, J. Jaroszynski,
and D.C. Larbalestier.

Applied Superconductivity Center,
National High Magnetic Field Laboratory, Florida State University

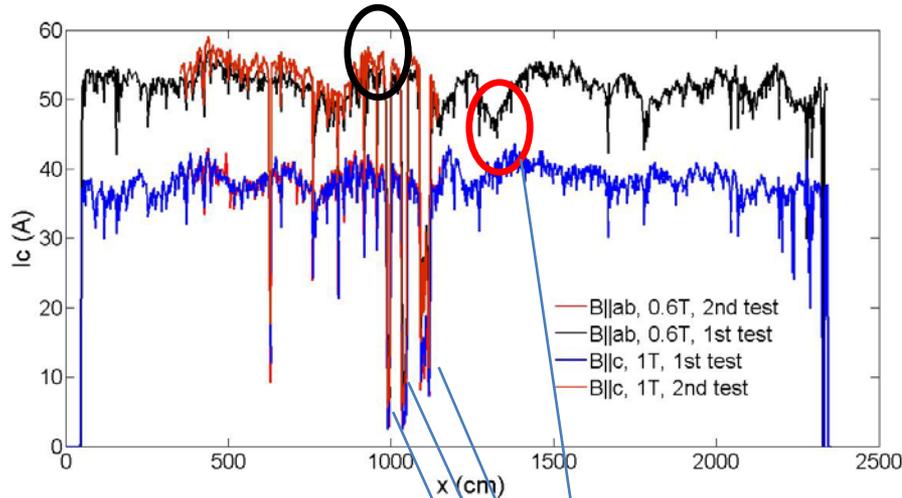
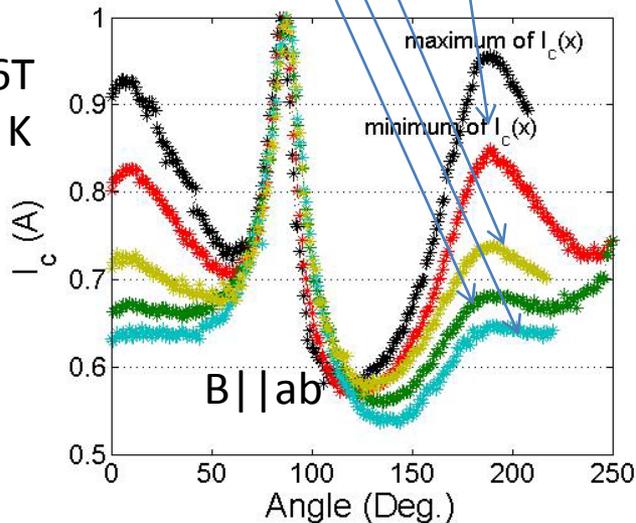
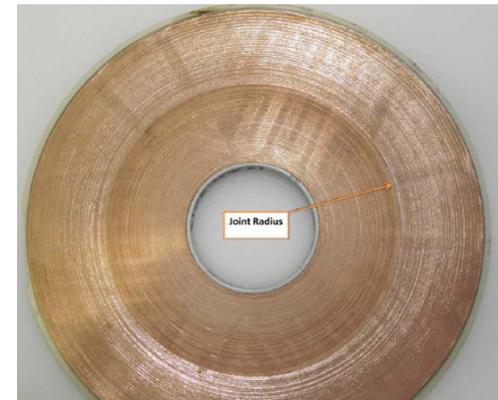
B=0.6T
T=77 K

Similar c-peak suppression observed in conductor from deconstructed coils

- The I_{ab}/I_c peak ratio at the maximum and minimum of $I_c(x)$ are 0.95 and 0.84, which could be a result of chemical variation.
- However, the I_{ab}/I_c peak ratio at defects drops even to 0.64.

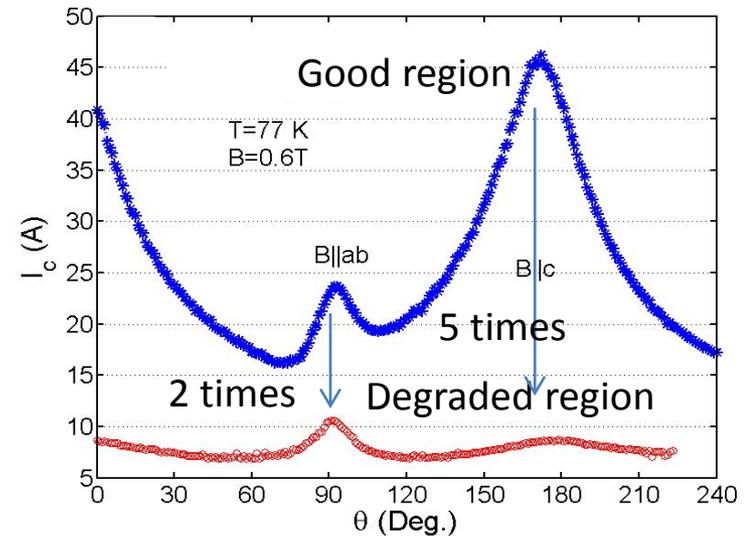
Pinning changes seen in CORC[®] cables after compression tests

- CORC[®] cables: Conductor On Round Core^[1,2]
- Stress dependence of I_c in LN₂ was tested by cable compression between two anvils.
- Cable deconstructed after test and individual tapes run through YateStar

$I_c(B||c)/I_c(B||ab)$ drops from 2.0 to 0.8

- Dominant pinning peak changes from c-axis to ab-plane in degraded regions

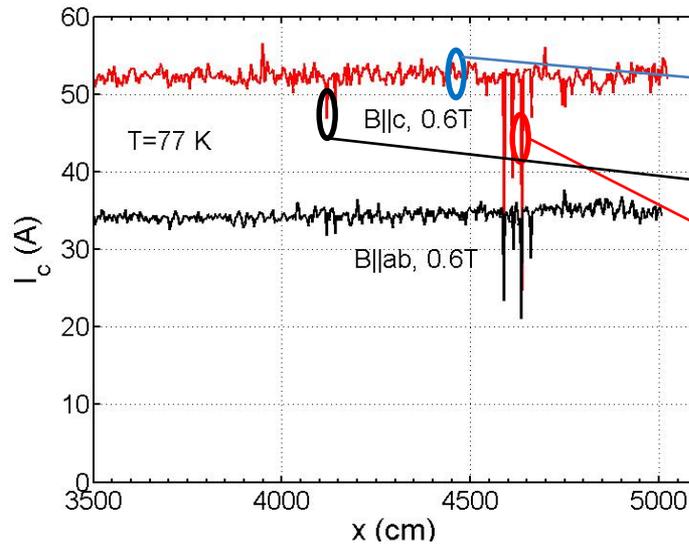
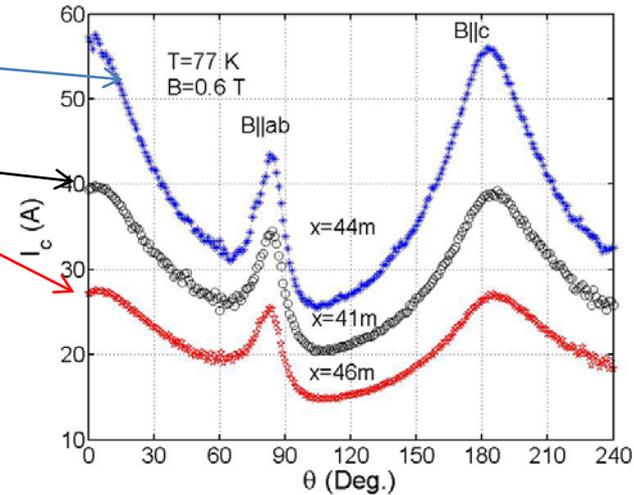
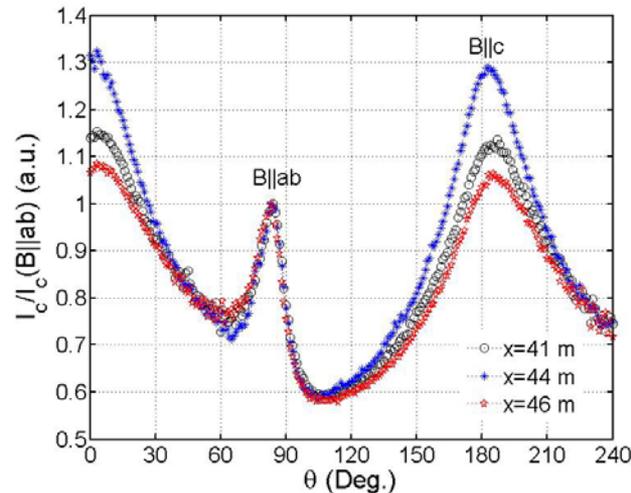
What is the anomaly? Degradation of I_c is cross-section AND pinning related!

- In good regions, $I_c(B||c)/I_c(B||ab)=1.3$
- In degraded region, $I_c(B||c)/I_c(B||ab)=1.1$

Unexpected loss of c -axis pinning in degraded regions.

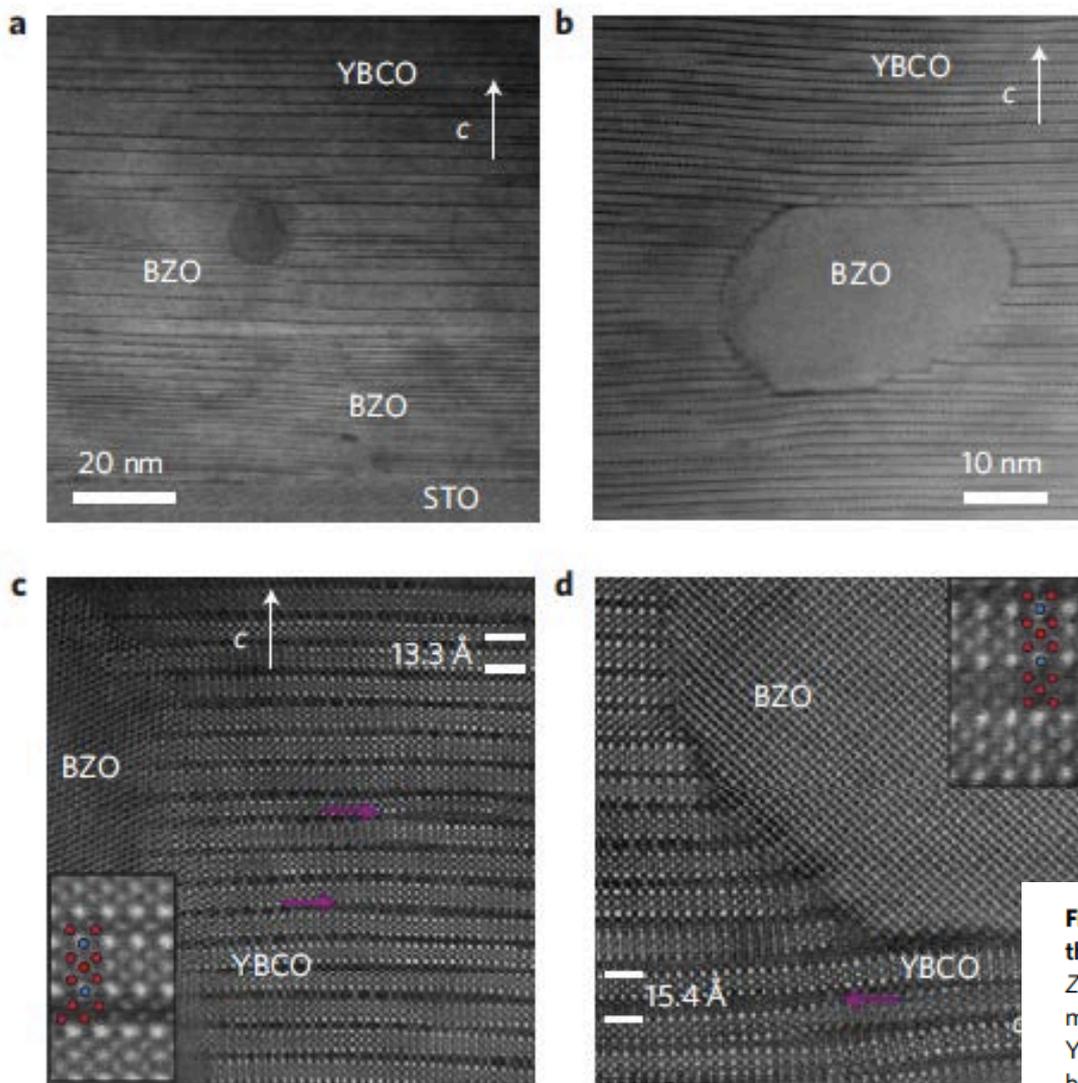
Figure 3 | Cross-sectional STEM micrograph of a YBCO nanocomposite thin film grown on STO along the [010] zone axis. a, Low-magnification Z-contrast images showing embedded BZO nanoparticles in the YBCO matrix. The horizontal dark stripes that cross the image are due to the Y248 intergrowths. **b,** Higher-magnification Z-contrast image showing the bending of the YBCO planes around the BZO nanoparticles. **c,d,** High-resolution Z-contrast images showing the interface between two different BZO nanoparticles with two different orientations and the YBCO matrix ($(111)_{\text{BZO}} \parallel [100]_{\text{YBCO}}$ and $(110)_{\text{BZO}} \parallel [010]_{\text{YBCO}}$ in **c** and $(110)_{\text{BZO}} \parallel [001]_{\text{YBCO}}$ and $(110)_{\text{BZO}} \parallel [100]_{\text{YBCO}}$ in **d**). These interfaces present a high density of Y248 intergrowths and cause a major distortion of the YBCO matrix. Purple arrows point to an intergrowth with two extra Cu-O chains added. The inset in **c** shows in detail the Y248 intergrowth, whereas the inset in **d** shows an intergrowth consisting of three Cu-O chains.

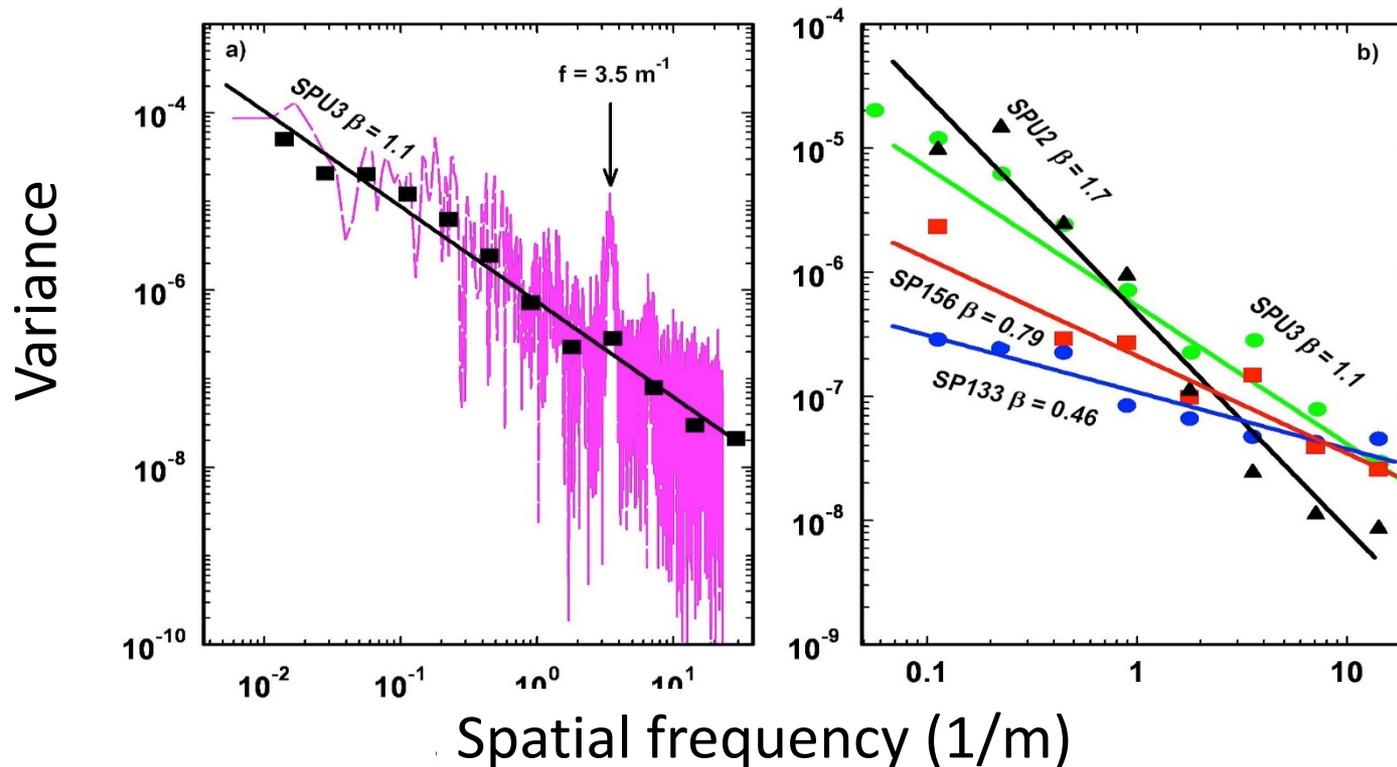
Fourier analysis: fluctuation variation vs. spatial frequency

-residual periodic

-1/f aperiodic

-the slope much lower in recent production => less long wave fluctuations
=> longer pieces can be cut from production tapes

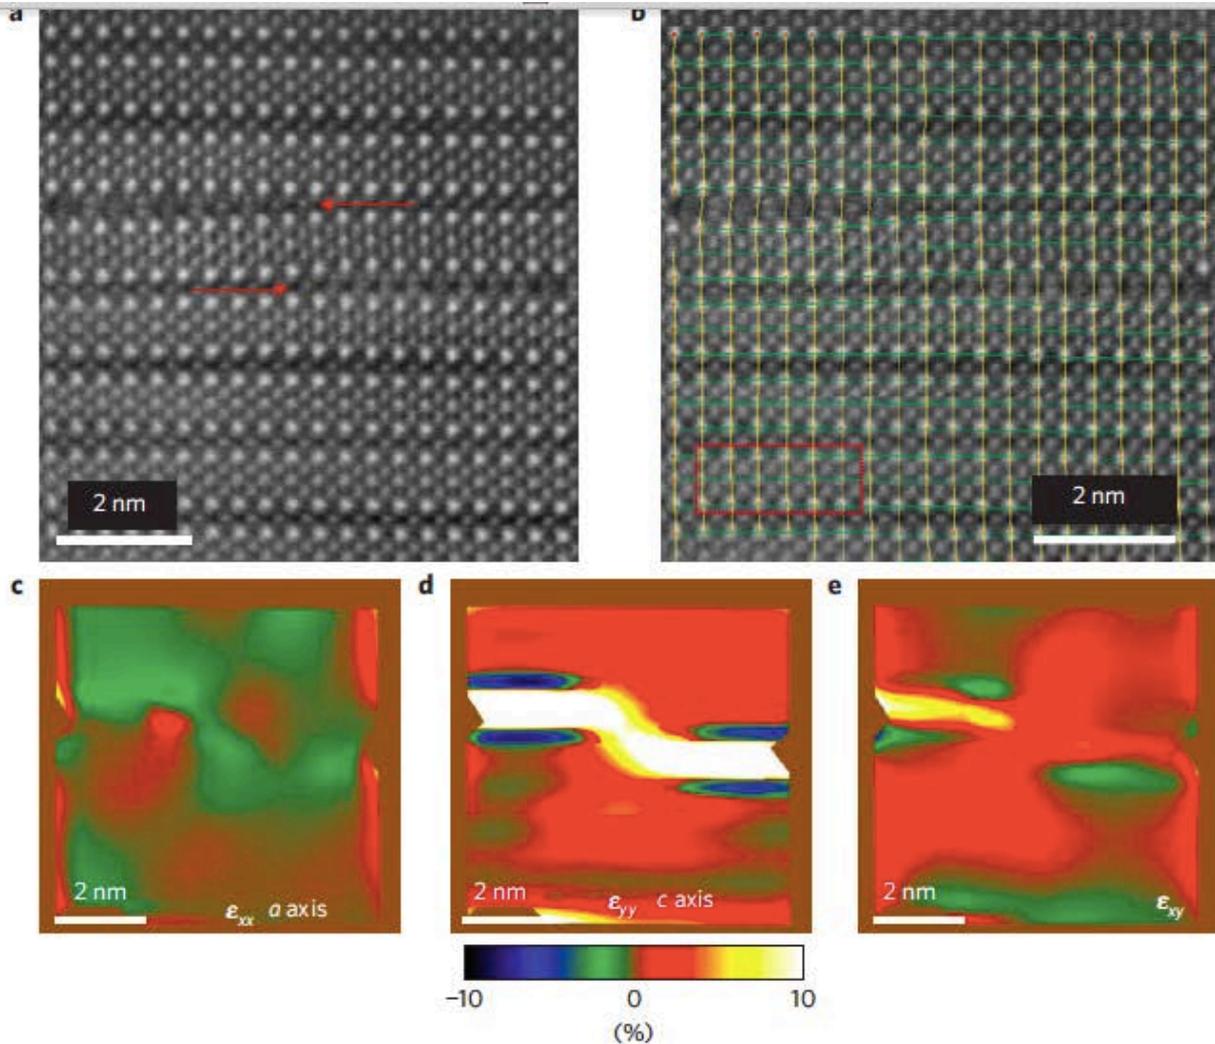
Figure 4 | Strain maps determined by Peak Pairs Analysis of cross-sectional STEM images showing intergrowths. a, Z-contrast image from which the strain maps were generated. The red arrows indicate two close intergrowths. **b,** Grid obtained by Peak Pairs Analysis from the image shown in **a**. The dotted red rectangle indicates the region of the image taken as reference. **c-e,** ϵ_{xx} , ϵ_{yy} and ϵ_{xy} maps, respectively.

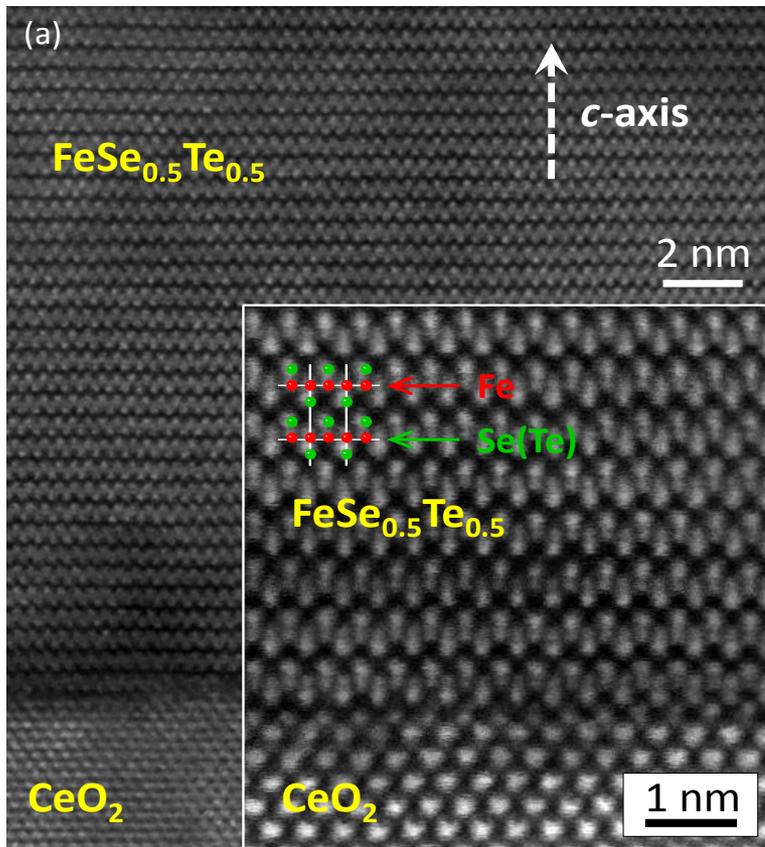
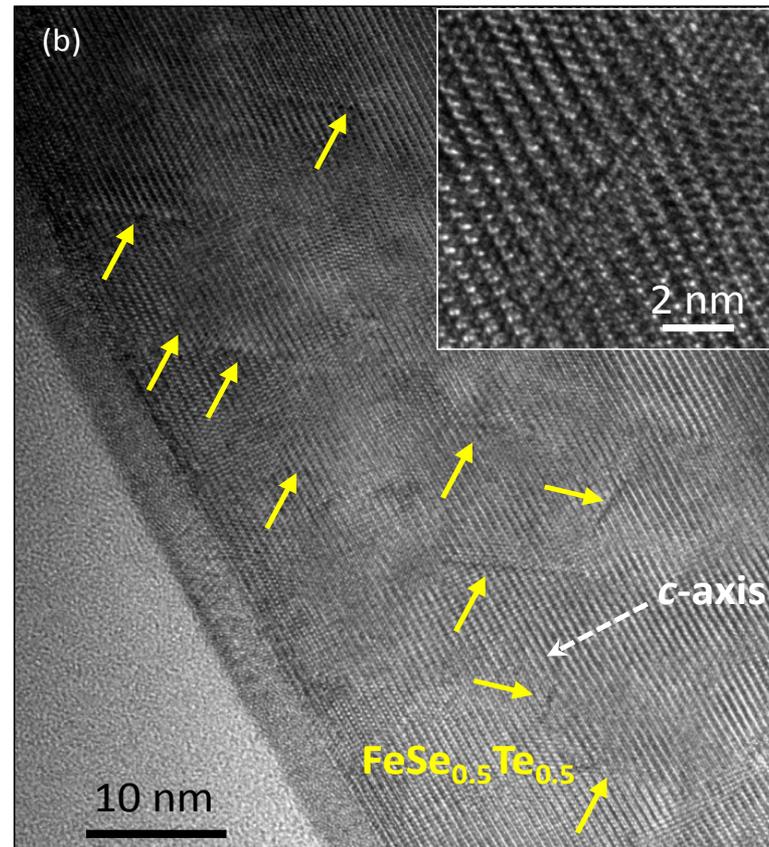
Fig.2 Microstructure of $\text{FeSe}_{0.5}\text{Te}_{0.5}$ films. **a** ADF STEM images of the representative FST film on the CeO_2 buffer layer. Inset: high-resolution image at the interface between CeO_2 and $\text{FeSe}_{0.5}\text{Te}_{0.5}$. **b** HRTEM image of $\text{FeSe}_{0.5}\text{Te}_{0.5}$ film irradiated with 1×10^{15} p/cm² dose of 190 keV proton. Inset: high resolution image of splayed cascade defect and strain field produced by 190 keV proton irradiation.

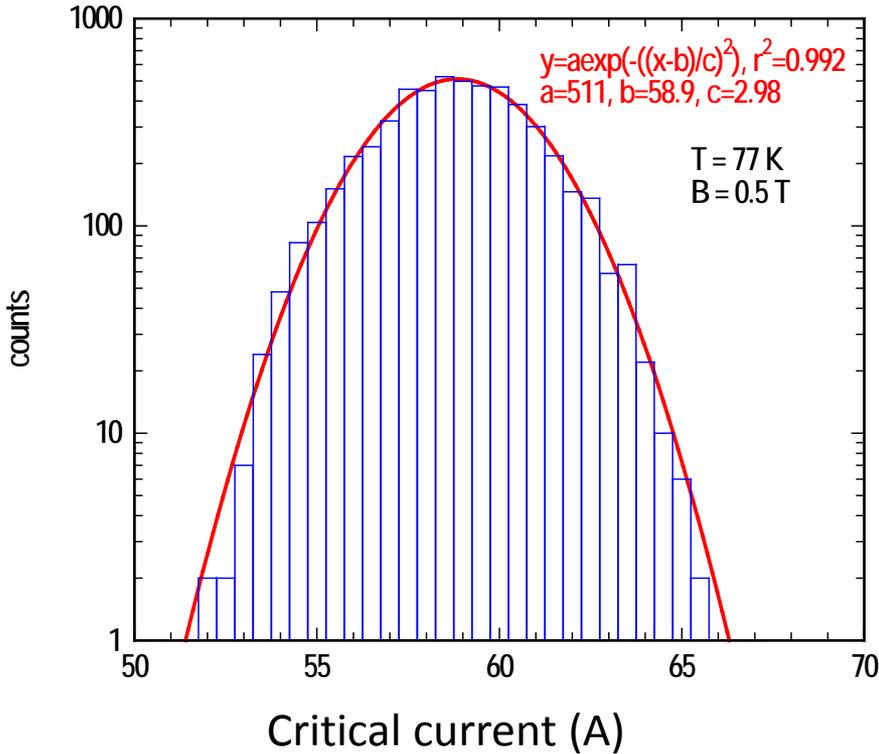
Gaussian in one tape (good)

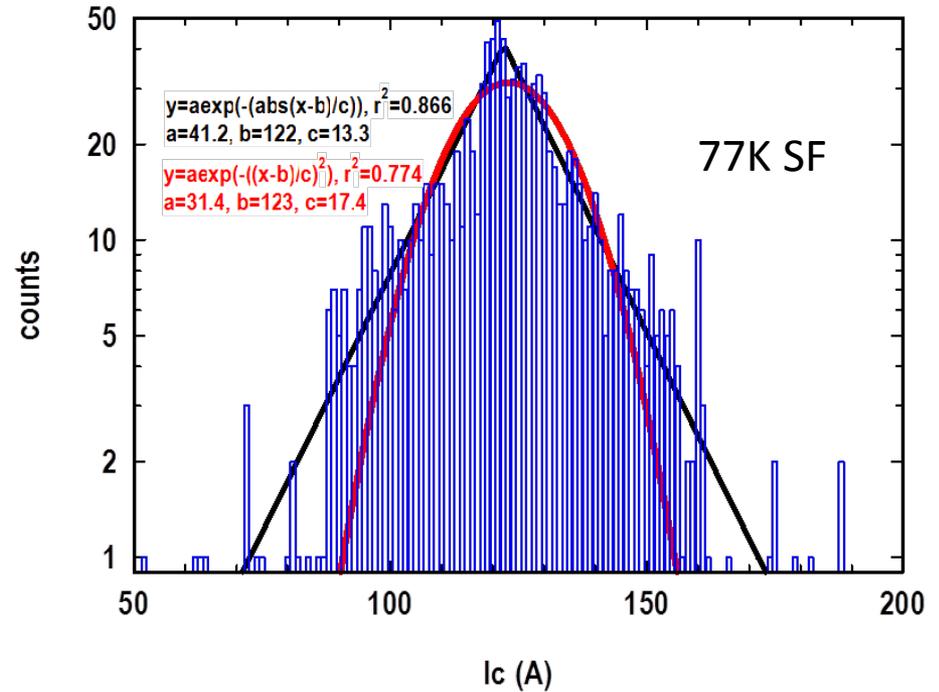
Exponential between different tapes (bad)

I_c distribution in several short samples (~1200 measurements) taken from many different production runs of the same AP process

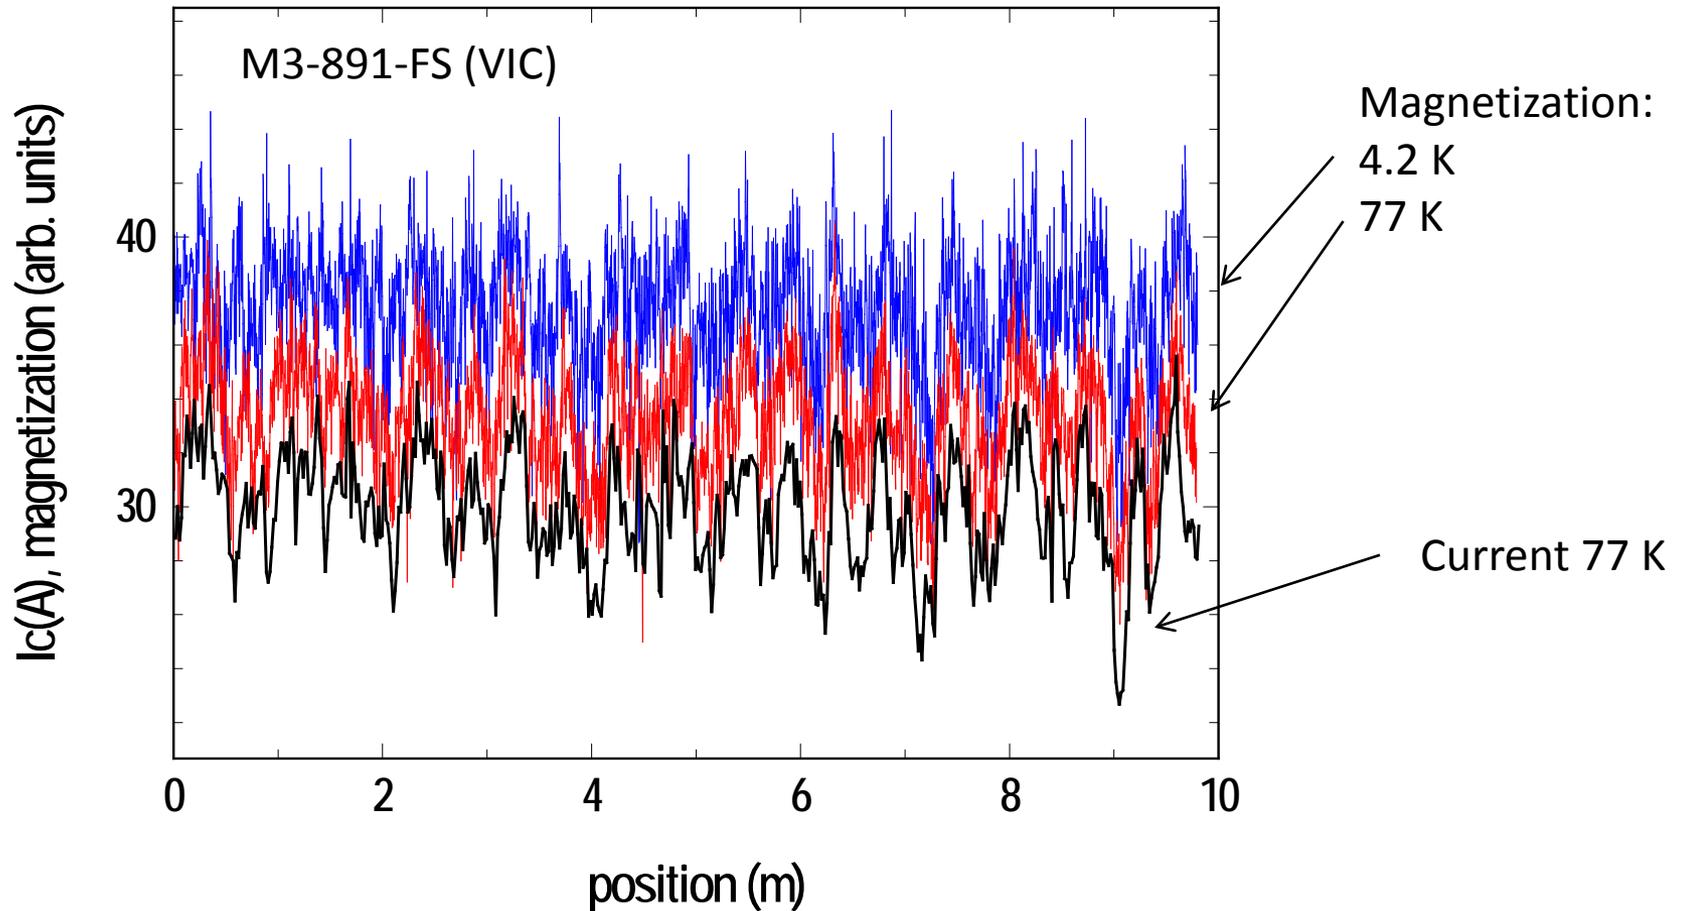
Reasons for I_c variations along the length: cross section variations?

I_c fluctuations along the tape are well correlated between 77 and 4.2 K
This is unusual and probably due to cross section variations
in this VIC tape

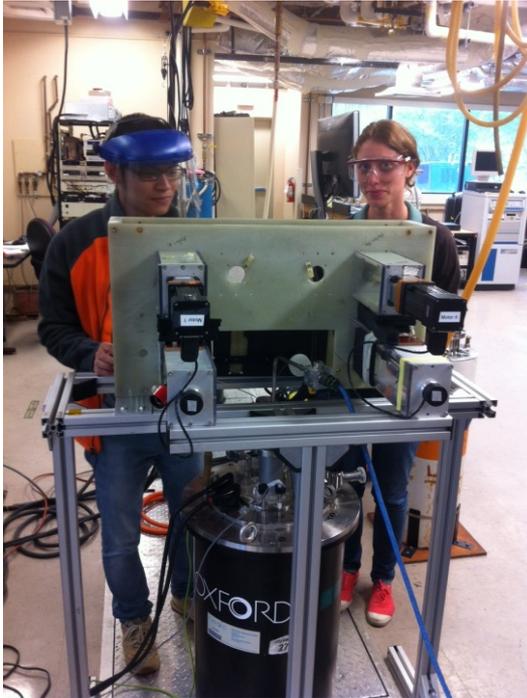
Magnetization reel-to-reel measurement in LHe

Position of 1st Hall probe array;
measuring remanent
magnetization

Position of 2nd Hall probe array;
measuring in field magnetization

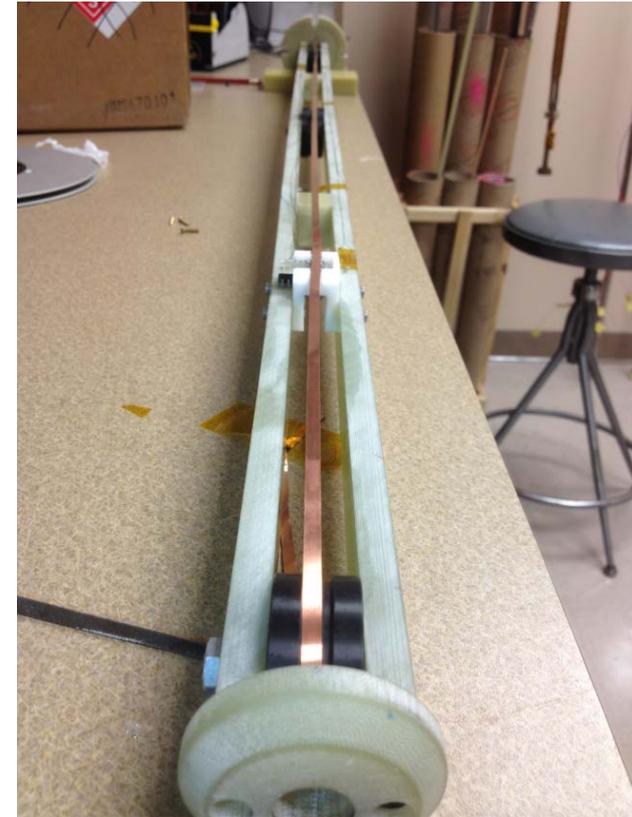
Center of field (B_{\max})

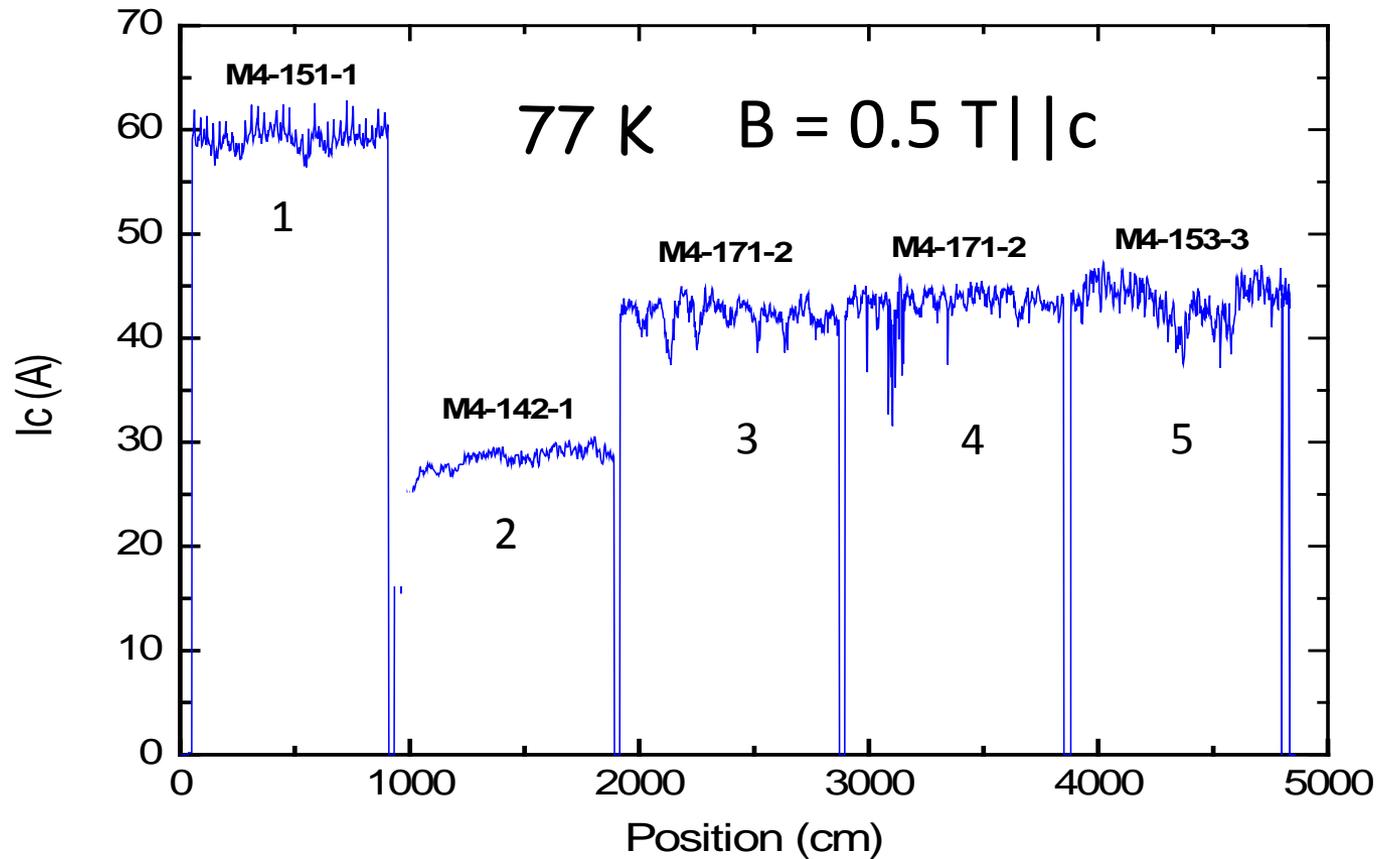
5 recent REBCO tapes: I_c vs position:

Again: variations in different tapes:

Tape 1 very high I_c

Tape 2 very low I_c
