Epoxy and quench training of superconducting magnets: A dedicated study

Shijian Yin, Tengming Shen

Lawrence Berkeley National Laboratory

February 9, 2017

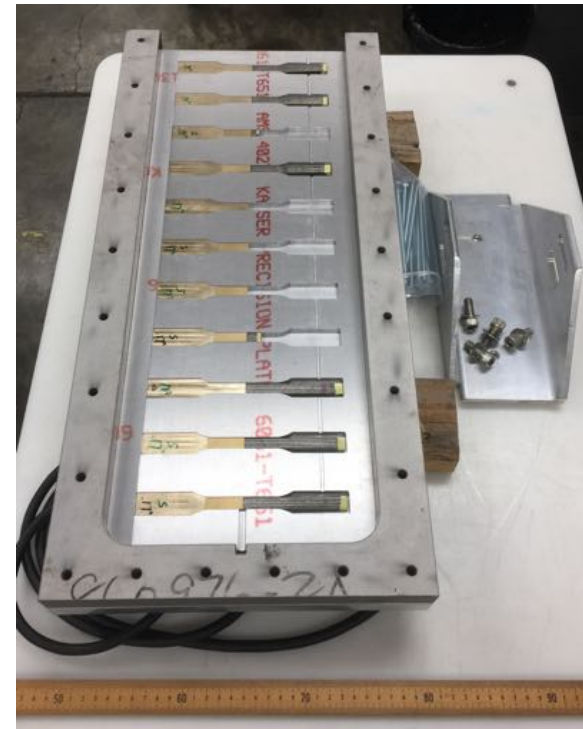
Fig. The second layer mold and legs

- Vacuum impregnation epoxy mold designed and fabricated.
- 2-layer design capable of fabricating 20 samples with each VPI run.

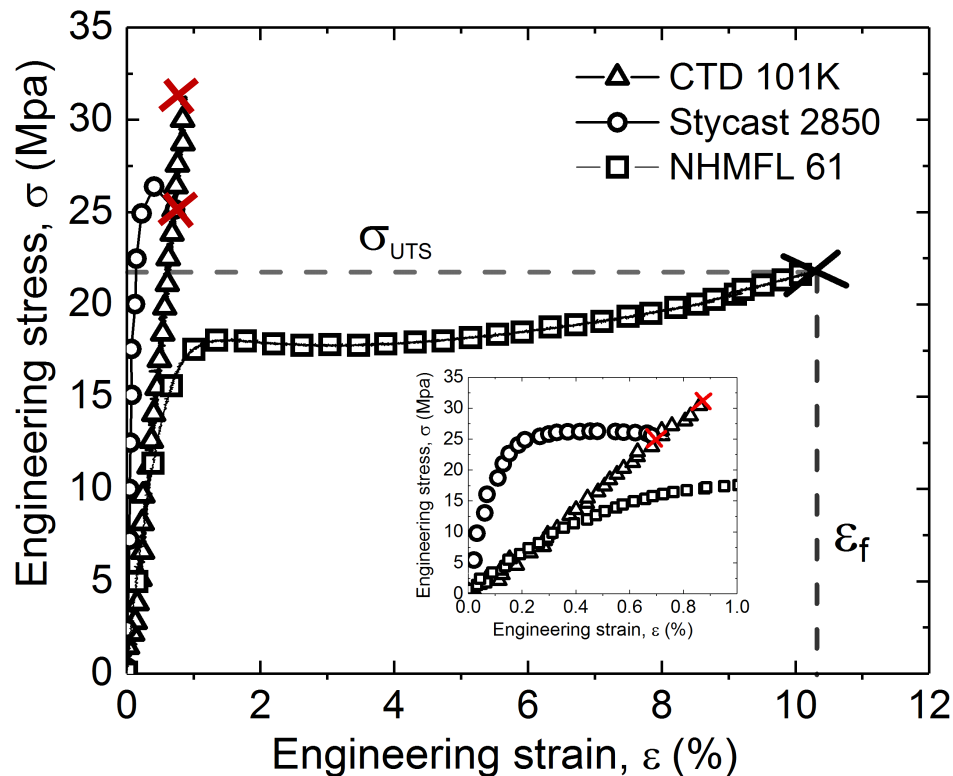
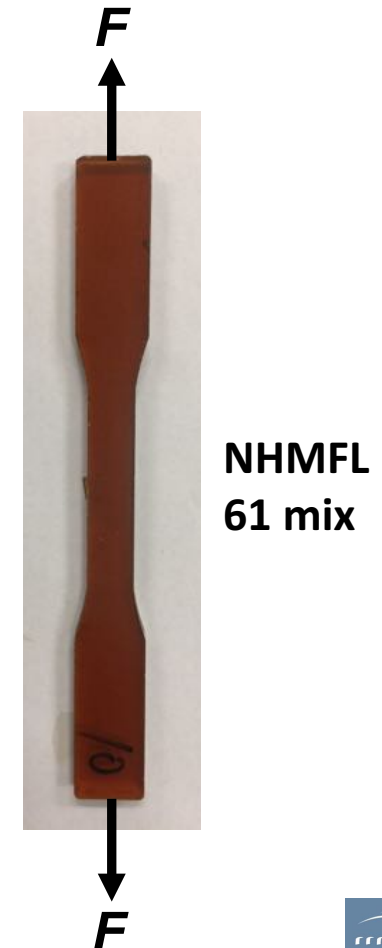
Preliminary results – tensile tests of epoxy only samples

RT, test standard - ASTM-D638

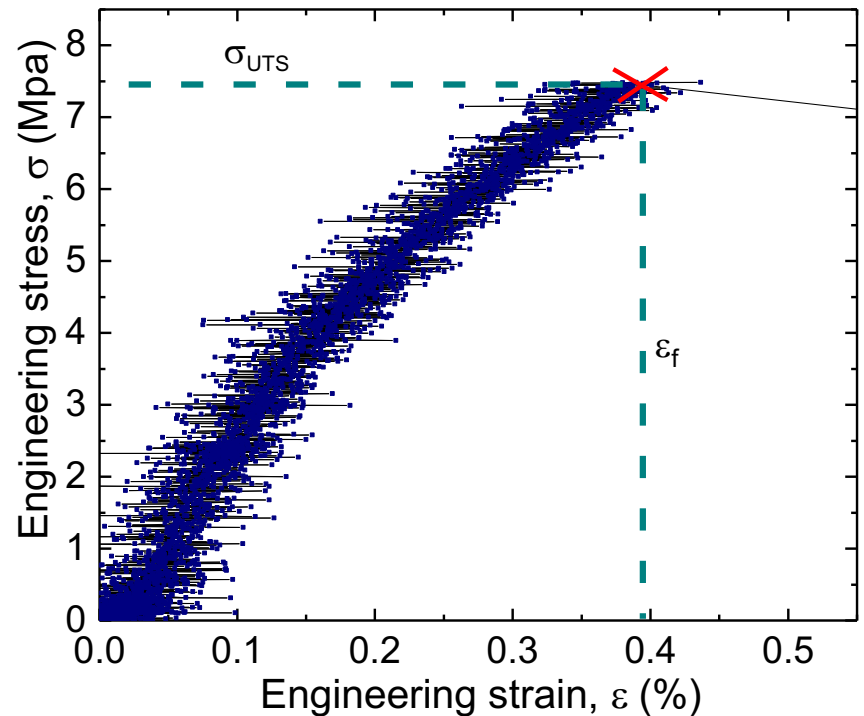
Preliminary results – fracture shear stress is low – double-lap shear test

Fracture shear stress test of **CTD101K/954/Nb₃Sn Rutherford cable** at RT

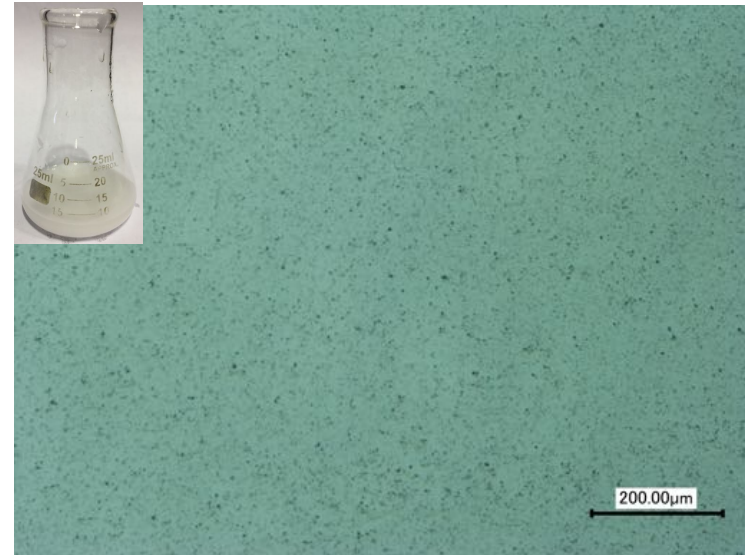
BNNS disperse in isopropyl alcohol

**PBA-BNNS disperse well in IPA
After 3 h ultrasonic mixing**

Procedures to mix, disperse functioned BNNS into epoxy, and WPC are being developed
