U.S. MAGNET
DEVELOPMENT
PROGRAM

SMCTM1a test summary and next steps

October 10, 2023

US Magnet Development Program
Fermi National Accelerator Laboratory

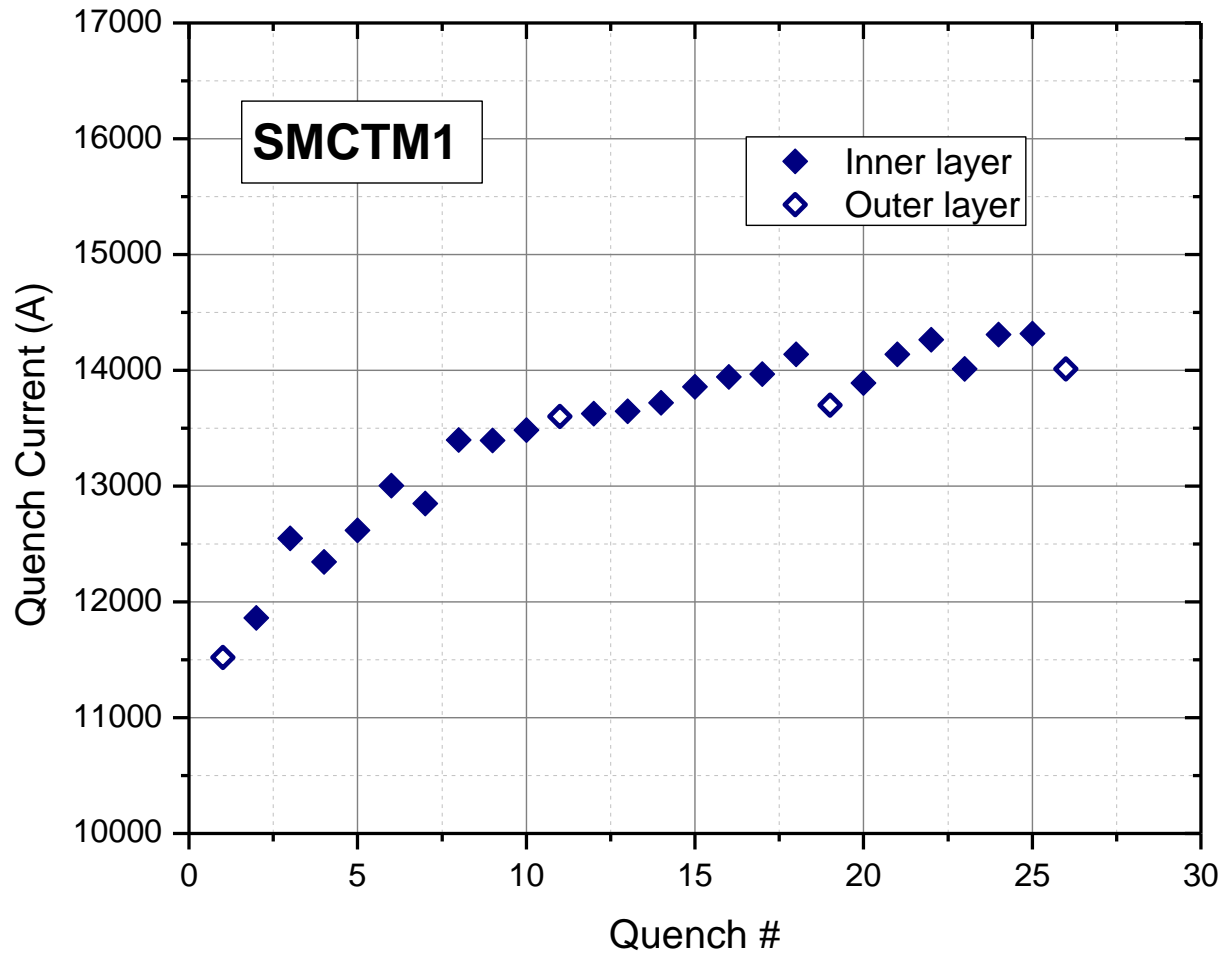
SMCTM1 Training at 1.9 K

Outer layer quenches:

- 1st quench was in the D4-D5 segment
- 3 more quenches in the D6-D7 segment (pole turn)

Remaining quenches were all in the inner layer:
Position is unknown because VTs were open

86% of SSL reached in 18 quenches

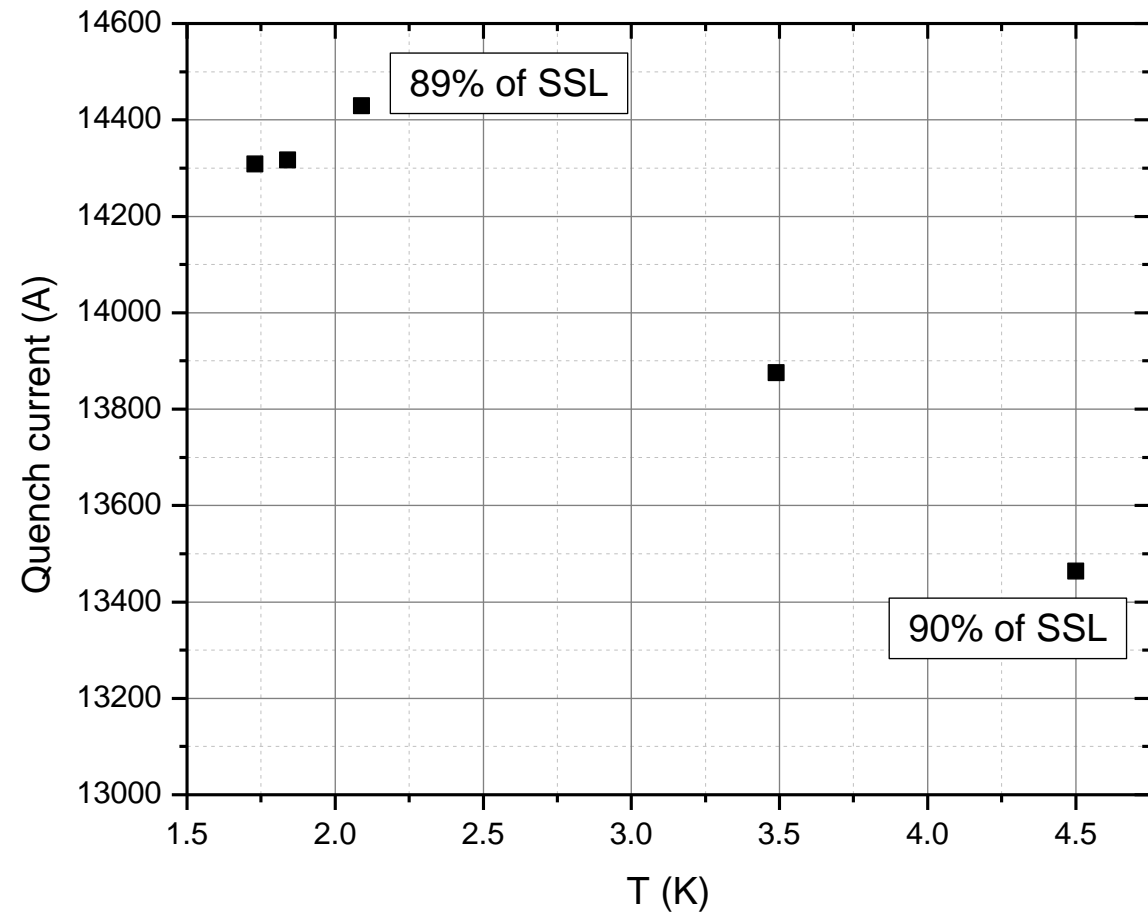
Temperature dependence

1.9 K		4.2 K		4.5 K	
kA	Tesla	kA	Tesla	kA	Tesla
16.47	14.21	15.15	13.23	14.89	13.04

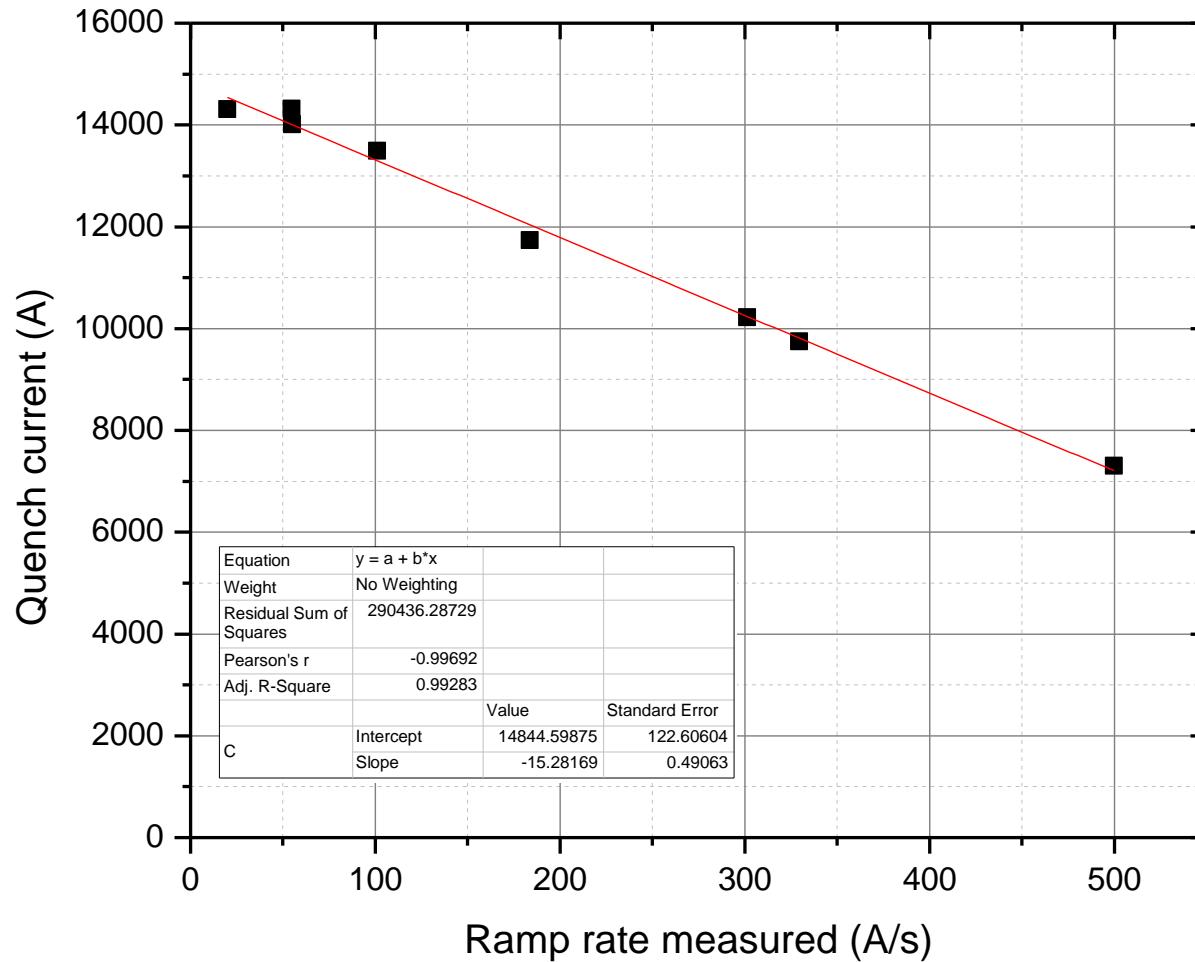
Ramp rate dependance

- Linear extrapolation at 0 ramp rate: maximum quench current is 15 k
- 13.1 T; 91% of SSL at 1.9 K

9% reduction of maximum achieved quench current with respect to SSL can be due to conductor degradation

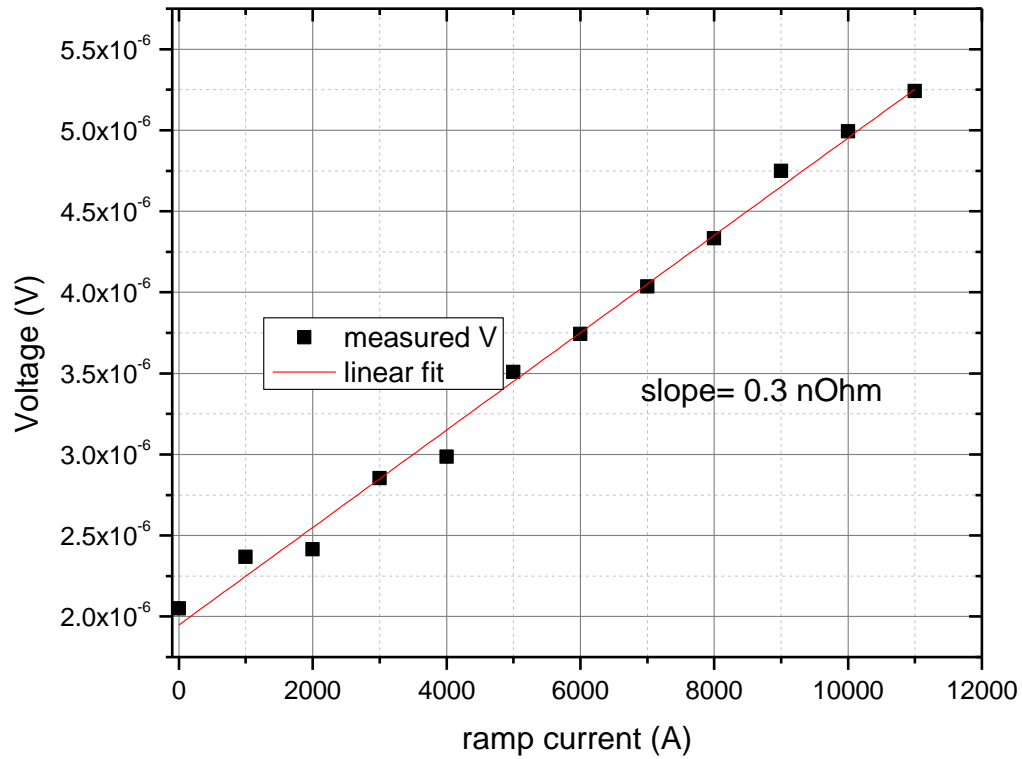
Splice measurements

Splice resistance = 0.3 nΩ

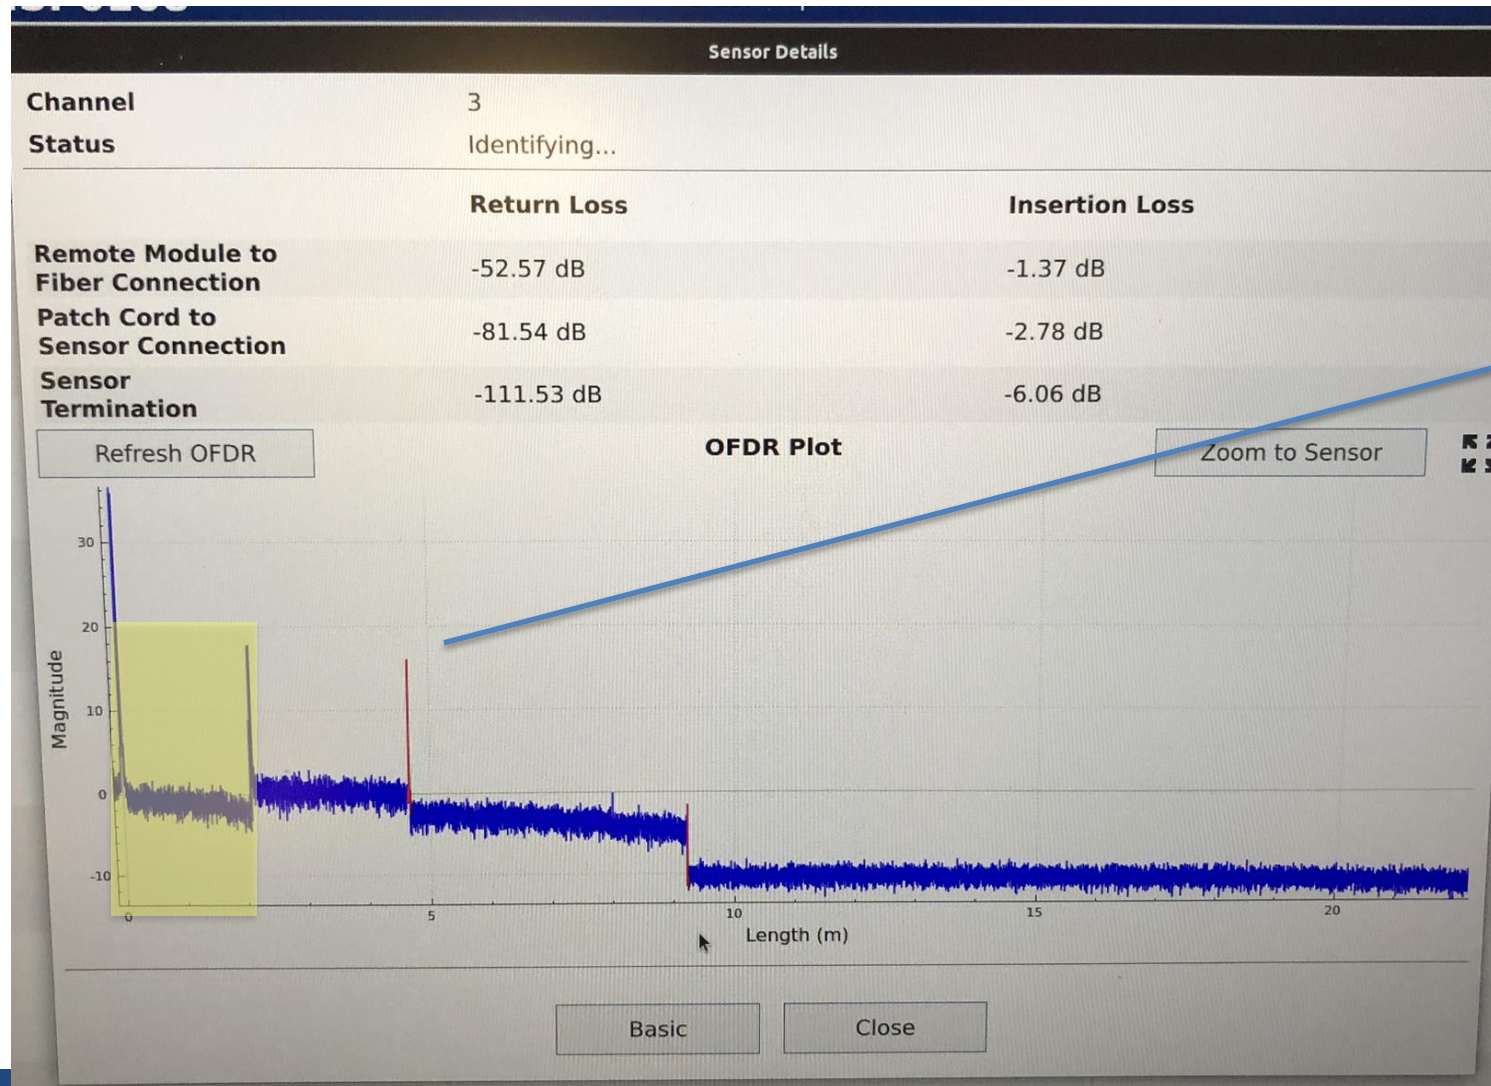
Fiber was pinched

Fiber was rekeyed:
4 m of patch cable
4.5 min cable

2m
Feedthrough

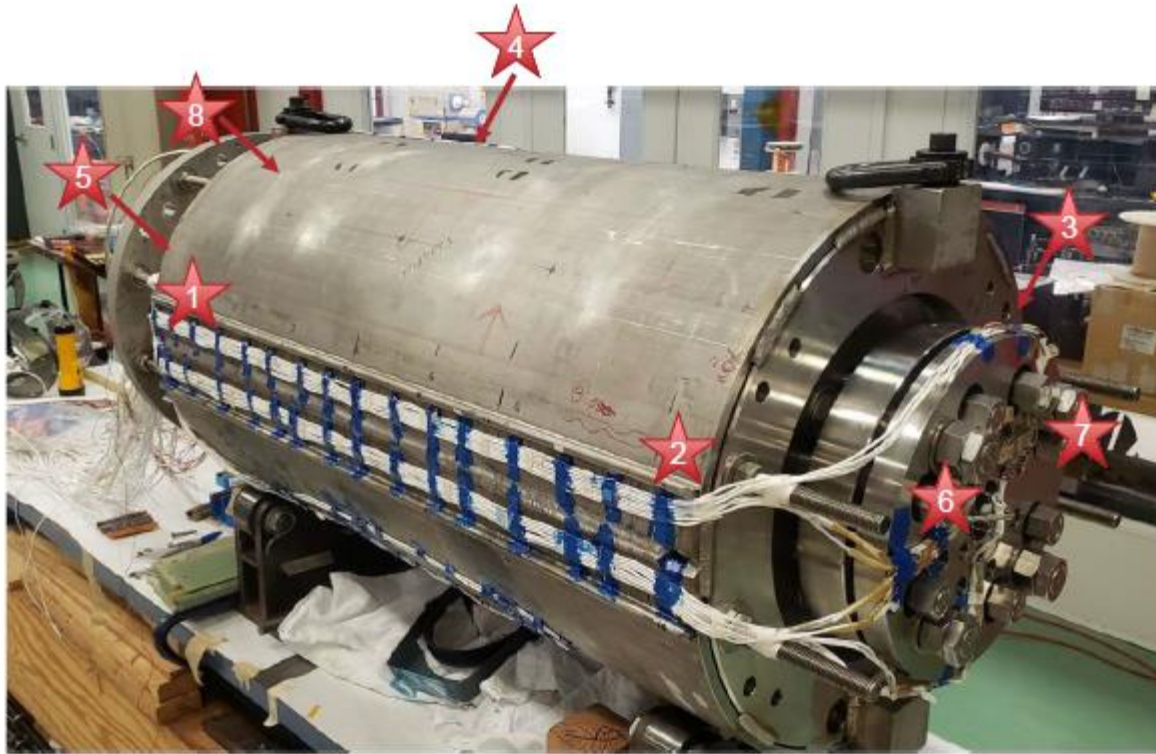
Acoustic sensors

- 1-4 are glued at MP 15mm from shell.
 - Positions nearest to midplane close to body of magnet allow longest t_{delay} from side to side for improving positioning resolution
 - Glued to small stainless blocks via stycast
 - Alternate location is glues to the end ring in adjacent location to allow clearance to fit in dewar
- 5-8 are glued onto rod ends
 - Possibly provide some L/r info, mostly longitudinal
