Water Flood in Building 66

October 22, 2020 – LBNL Building 66 (Originating from 66-427)

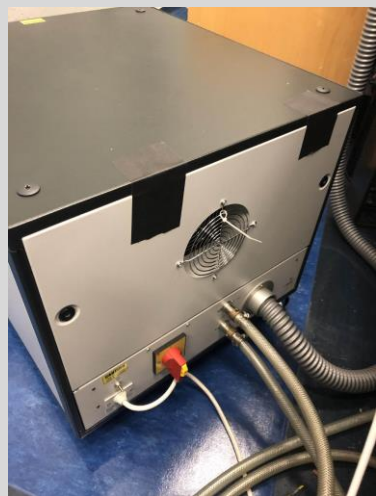
Laser Chiller in 66-427 Showing Connected Water Hoses

- Clamp used to secure hose connection to chiller found to be loose
- Without secure connection hose was able to become dislodged presumably due to force of water pressure

- Check of water connections to research instruments to ensure clips are tight and hoses are not damaged or showing signs of ageing
- Add hose inspections to annual laboratory inspections
- Research and implement alternatives to unattended continuous water supplies where feasible
- Research and install water sensors to detect future leaks

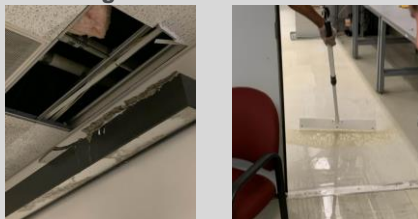
Water Damage to Ceiling Tiles and Pooling in Labs on Floors Below

- Late evening/early morning of 10-21/22 a hose connected to house water supply became dislodged from unattended laser chiller in 66-427
- Water flowed from hose onto lab floor and leaked into labs and offices on the 4th, 3rd and 2nd floors
- Water leak discovered by lighting crew during walkthrough at approximately 5 am on 10/22
- Cleanup crew collected over 1,000 gallons of water – total volume released is higher
- B66 closed to researchers on 10/22 when water damage to electrical panels discovered – building remains closed
- Damage resulted to B66 electrical and ventilation systems, walls, floors and light fixtures on 2nd, 3rd and 4th floors
