COMB progress and preliminary **CORC** wire test results in LN₂

Vadim Kashikhin, Vito Lombardo General MDP Meeting January 6, 2021

Conductor On Molded Barrel (COMB) magnet technology

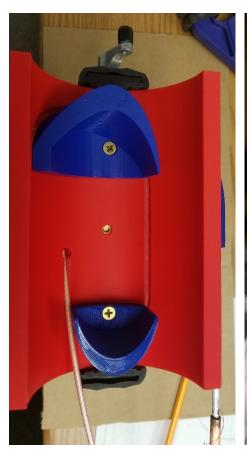
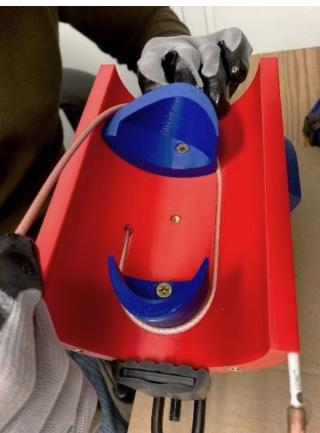
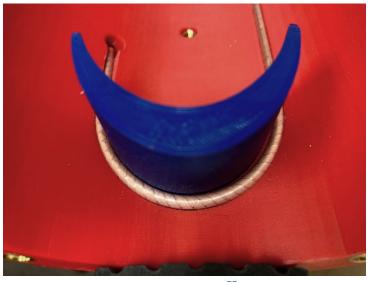
Inner layer winding

A two-step process:

the cable is pre-bent around the auxiliary spacer at the first step and then pushed into the channel at the second step

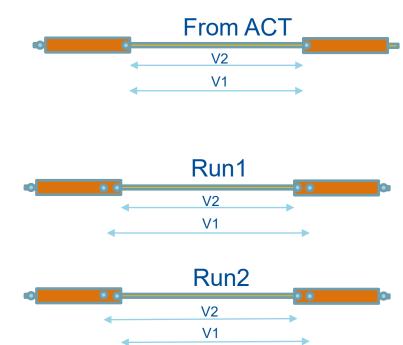
Sample 1 - Raw data from the first 2 runs, no resistive correction

Two pairs of voltage taps were installed by the vendor inside of the terminals a few cm from the inner ends (optimum location where all the REBCO tapes are soldered together)

The location of redundant VTs is supposed to be the same, but there was a considerable difference in resistances

Tried two combinations, however the difference in Ic was negligible after the resistive correction
