U.S. MAGNET
DEVELOPMENT
PROGRAM

15 T dipole coil potting issues: status report

January 24, 2018

US Magnet Development Program
Fermi National Accelerator Laboratory

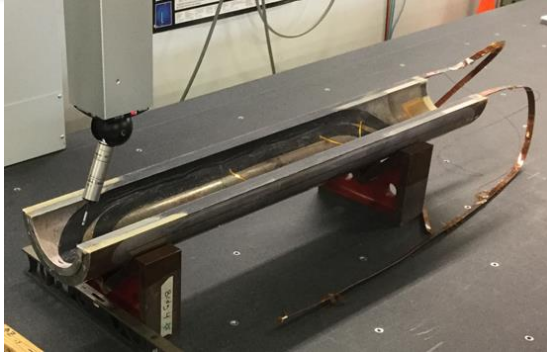
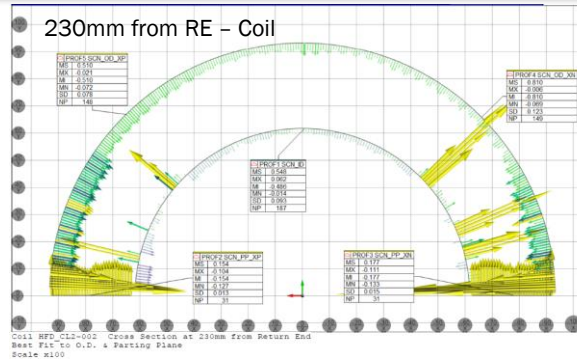
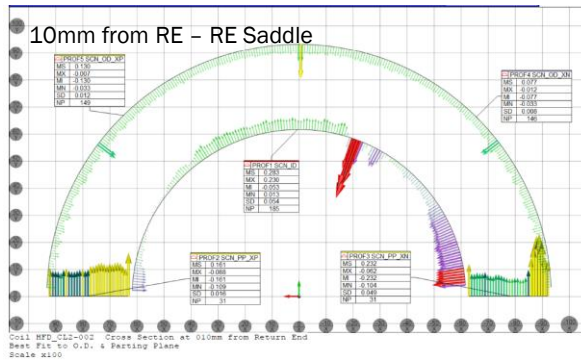
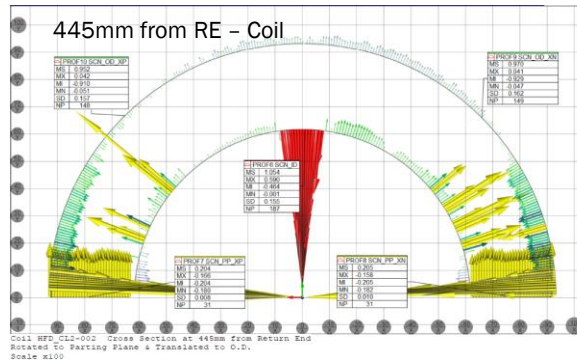
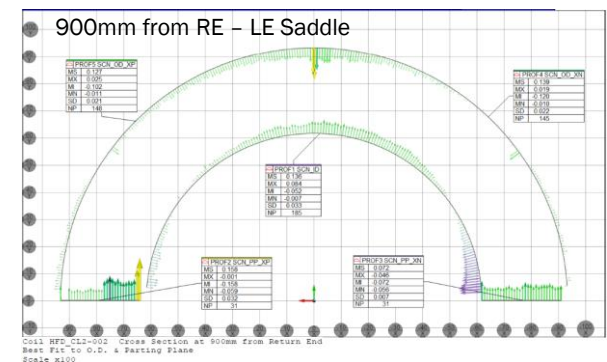
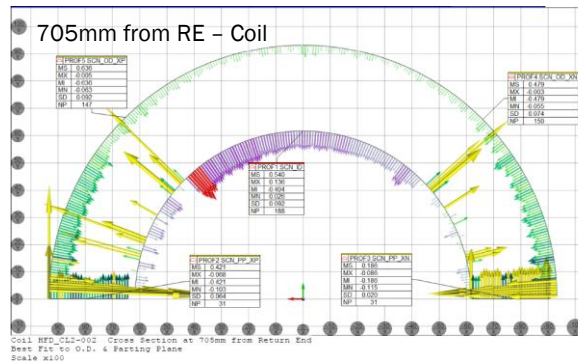
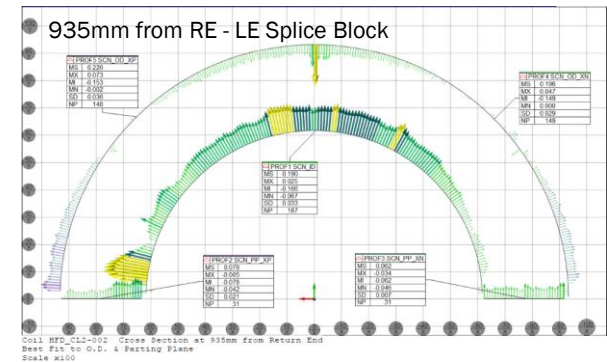
Coil size measurements

- Visual inspection of the 1st impregnated L3-L4 coil HFD-CL2-002 has revealed large dents on both sides of the coil outer surface and wrinkles on the coil inner surface
 - substantial degradation of the magnet quench performance
- The purpose of the coil review
 - to identify and correct possible effects related to the coil impregnation procedure
 - develop a plan to replace the lost coil with minimal impact on the program.

- **Outer surface dents**
 - Modify the impregnation base plate [186.3mm]
 - Trim the impregnation shell [2mm]
- **Inner surface pockets**
 - Increase mandrel OR by 0.127mm [sticky Kapton or Teflon tape]
 - Fill pockets with Stycast and re-cure

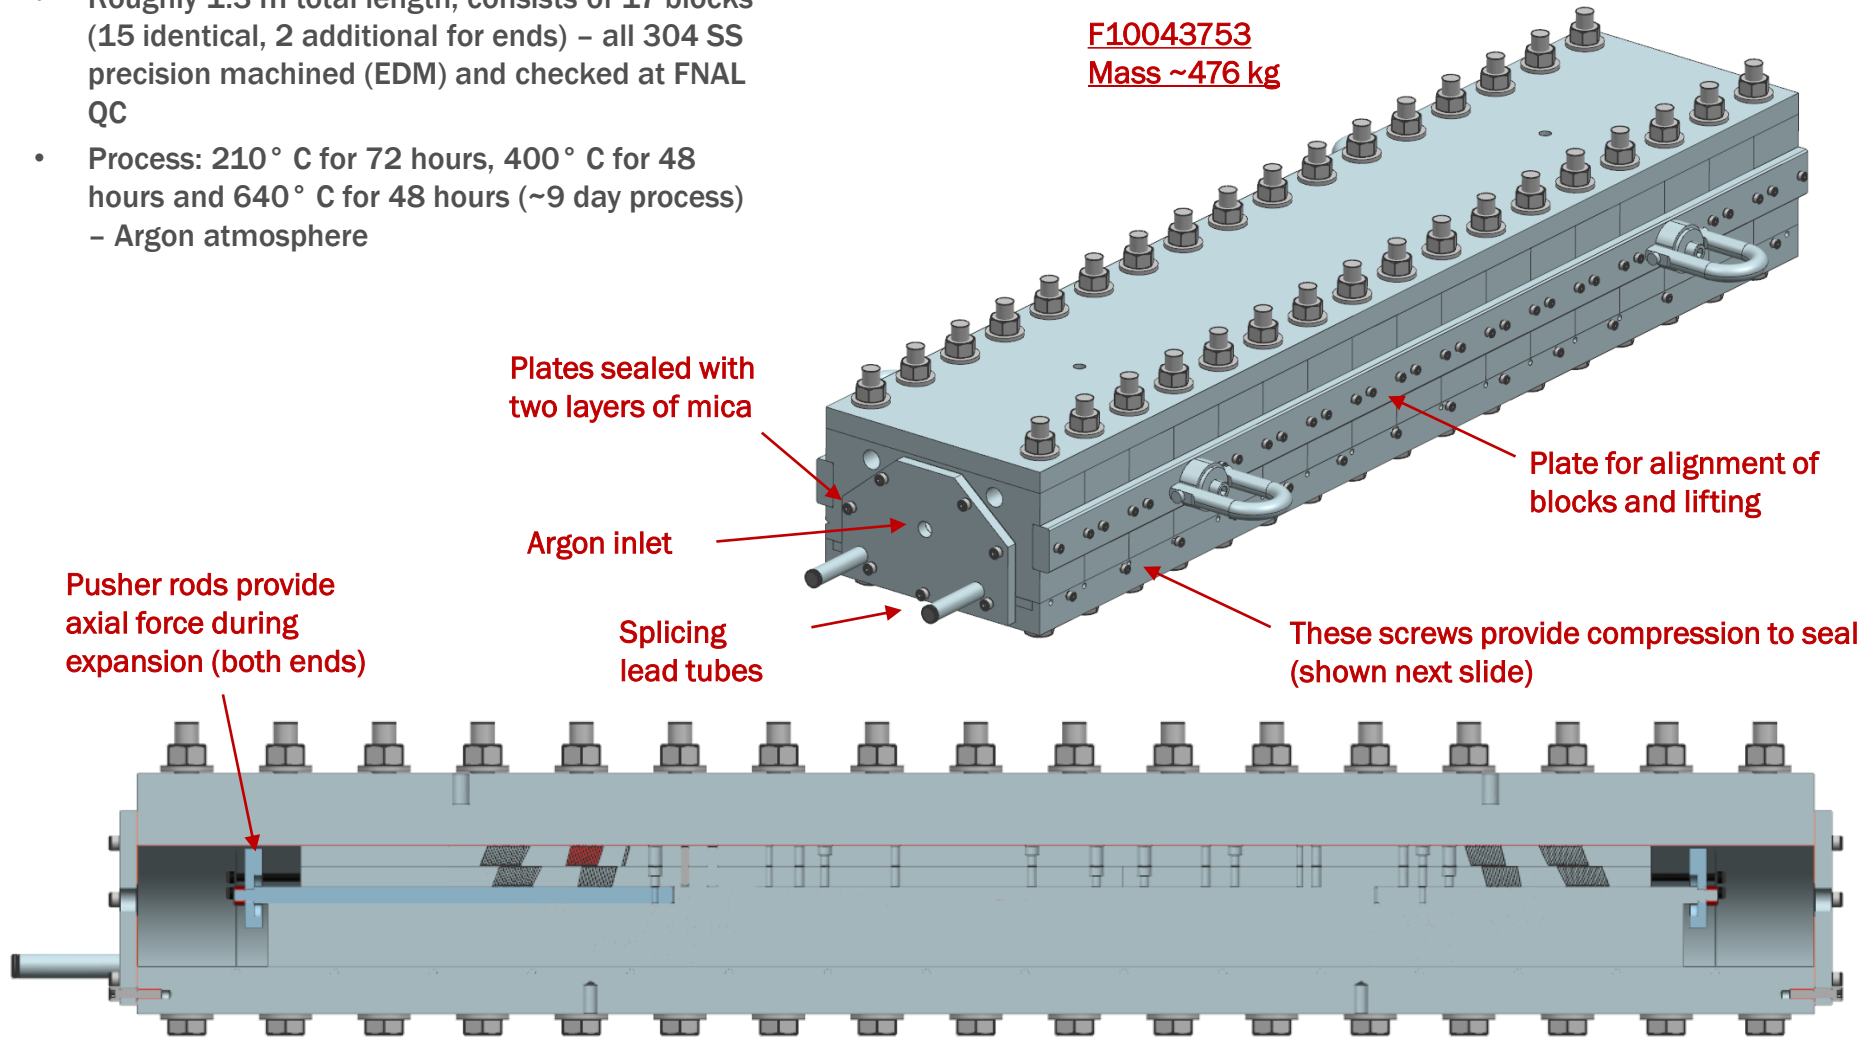
L3/L4 Reaction Tooling

- Roughly 1.3 m total length, consists of 17 blocks (15 identical, 2 additional for ends) – all 304 SS precision machined (EDM) and checked at FNAL QC
- Process: 210° C for 72 hours, 400° C for 48 hours and 640° C for 48 hours (~9 day process) – Argon atmosphere

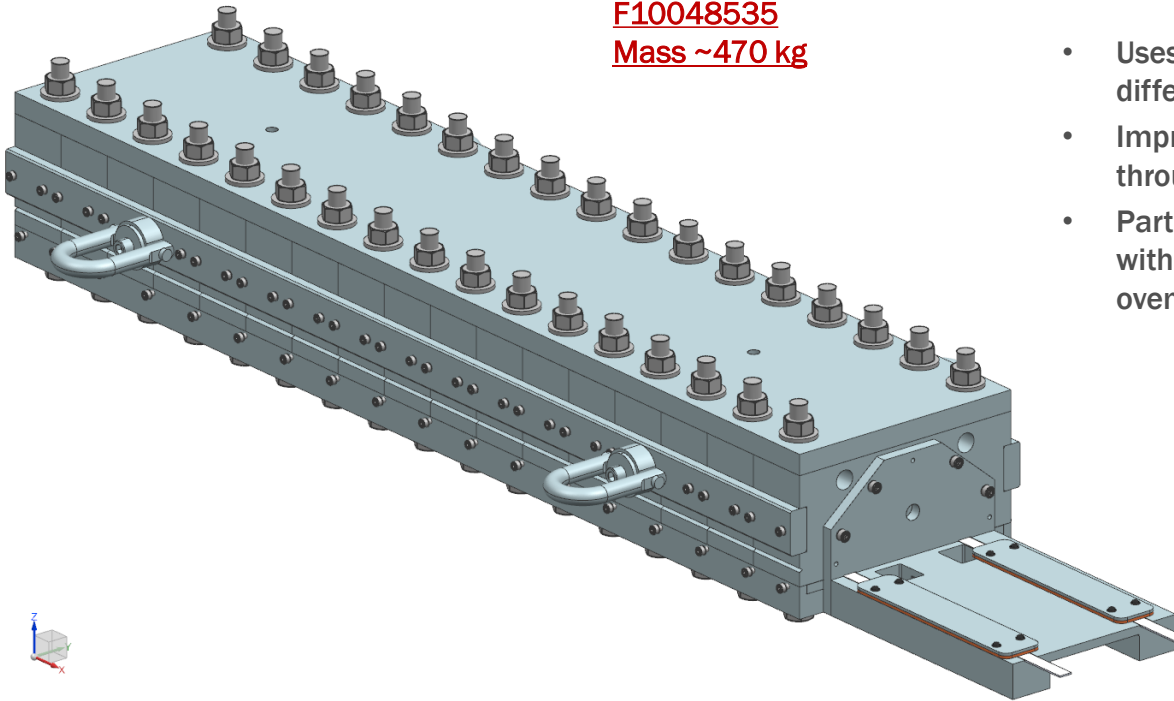
L3/L4 Impregnation Tooling

- Uses same tooling used for reaction, but with different insulation and sealing material
- Impregnation end plates allow leads to extend through plate, sealed using o-ring
- Partial vacuum pulled around assembly (in IB2) with epoxy temperature of 60 °C, cured in other oven at 125 °C for 21 hours

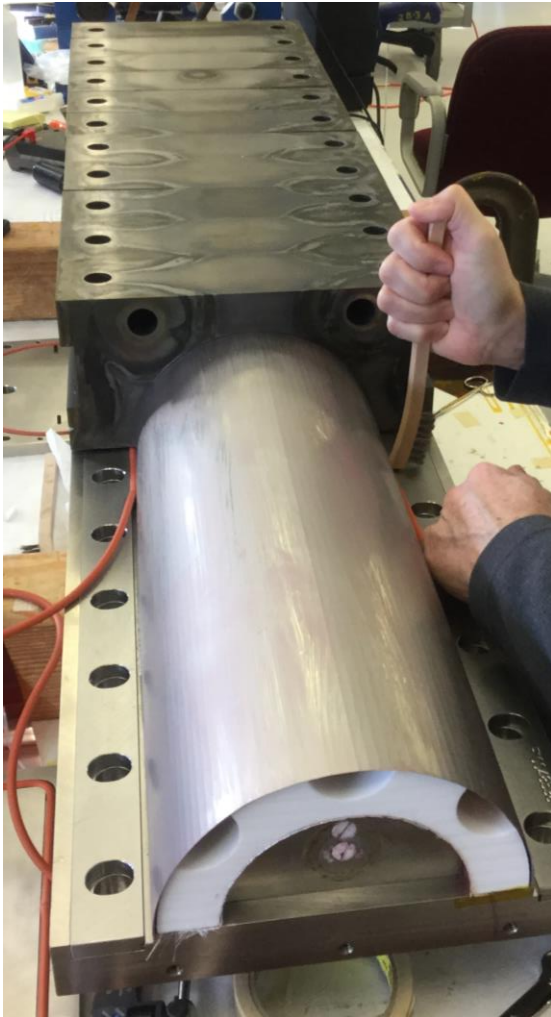
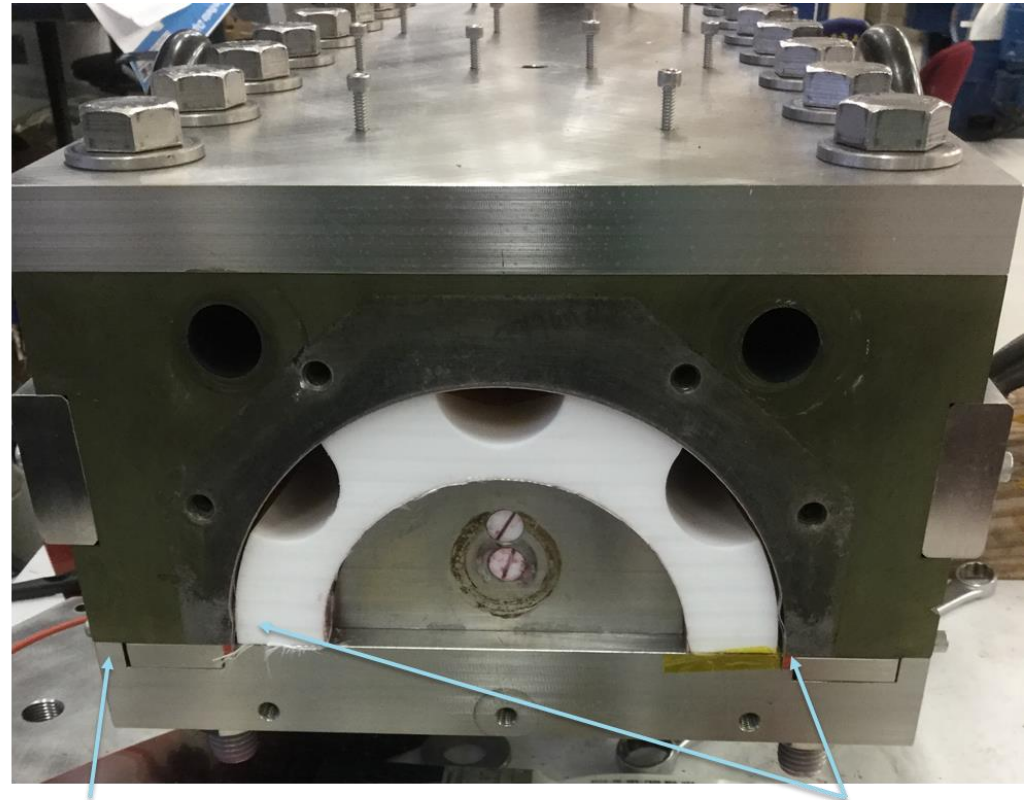
Impregnation tooling assembly

Started from 35mil SS Shims

Shell buckling

Buckling in shell
