Evidence of Excessive Ag-Mg Grain Growth Resulting in Sheath Rupture and Leakage of Bi-2212 Rutherford Cables During Overpressure Processing

Christopher Escobar¹, Jean-Francois Croteau¹, Jianyi Jiang², Mehul Nair¹,
Tengming Shen¹

1. Lawrence Berkeley National Lab
2. National High Magnetic Field Lab

Presented at the US Magnet Development Program Biweekly meeting.

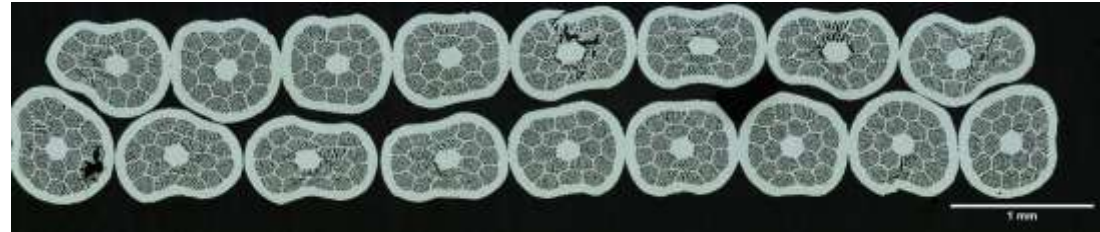
RC4 Cable (50 bar OPHT)

Postmortem analysis revealed two Types of Leakage in OPHT Rutherford Cables and the occurrence of AgMg outer sheath ruptures

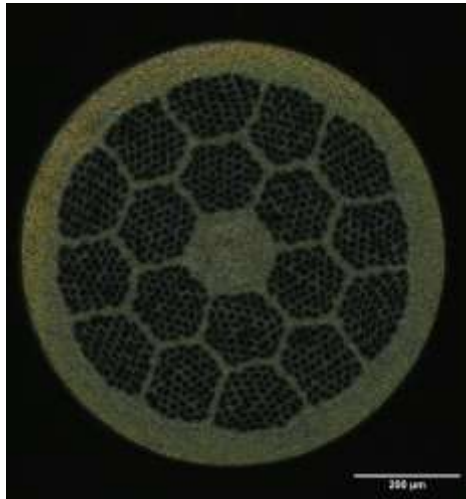
RC5 Wire (PMM170123):
Green

- The deformation of the wire during the cabling process spurs grain growth at those boundaries.
 - We hypothesize that these grains are more ductile and densify at different rates, resulting in sheath rupture (indicated by red box).

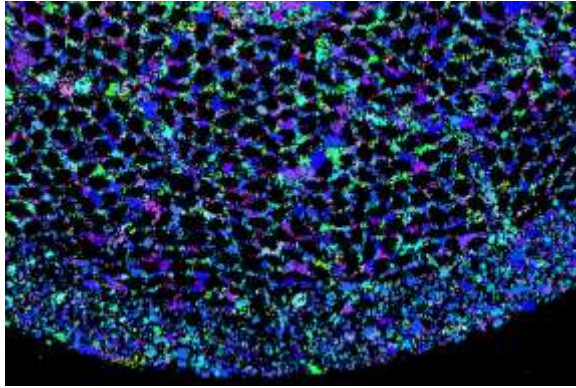
RC5 (PMM170123) Green Wire

SEM EBSD Maps of Round Wires (IPF-Z) showed that grain sizes in wires from industry varies, perhaps leading to variations in leakage severity in different coils

- We hypothesize that the leakage discrepancy is a result of large grains that are formed or already exist in the Ag-Mg sheath.
- RC4 OPHT shown in the next slide
