Analyses of the plastic deformation of coated conductors deconstructed from ultra-high field test coils

Xinbo Hu, Michael Small, Kwanglok Kim, Kwangmin Kim, Kabindra Bhattarai, Anatolii Polyanskii, Kyle Radcliff, Jan Jaroszynski, Uijong Bong, Jeong Hwan Park, Seungyong Hahn and David Larbalestier

Aug 05, 2020

The Little Big Coil NI coil went through 3 iterations..(LBC1-3)

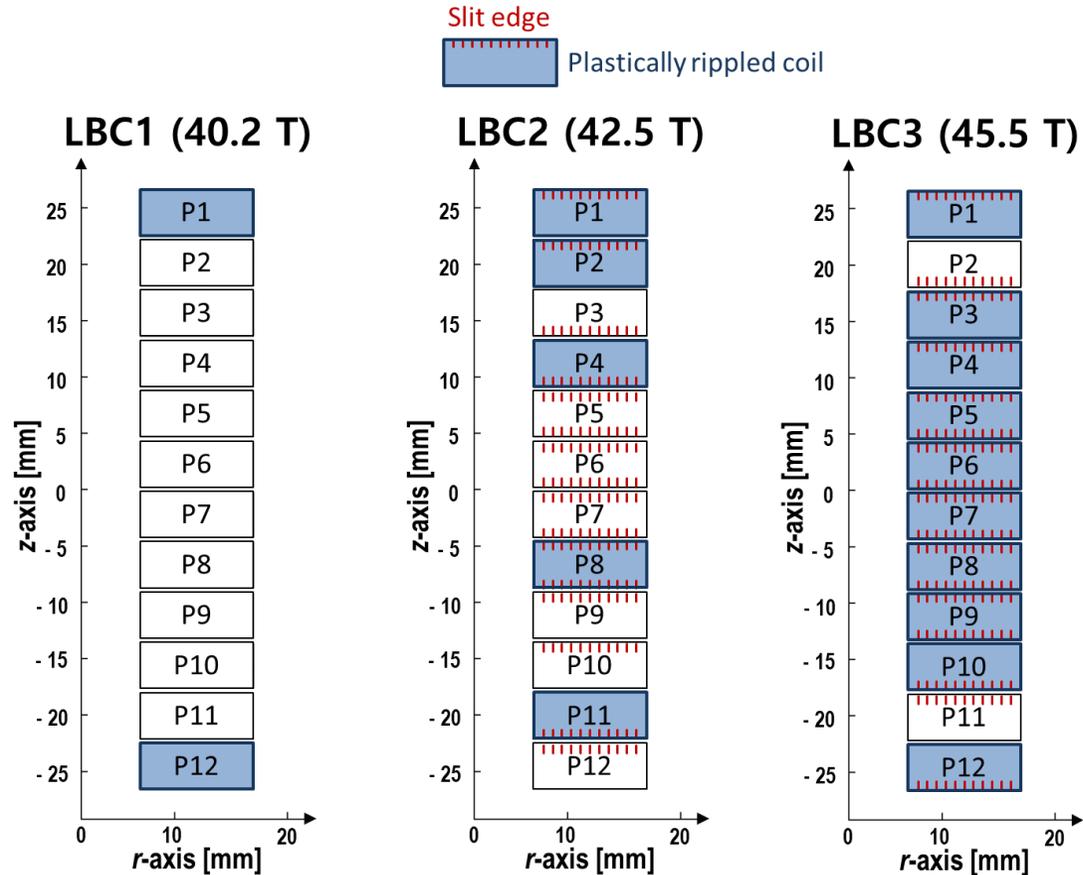
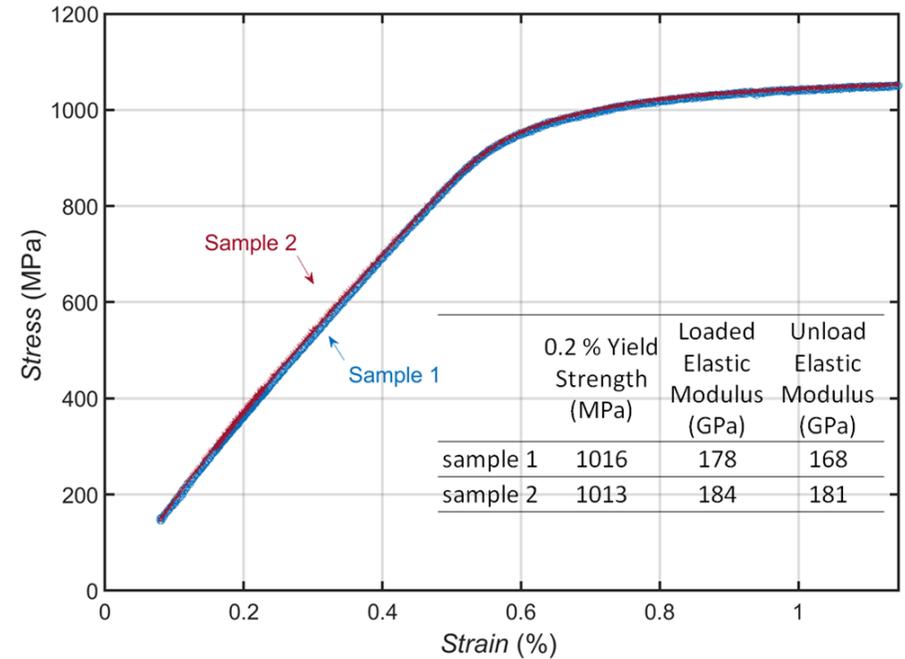
An important observation is that the slit edge is more easily damaged when placed towards the outside of the magnet

A summary of the slit edge orientation and the rippling
