Analysis of "15 T" quench data

US Magnet Development Program
Fermi National Accelerator Laboratory

MDPCT1 ("15 T") tests

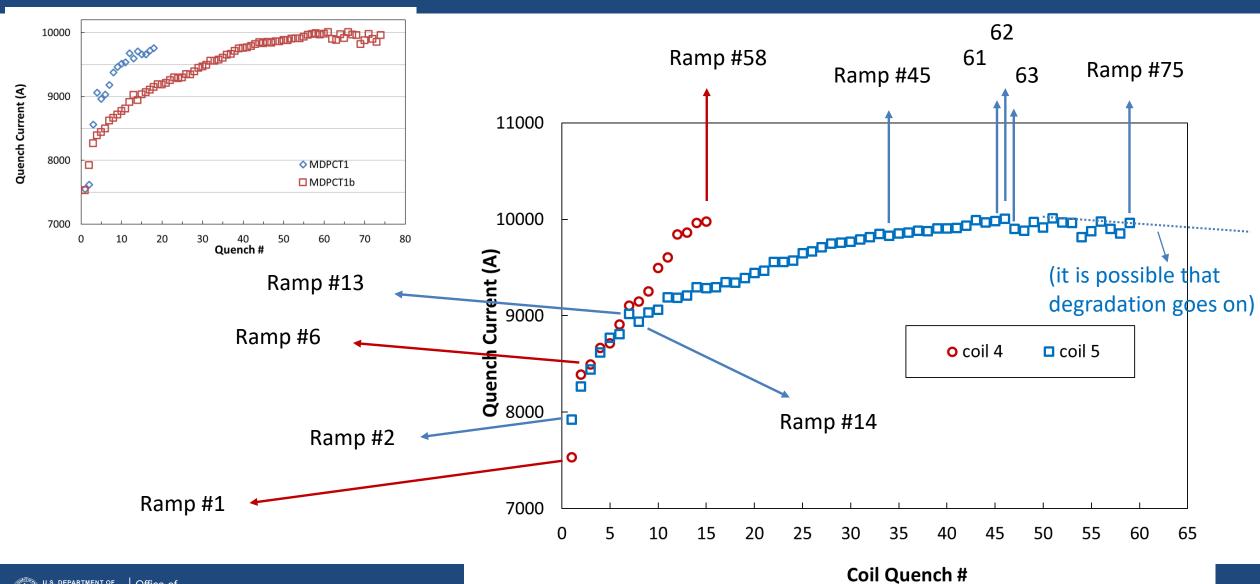
MDPCT1b Training

Most MDPCT1b quenches (and all in TC2) were in coil 5C

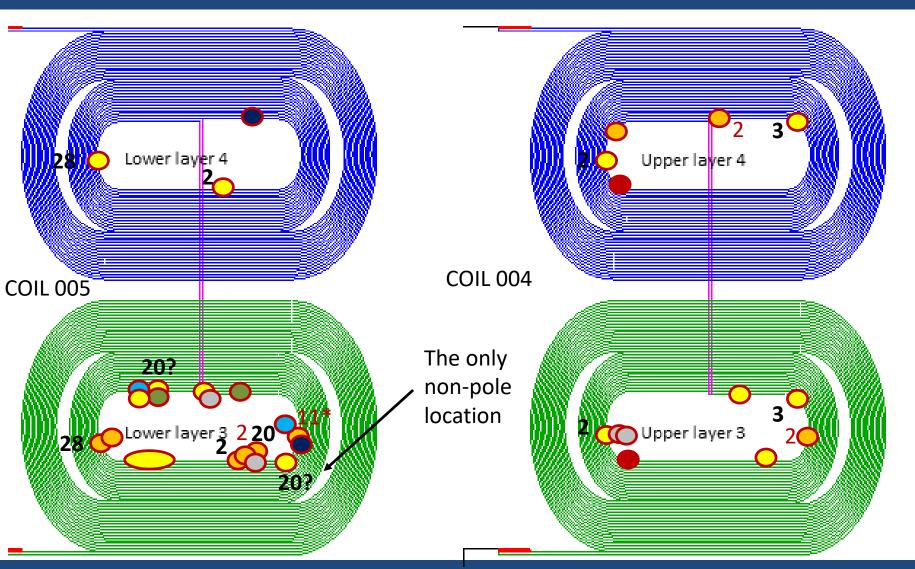
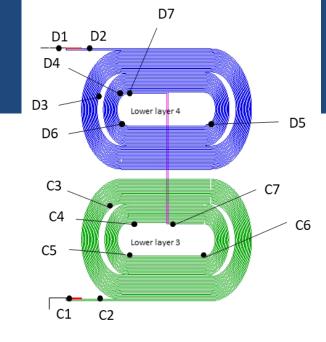
Quench locations at a glimpse (TC1)

- Those colors indicate quenches in different non-adjacent segments (often in different layers/coils)
- This color indicates fairly well known location
- This color indicates not so well known location
 Both colors (and only them) can have associated numbers which are the numbers of similar quenches

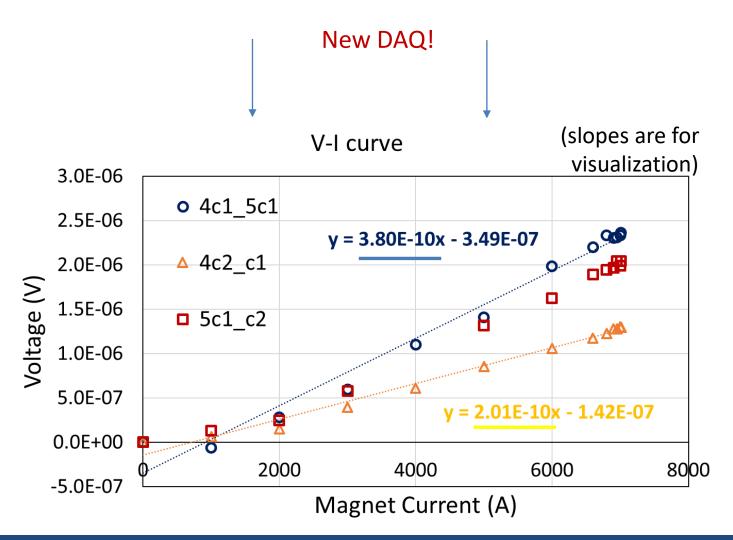
MDPCT1b V-I measurements

Splice resistances with the new system are consistent with earlier measurements. The new system allows for simultaneous measurements of many segments.

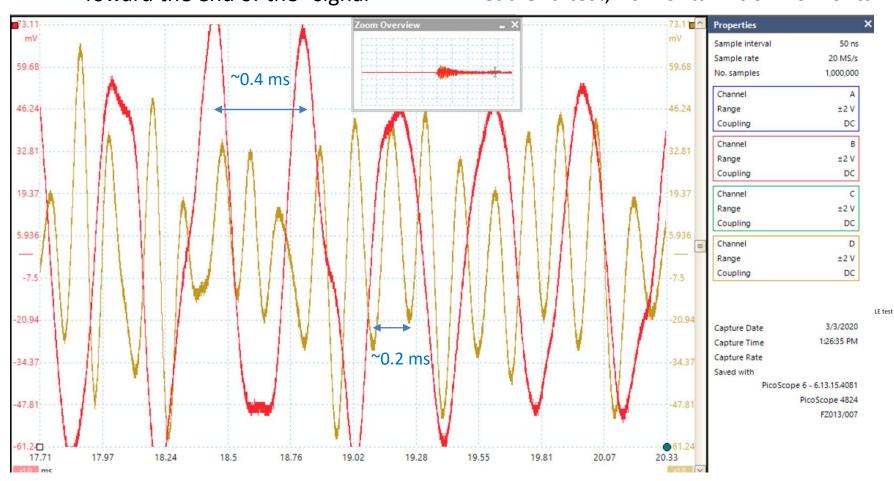
Lead end test, horizontal hit on horizontal magnet

There is a mix of waves interfering but main modes can still be seen – longitudinal and sheer waves with characteristic periods

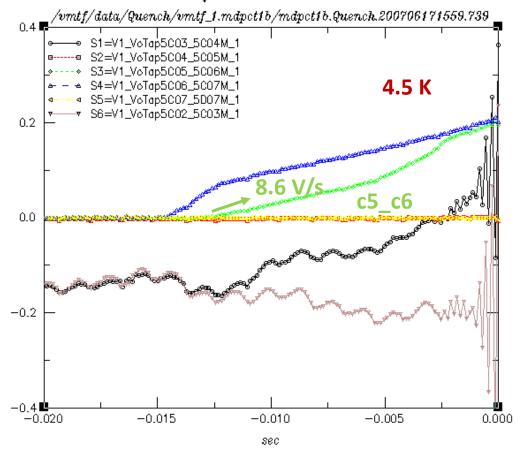
Ramp 86 (TC1) (8886 A)

(last quench in TC1)

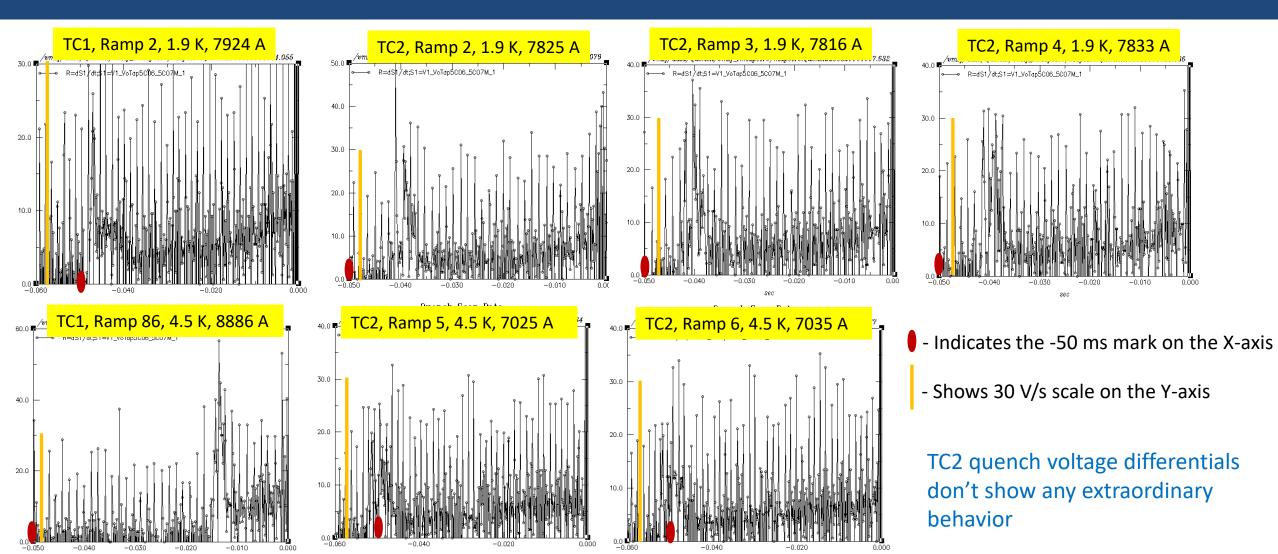
Voltage differentials in the (same) quenching segment

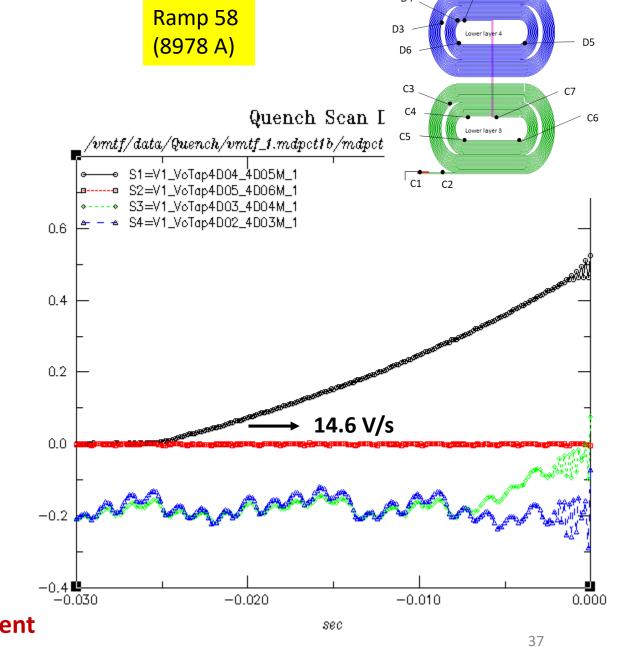
No significant differences in propagation pattern toward the end of the training curve; faster propagation at higher current (factor of ~2).

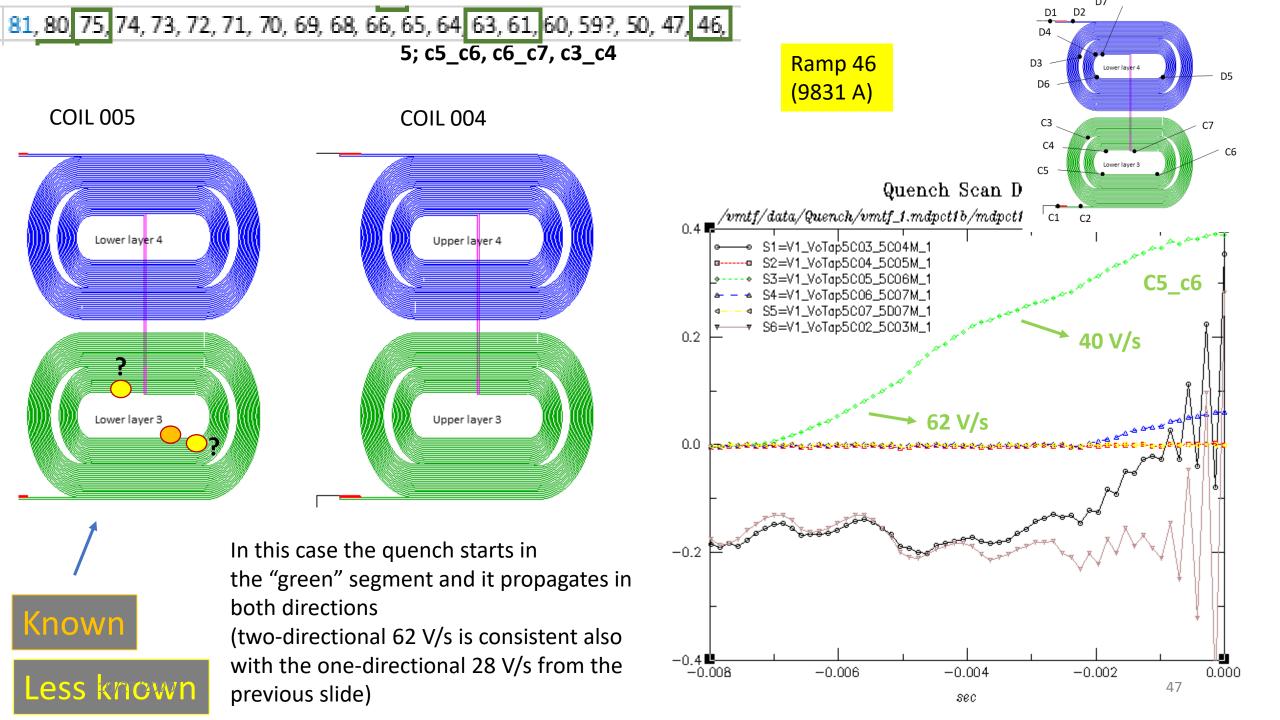
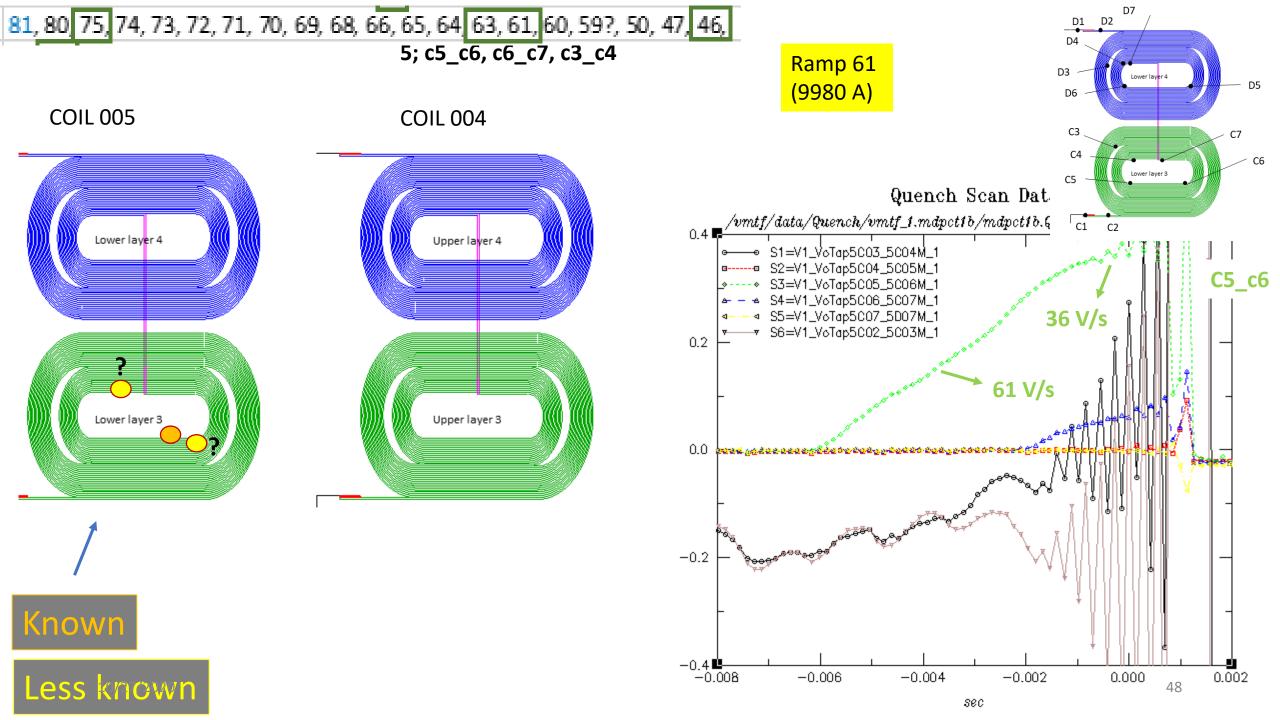
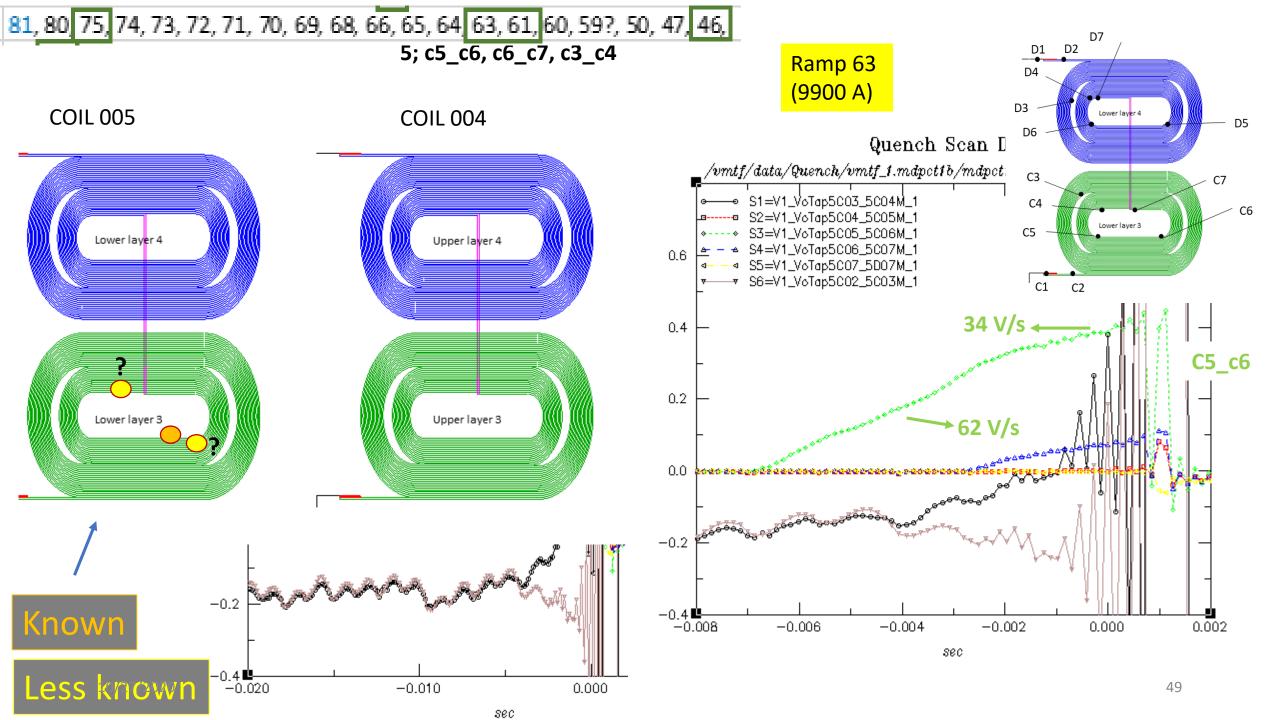
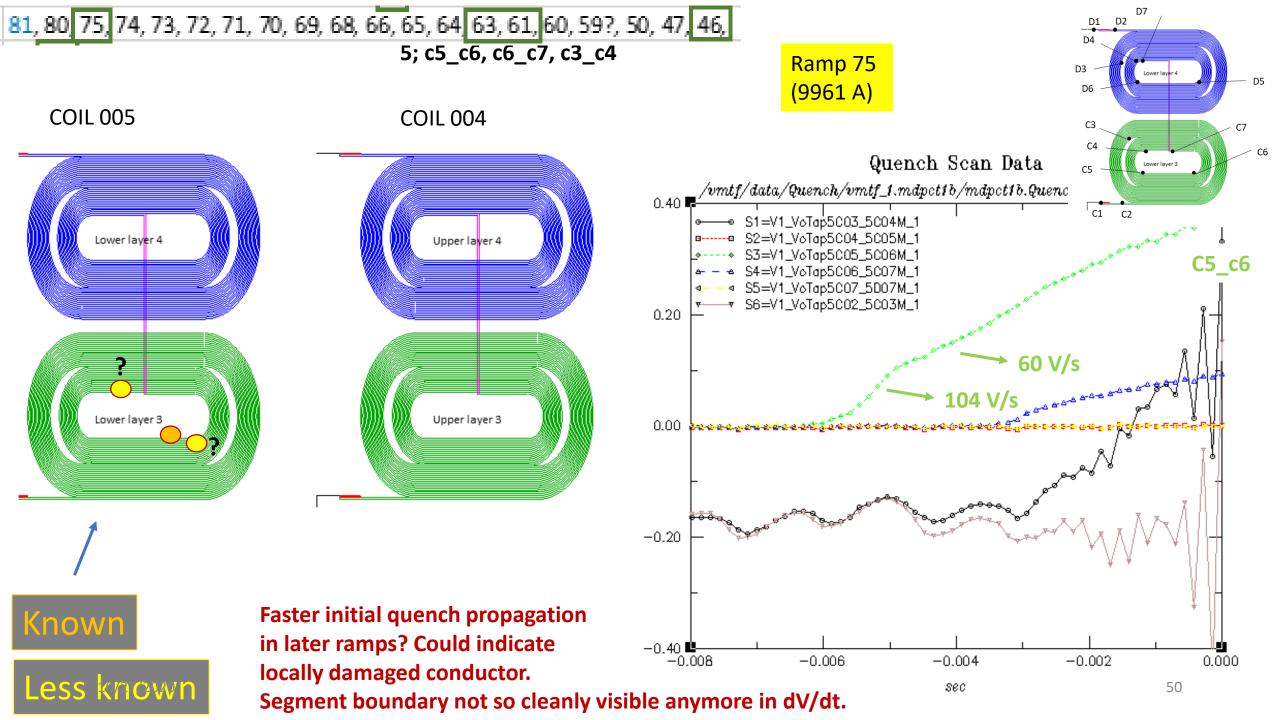
Pattern 3

(with limiting quenches)

(9883 A)
