**U.S. MAGNET  
DEVELOPMENT  
PROGRAM**

# CCT Progress Update

04/19/2017

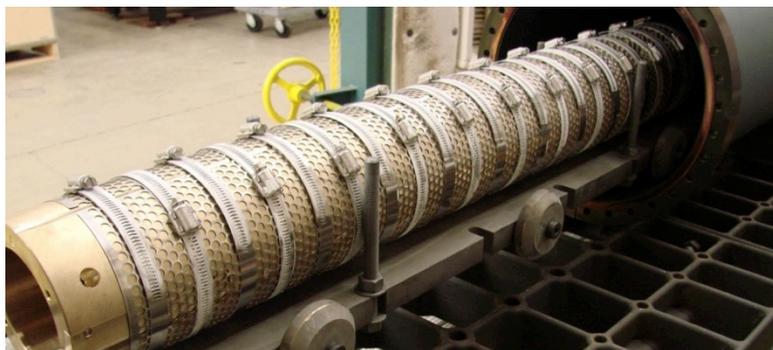
Heat Treatment

- Coil was wrapped with perforated stainless steel sheet and secured with hose clamps
- CCT3 Cable protrudes from the surface of the mandrel after heat treatment by ~1.5 mm
- Mandrel distortion could not be measured accurately due to cable protrusion
- Resistance from coil to mandrel after heat treatment is on the order of a few hundred  $\Omega$  due to Carbon residue on the glass braid

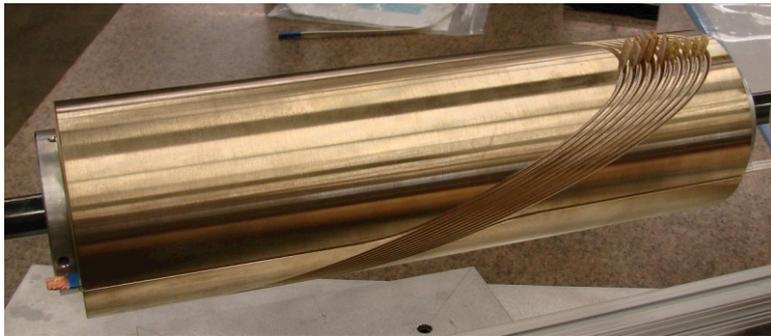
CCT Heat Treatment Test Mandrel

- Need to avoid conductor damage during heat treatment and assembly
- Test mandrel with large gaps at the pole was machined to further understanding
- Cable is removed and etched down to the sub-elements to inspect for damage
- No apparent damage was seen after initial test with added pole expansion space

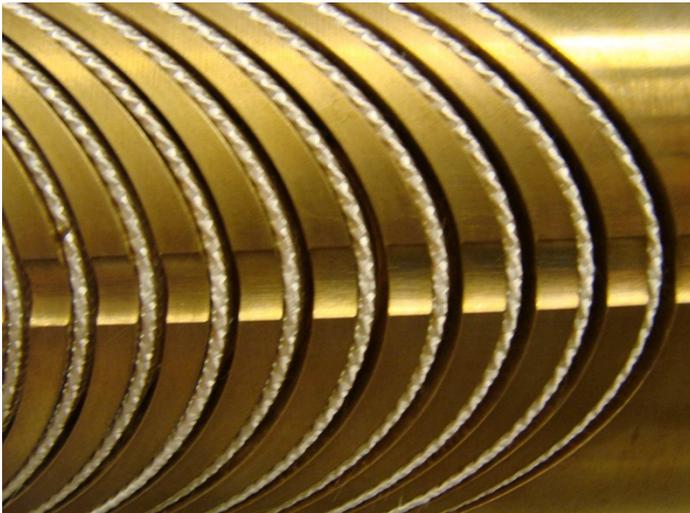
Pole Gaps

- CCT 4 Mandrels have 1.25 mm gap at the pole for cable expansion
- Other features are the same as CCT3
- Cable is wound against the inner surface of the turn at the pole
- Resistance to mandrel  $> 5 \text{ k}\Omega$ 
  - Wider groove by 0.1 mm
  - Extra space at the pole

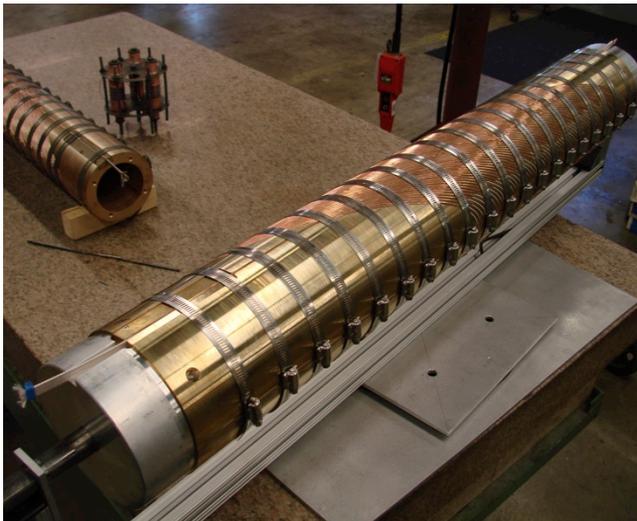
CCT4 Heat Treatment Configuration

- Copper wire was inserted into groove to force the cable to the bottom of the channel (same as 10-turn tests)
- Mandrel is wrapped with hose clamps
- Cable stays in channel after heat treatment
- Mandrels distort 0.5 – 1 mm after heat treatment in the N/S orientation
  - Not yet clear how much influence cable has on distortion as opposed to machining stress
  - May require additional annealing step after grooves are machined to avoid distortions
