U.S. MAGNET
DEVELOPMENT
PROGRAM

MDPCT1b Magnet Disassembly

MDP general meeting

March 31, 2021

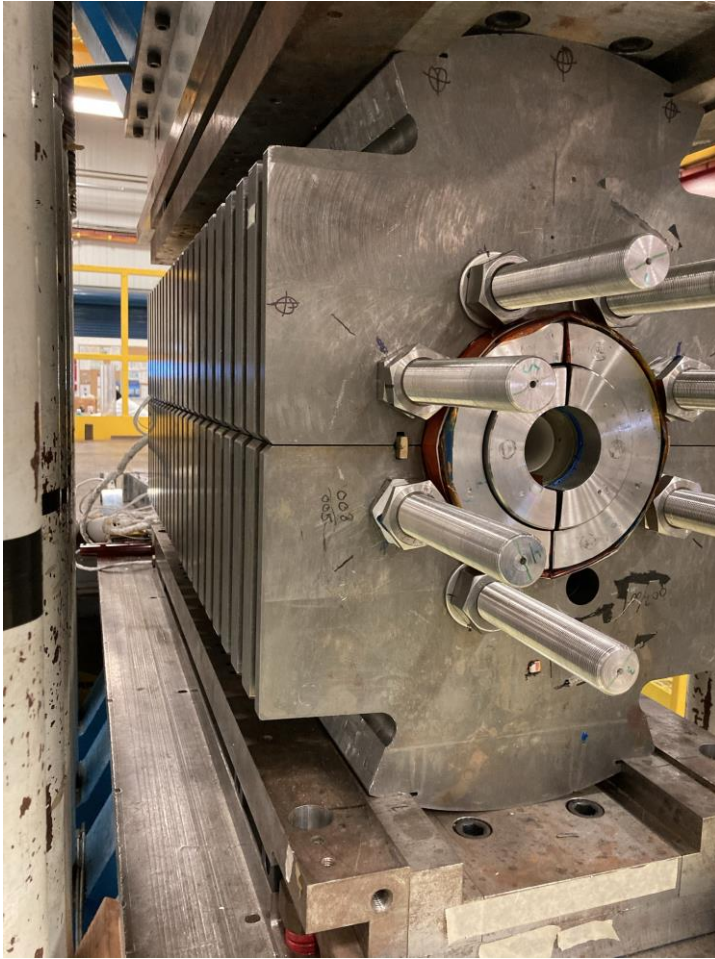
Magnet iron w/o clamps under press load

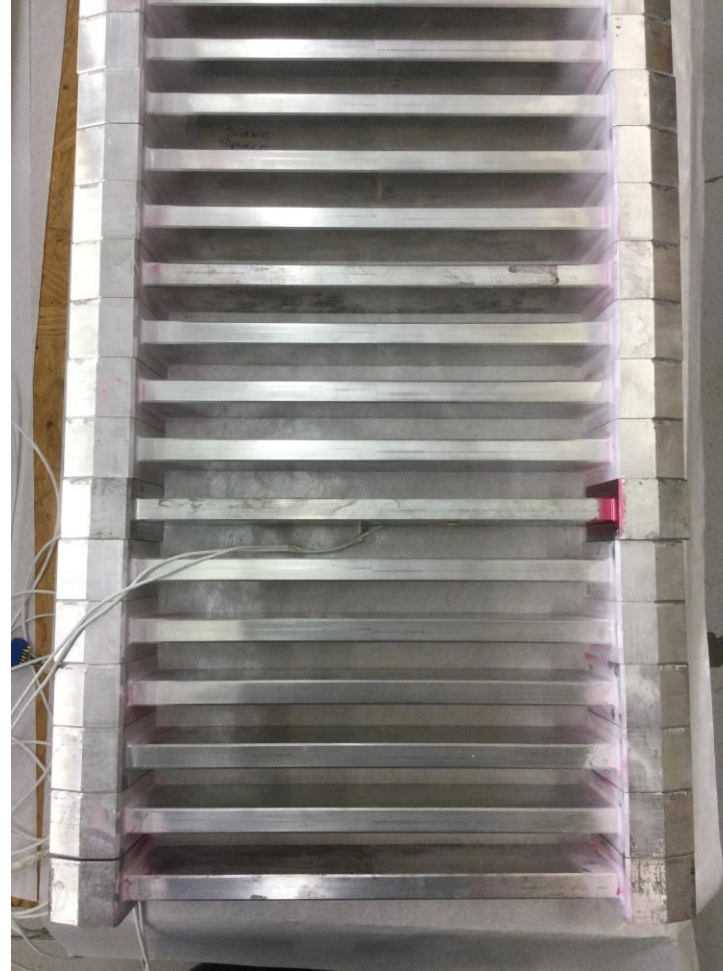
“Painted” clamps on the table

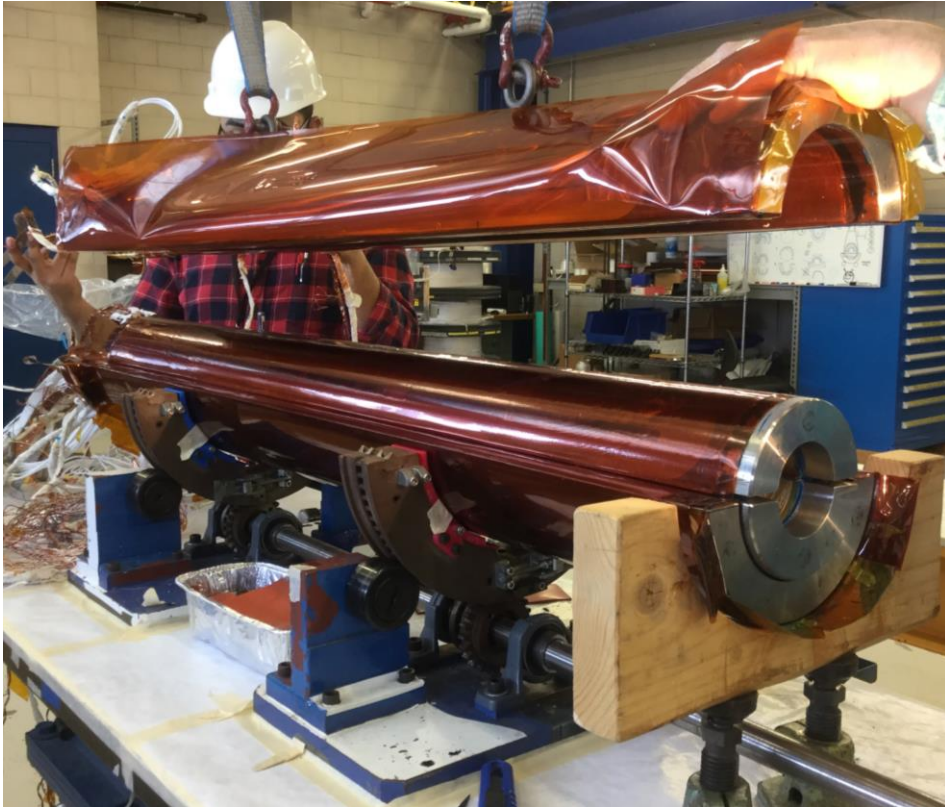
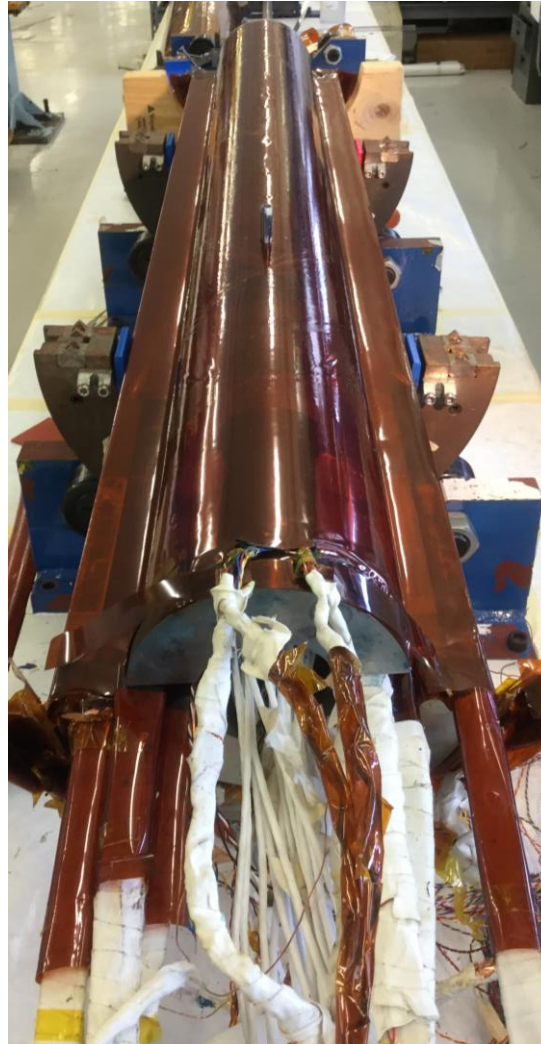
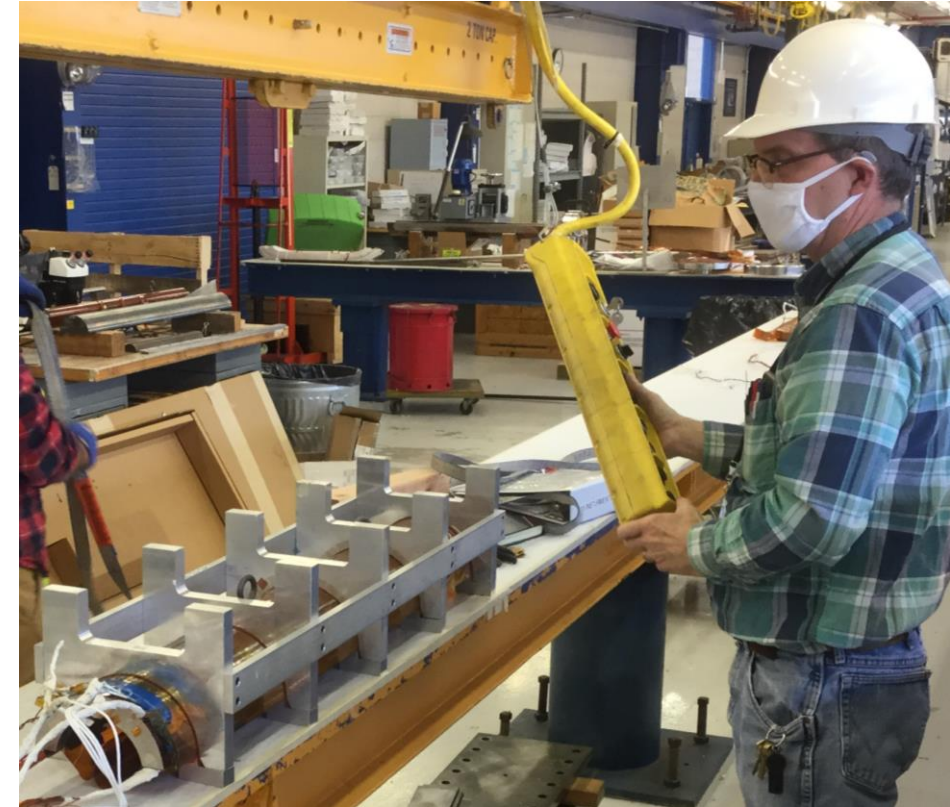
Lifting of the outer coil

Outer coil in the holding fixture
